**NATIONAL BUREAU OF AIR ACCIDENTS INVESTIGATION OF
UKRAINE**

PRELIMINARY REPORT

**of Investigation into Serious Incident, Which Took Place With CESSNA C510,
Reg. YR-CMO, Aircraft on March 03, 2021, During Operating Flight en Route
Kyiv (Zhulyany) – Odesa.**

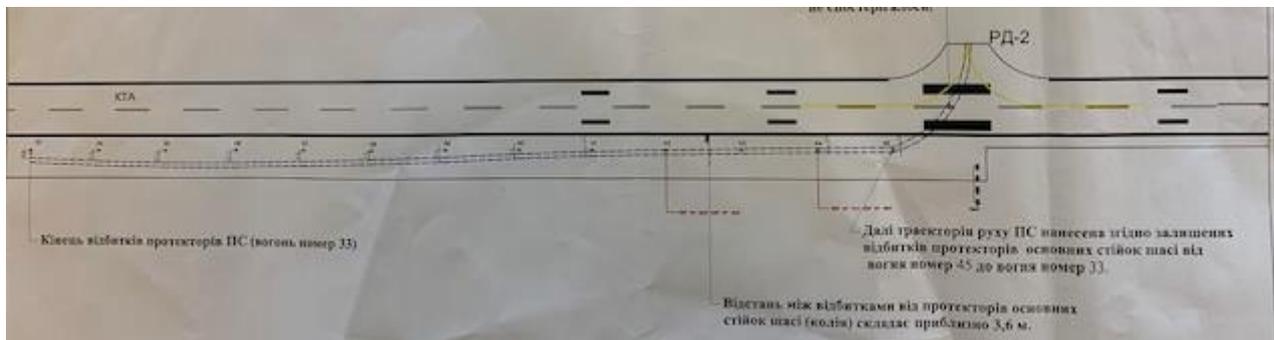
Fig. 1. The sketch-map of a serious incident with the Cessna C510 YR-CMO aircraft

At 18:12:15, the controller of the airport traffic control tower gave permission to the crew of the Cessna C510 aircraft to take off. According to the traces of the landing gear of the aircraft, which remained along the take-off line, the aircraft passed through the side lights № 44, 43 and 42, then moved to the left of the line of lights and took off at a heading of 259°. As a result of the collision and incursion, lights No. 44 and No. 42 were destroyed. The aircraft was not damaged.

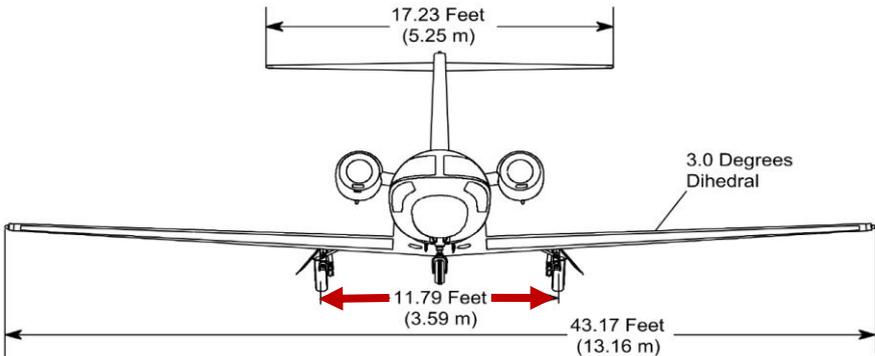
Fig. 2. Dimensions of Cessna C510 type aircraft

In order to confirm the assumption of the type of the aircraft that left wheel traces during take-off from the RWY26 side safety strip, information was requested from the NTSB on the Cessna C510 aircraft dimensions. According to the information provided by the aircraft manufacturer, the track width of the Cessna C510 aircraft is 11.79 feet (3 m 59 cm), which corresponds to the track width that remained on the left side safety strip of the RWY26.

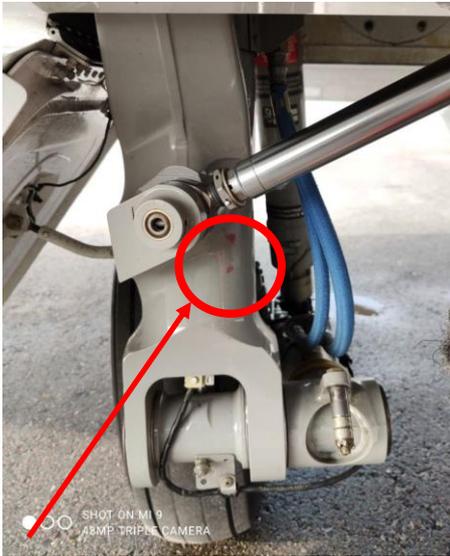
As a result of the incident, the aircraft was not damaged. After the aircraft returned from UKOO to UKKK and the aircraft was parked at L-17, the airport inspector, together with a representative of the handling company, took pictures of the right main landing gear of the Cessna C510 YR-CMO aircraft. On the right landing gear, red paint was clearly visible from the spring-loaded runway side light markers (see Figure 3).

Fig. 3. Photo of the right landing gear with a red mark from the spring-loaded runway side light markers

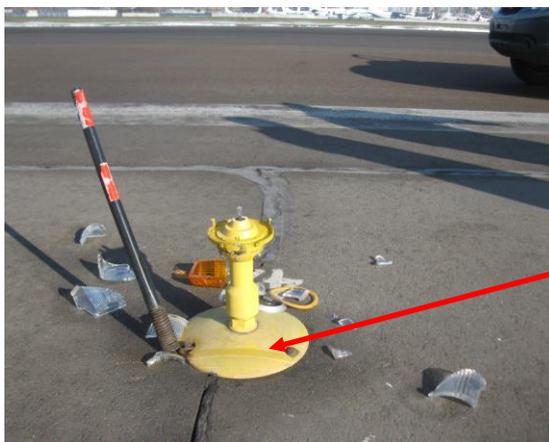
Fig. 4. Destroyed runway light No. 42.

As a result of the incident, the side lights of runways No 42 and 44 were damaged. Runway side light No. 42:

the upper part of the light was damaged, including the outer and inner scattering hoods and their attachments. At the base of the light attachment, a trace from the wheel of the landing gear of the aircraft is visible.

Aircraft wheel track

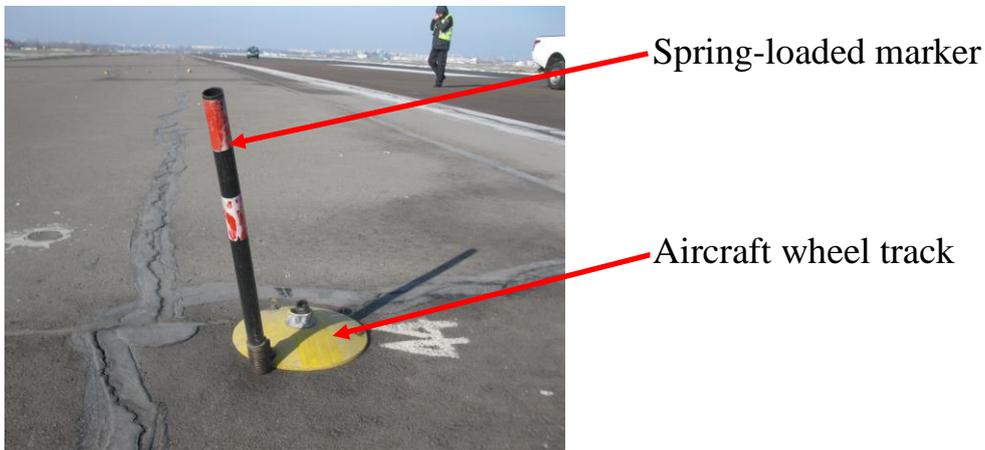
Fig. 3. Destroyed runway light No 44.

Runway side light No. 44:

the light is completely destroyed, fragments of light are scattered in the area between the lights No. 44 and 43. On the base of the light attachment, the aircraft wheel trace is clearly visible, which passes through the center of the base of the attachment.
