**FINAL REPORT**

**of Investigation into Serious Incident, Which Took Place With Piper PA30  
Twin Comanche, Reg. N918Y, Aircraft (Operator - INTERNATIONAL AIR  
SERVICES INC TRUSTEE 701 S CATRSON ST STE 200 Carson City NV  
89701 Corporation) on October 12, 2020, During Landing Roll at Lviv Airport.**

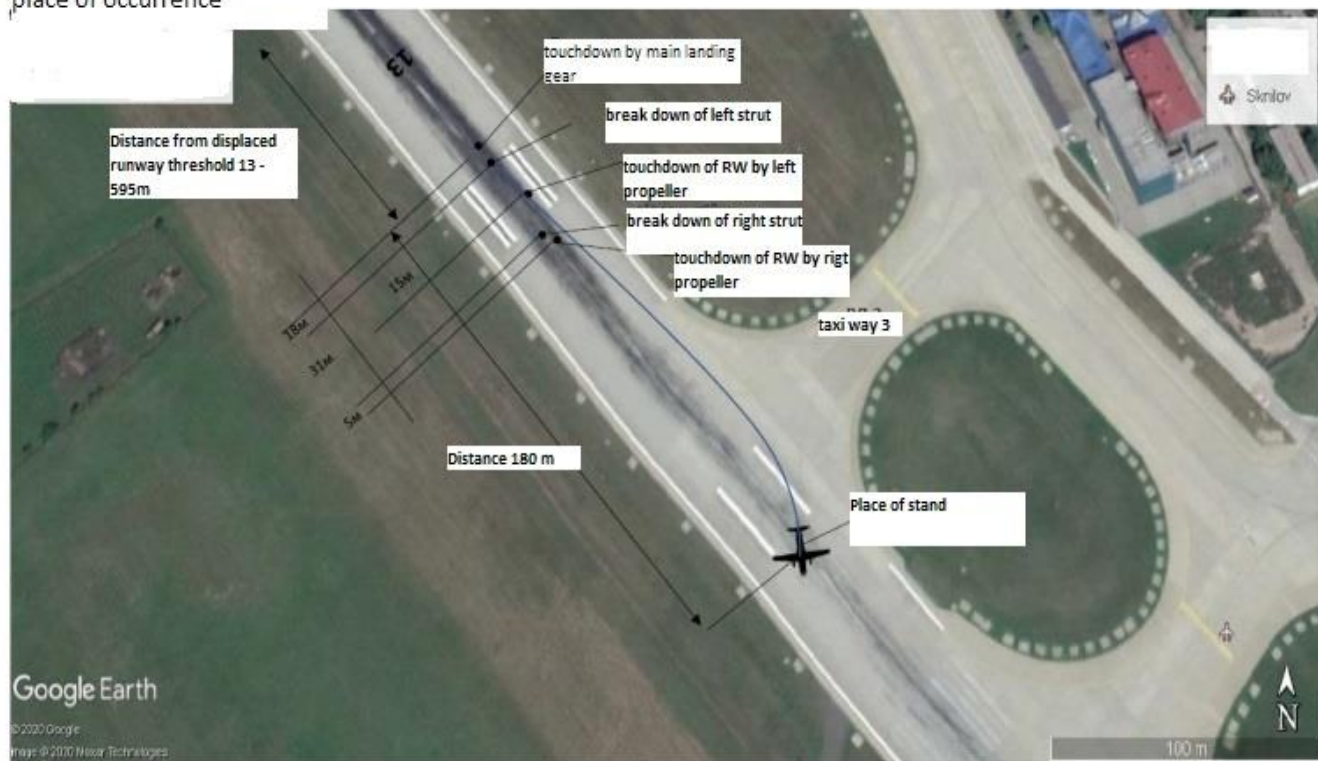
Part 1. Description of the  
place of occurrence

1) Touchdown point from runway threshold 13 - 595m; 2) Distance of moving down runway - 180m; 3) Place of aircraft stand from Runway threshold 13 - 775m on-course 175 o

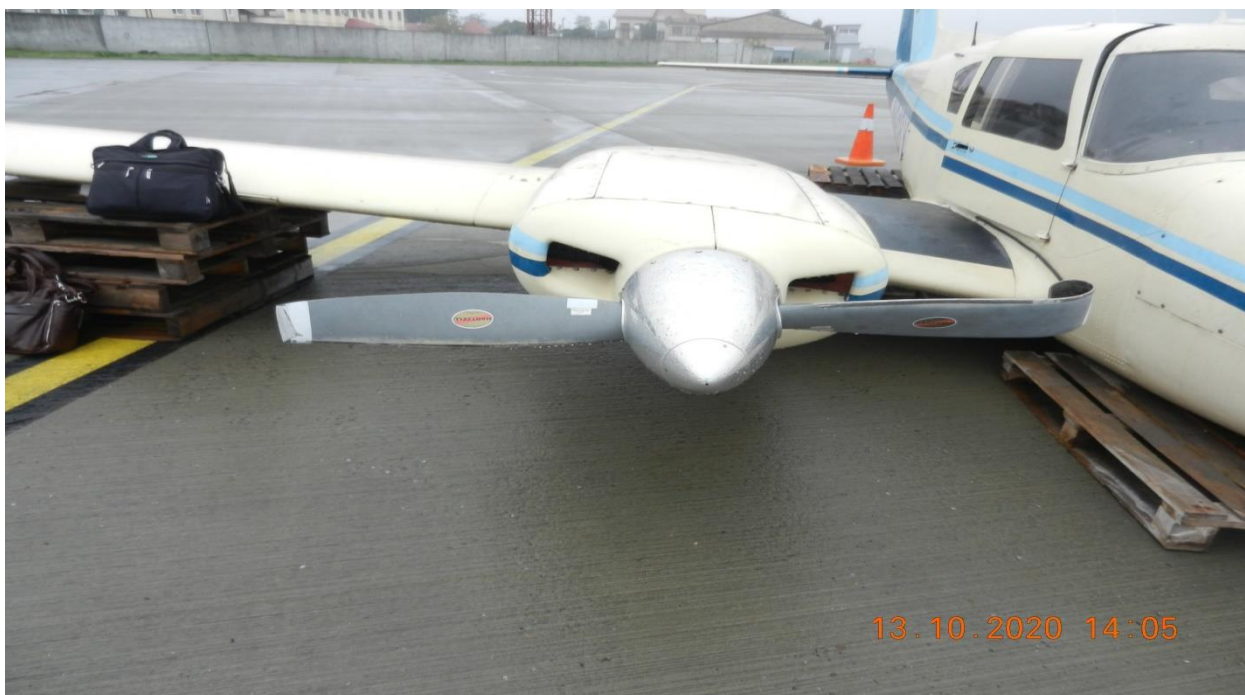
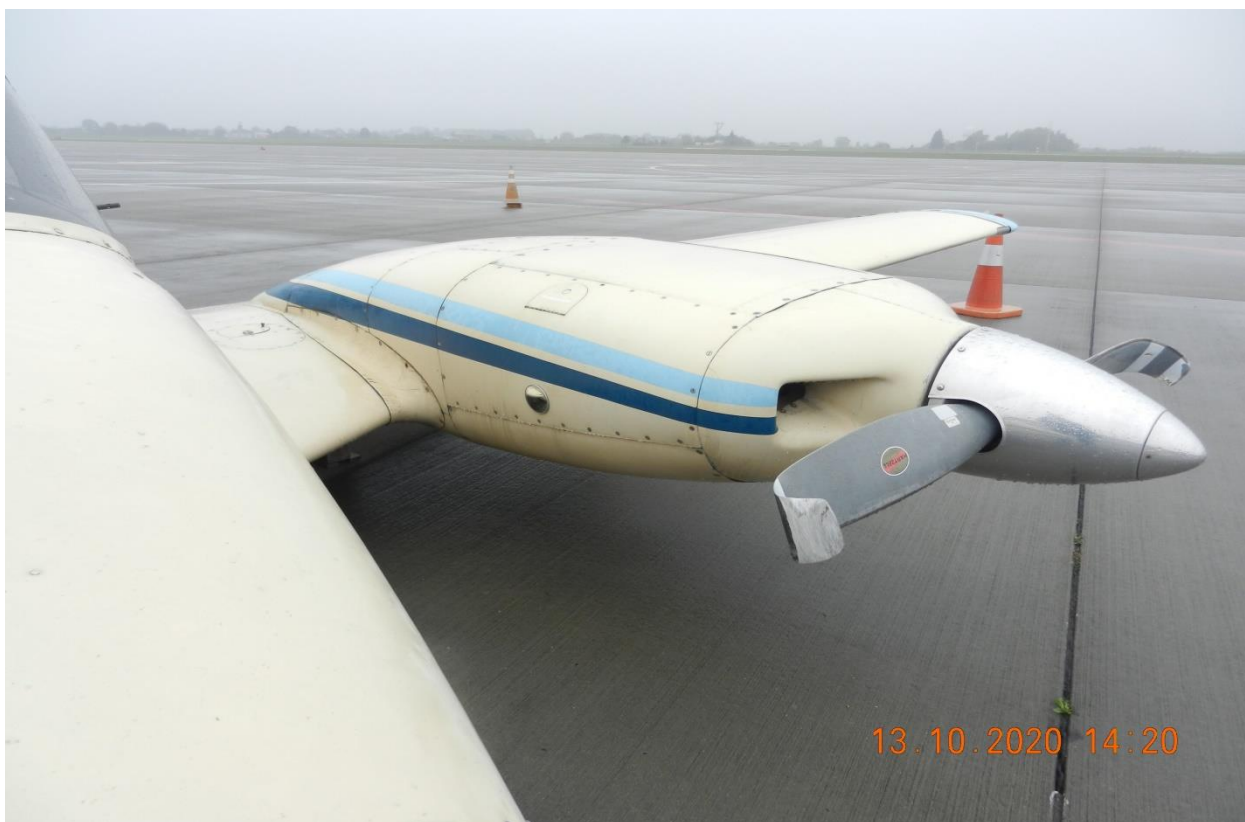
The aircraft inspection revealed:  
Deformed propeller blades of both engines;

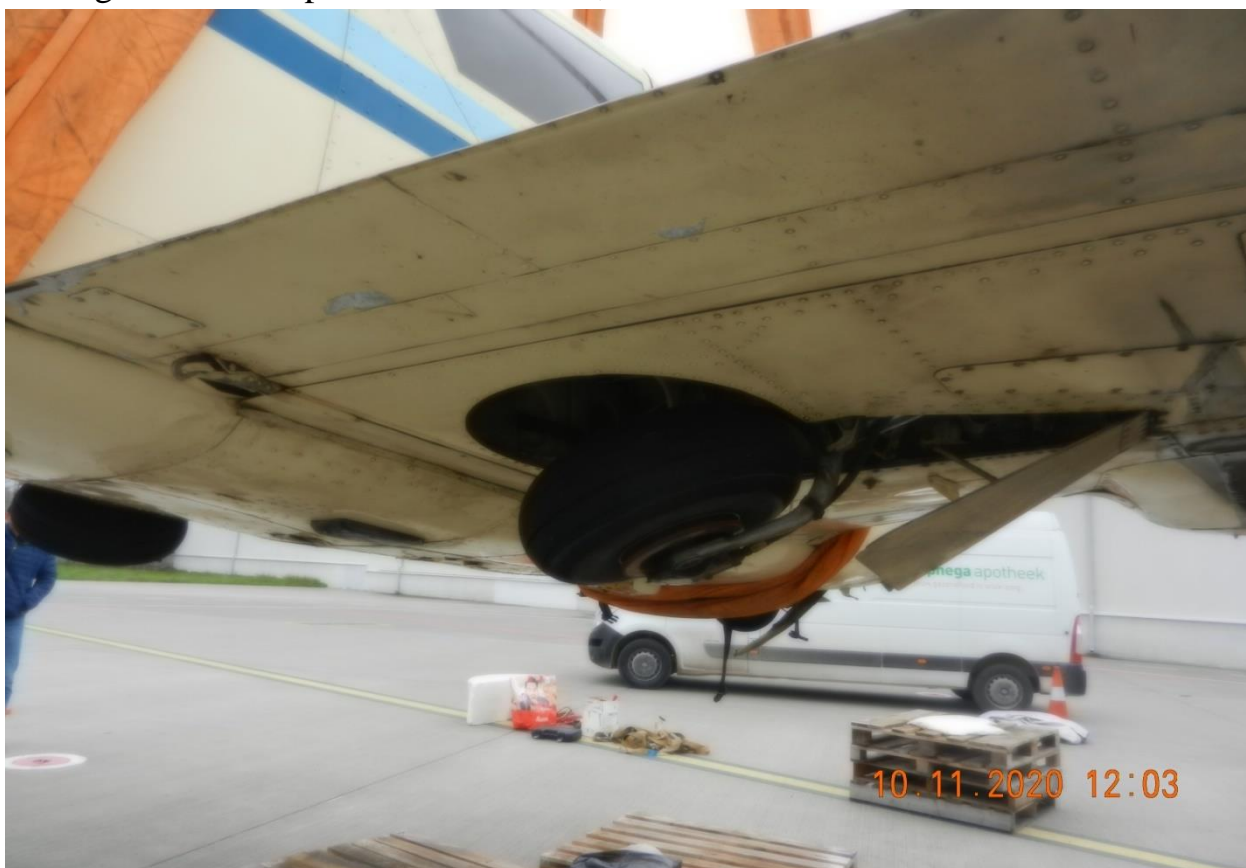
Damaged brake calipers of both wheels;

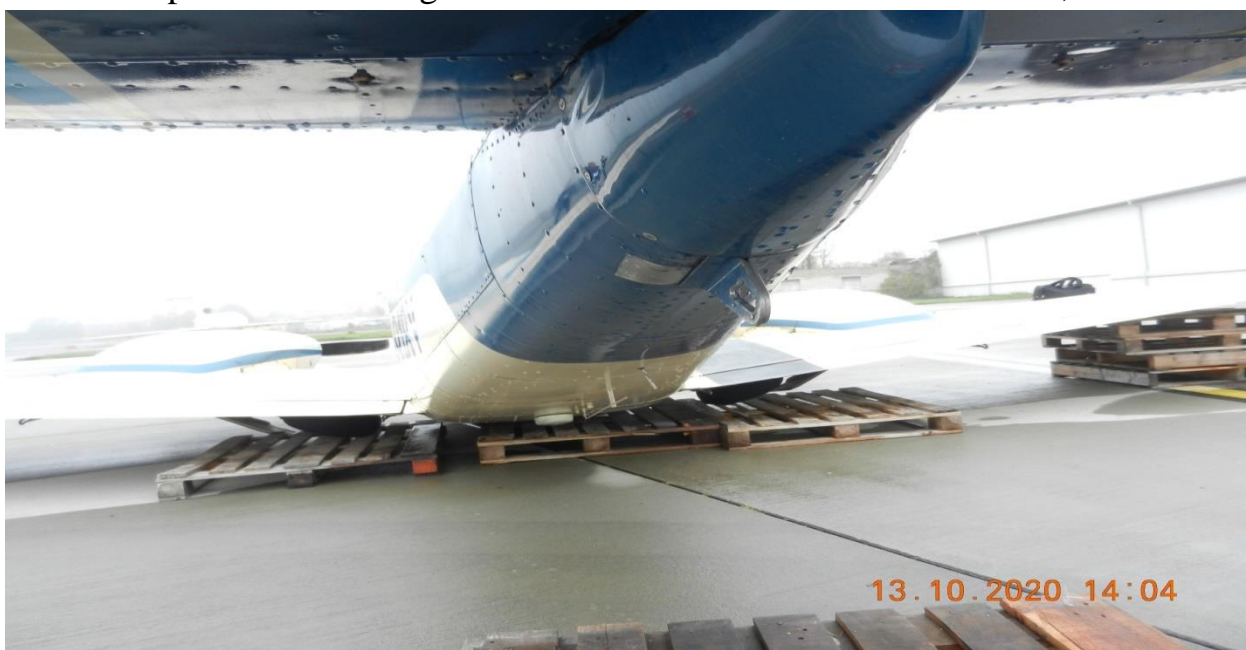
The lower part of the fuselage is deformed between the 4 and 5 frames;

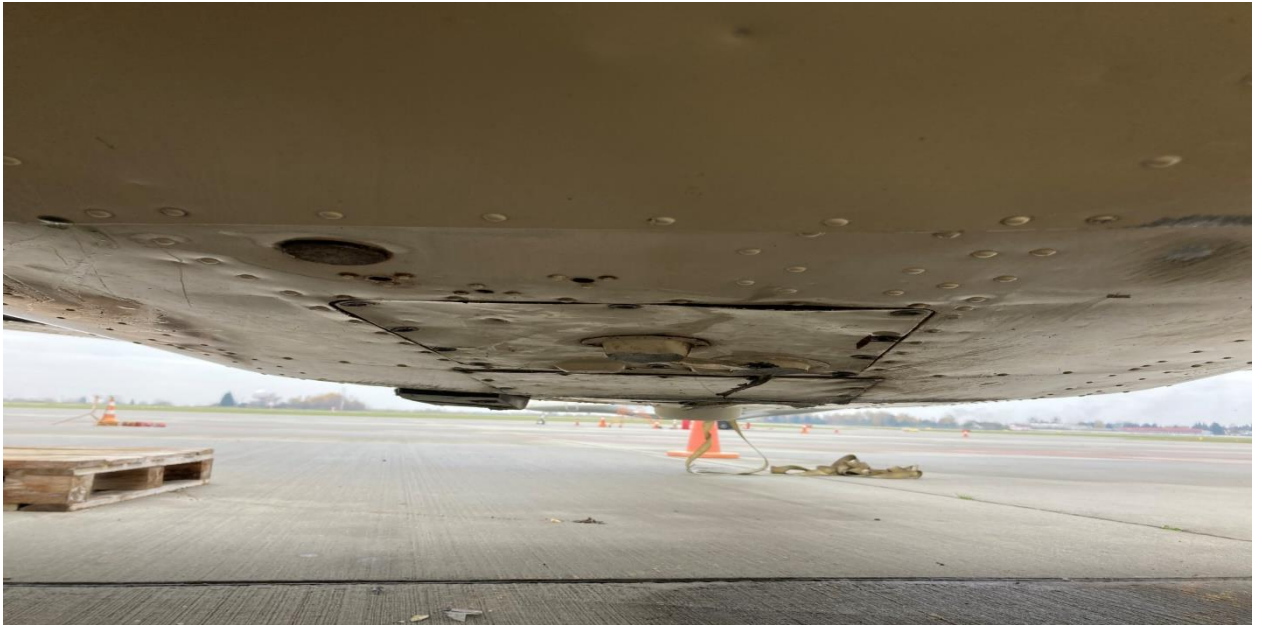
The cover of the inspection hatch of the fuel valves is deformed;

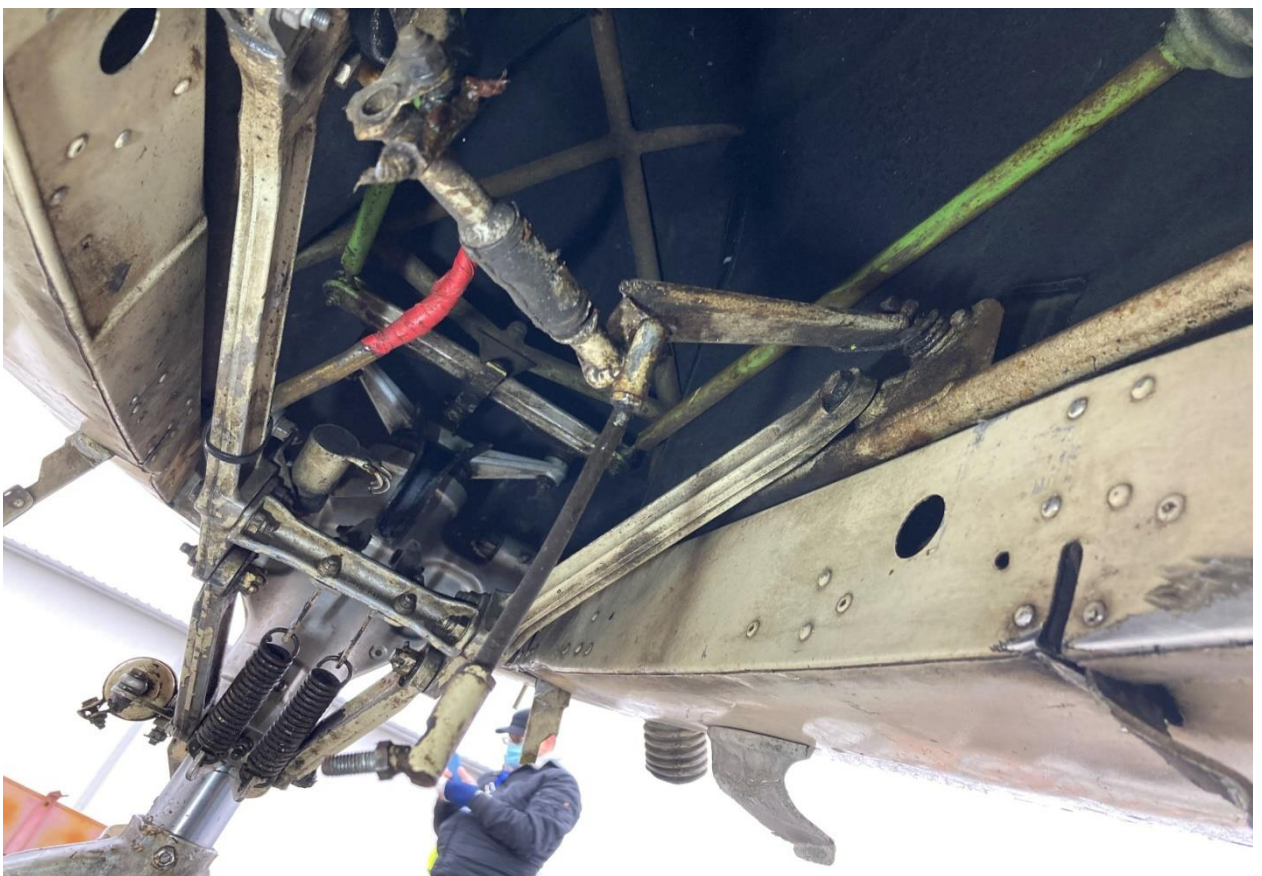
The mechanism of opening-closing the nose landing gear doors is damaged;

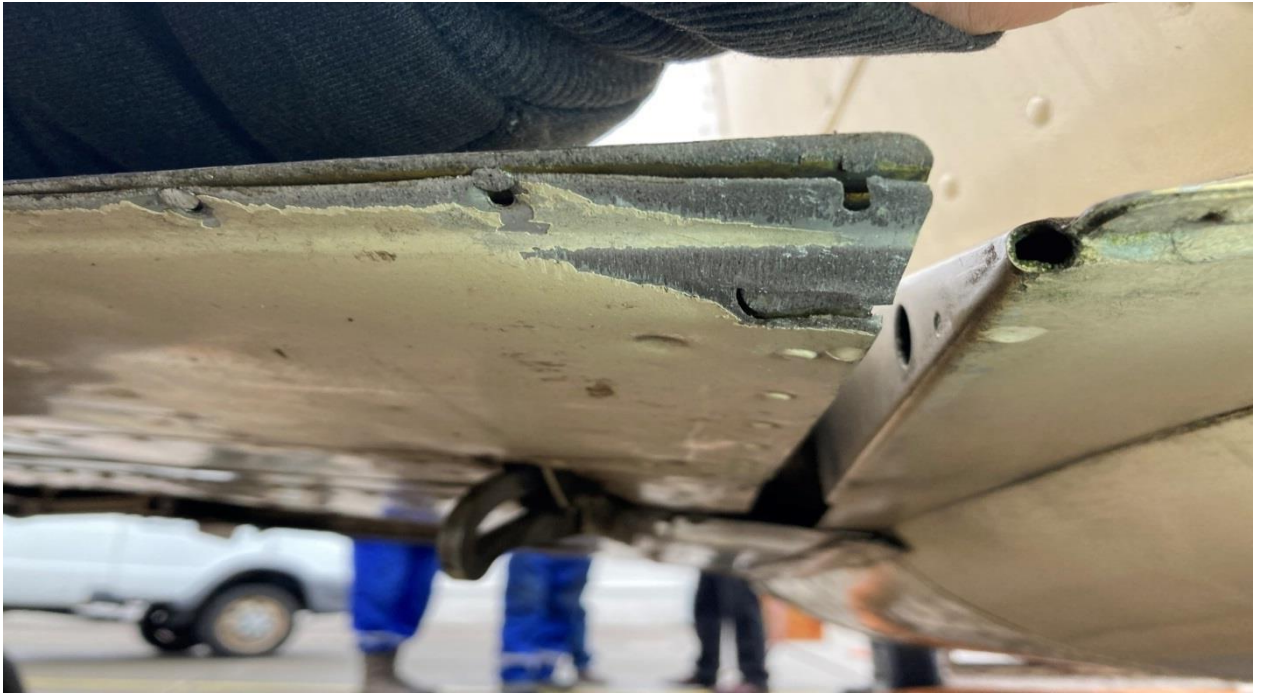
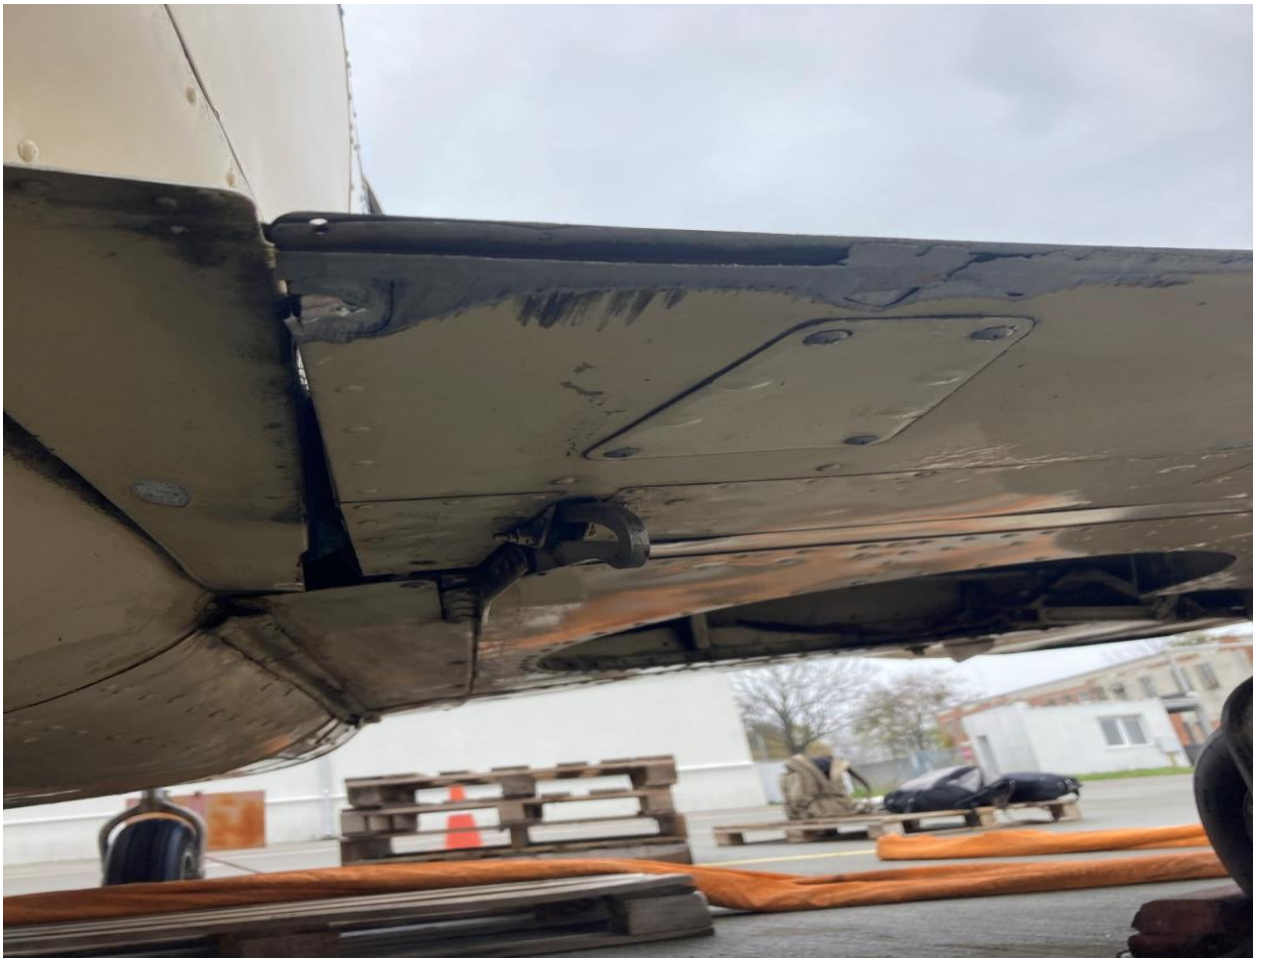
The lower skin of both flaps in the root part is worn out;

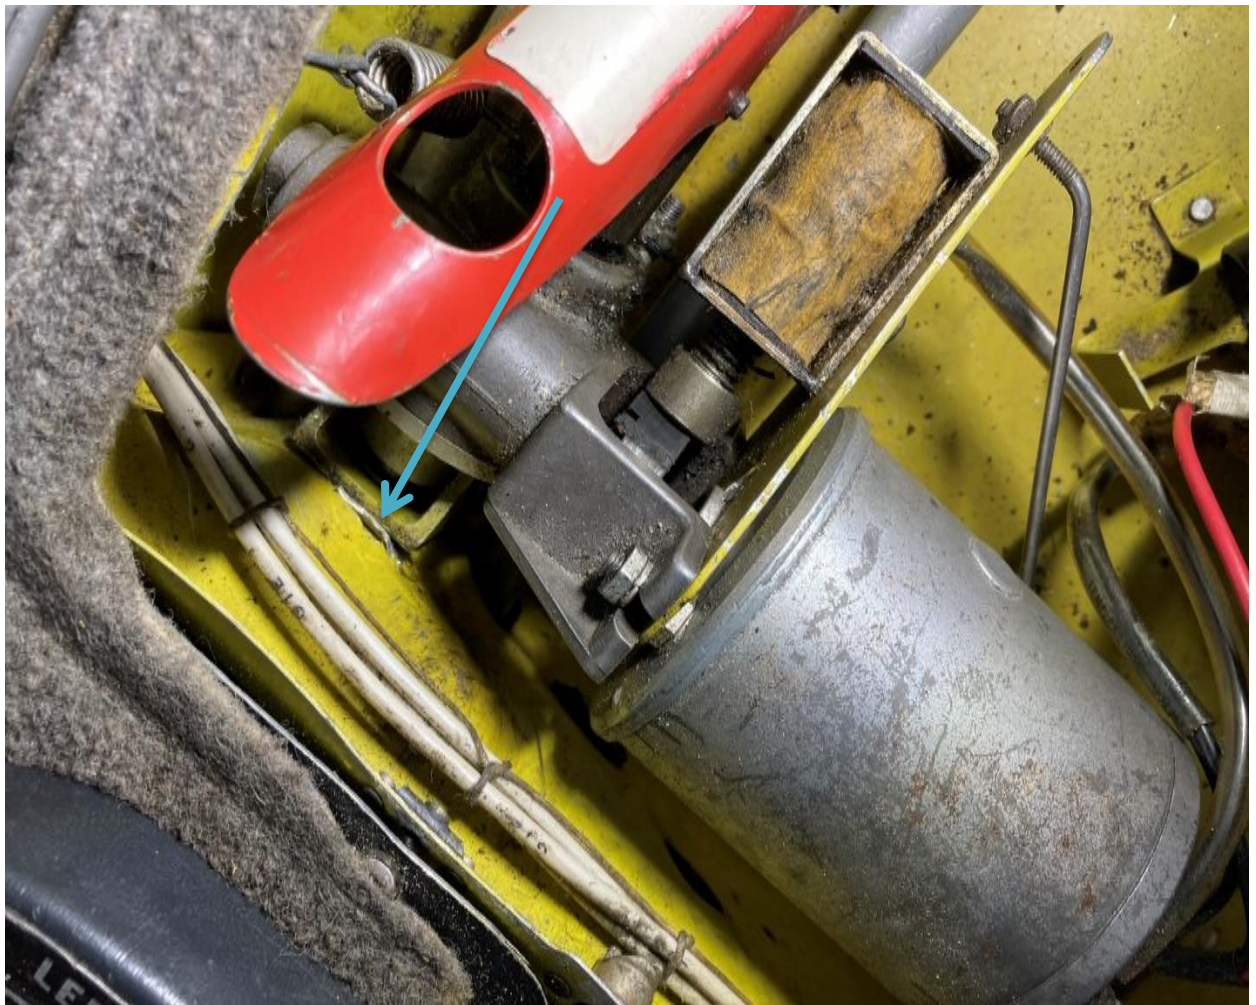
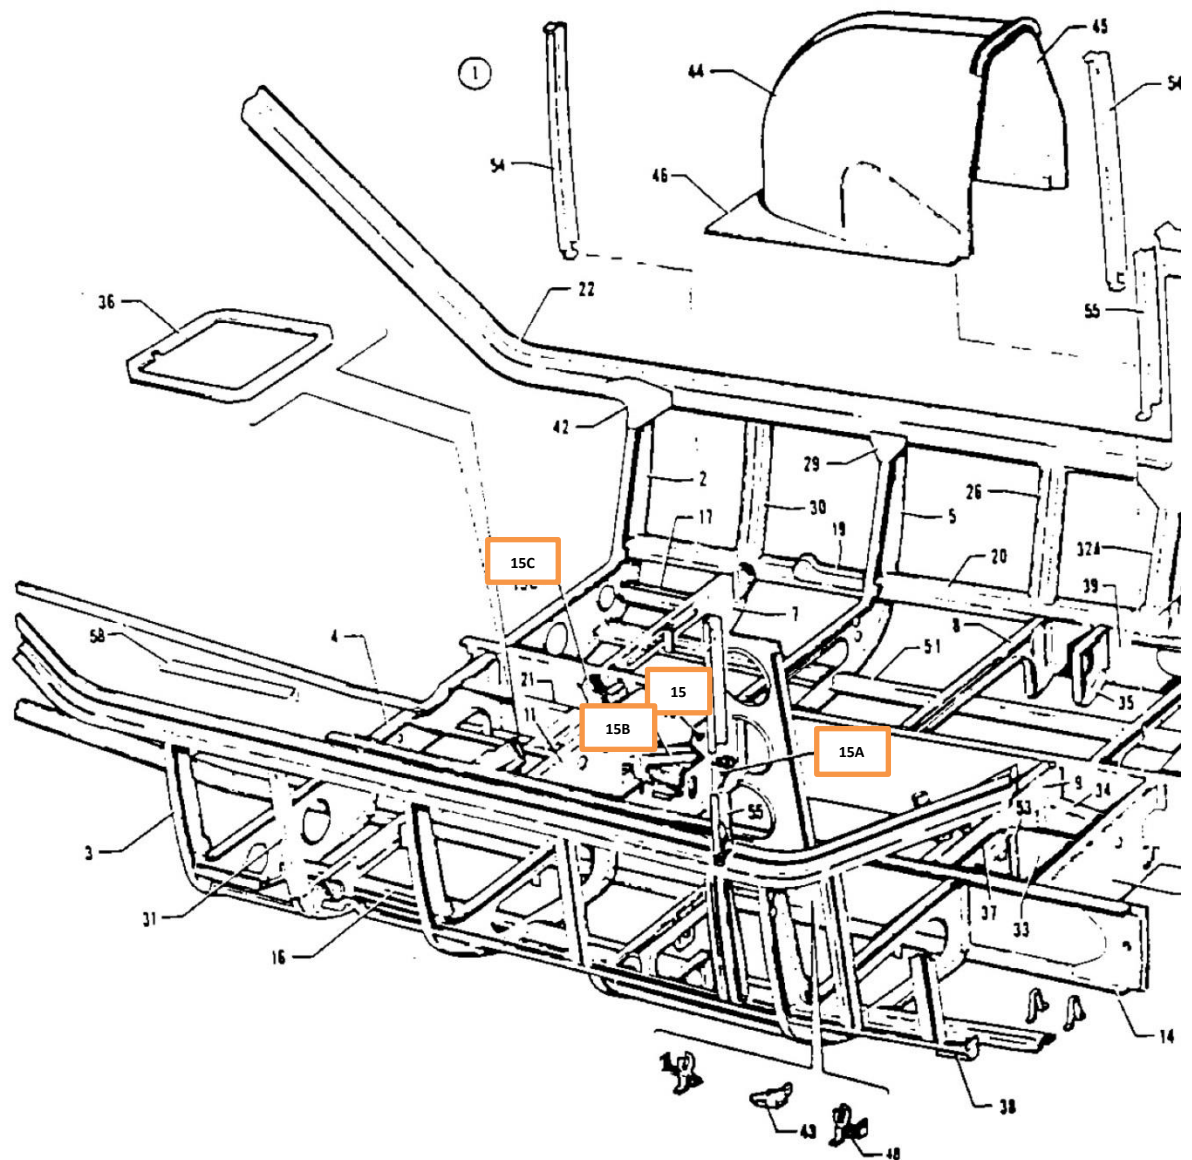
Figure 10. Fuselage Front Frame Assembly

Also there was found destruction of the frame, part No. 22631-02, with support, part No. 20954-00, and spar caps, part No. 20557-06, due to fatigue at the attachment point of the gear motor.

Loss of elasticity of rubber auxiliary left and right landing gear retraction and extension amplifiers (bungee shock cords), part No. 31322-07, which led to an increase in alternating pressure forces acting on the gear motor for landing gear retraction and extension, which in turn contributed to the development of the destruction of the bulkhead, part No.22631-02, with caliper, part No.20954-00, and spar cap, part No.20557-06, as a result of material fatigue at the point of attachment of the gear motor.

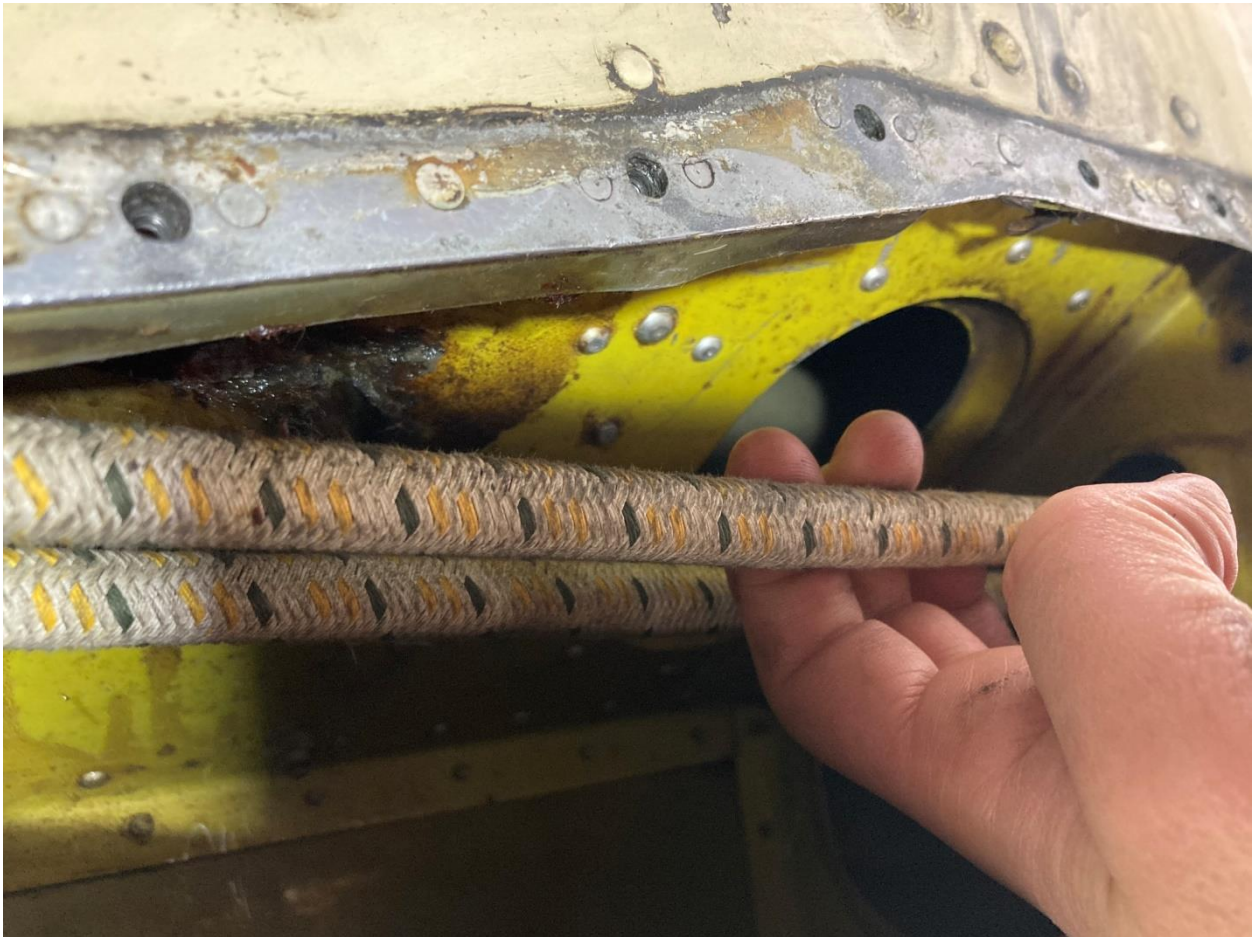
Marking of rubber auxiliary retraction and extension amplifiers for left and right landing gears (rubber main gear bungee shock cord) of part. No. 31322-07 in accordance with paragraph 3.7.1. MIL-C-5651D indicates that the components were produced in the fourth quarter of 2010, 2015 or 2020. According to the aircraft

logbook, the last replacement of these parts was performed on August 10, 2015. Therefore, the closest date for the production of parts was the fourth quarter of 2010. The service life of the specified parts is 3 years or 500 flight hours in accordance with paragraph 13 of Section J of the Piper Twin Comanche Service Manual of PA-30 – Description of Aircraft Systems Operation. Thus, the loss of elasticity exists as a consequence of their physical aging for ten years from the date of manufacture.

- Adhere to the proper control over the aircraft maintenance works with more strict control during maintenance of the life-limited units and components.
