**NATIONAL BUREAU  
OF AIR ACCIDENTS INVESTIGATION**

**FINAL REPORT**

**RUNWAY EXCURSION  
DURING LANDING AT “ODESA” AERODROME**

### **on Investigation into Accident (Runway Excursion) with Aircraft B-737-800, Registration No. TC-JGZ, Which Took Place on November 21, 2019, During Landing at "Odesa" Aerodrome**

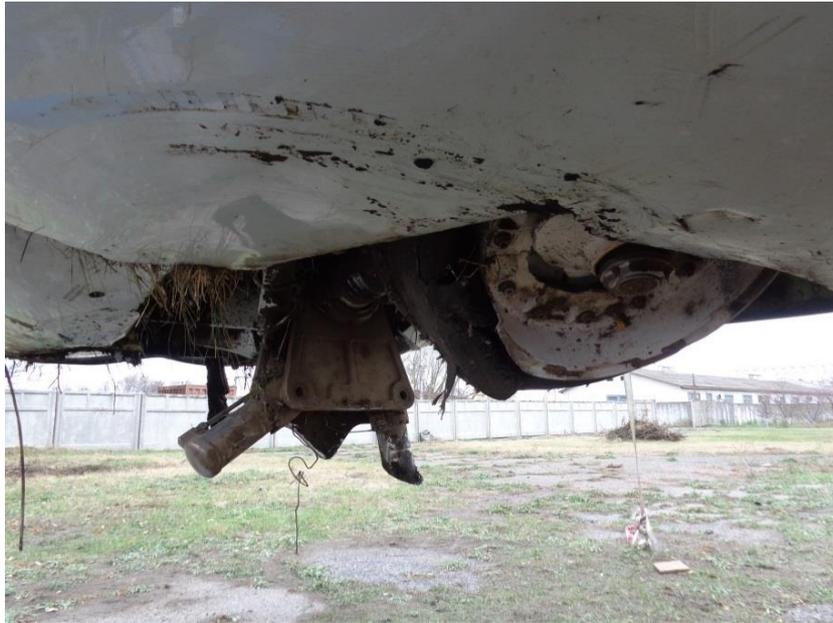
- Destruction of the retraction and extension link attachment assembly of the nose landing gear (NLG), collapse of the NLG backward vs. the flight direction, with destruction of the fuselage skinning and electronic equipment access door (Photos 1, 2, 3);

Photo 1. NLG position after the accident

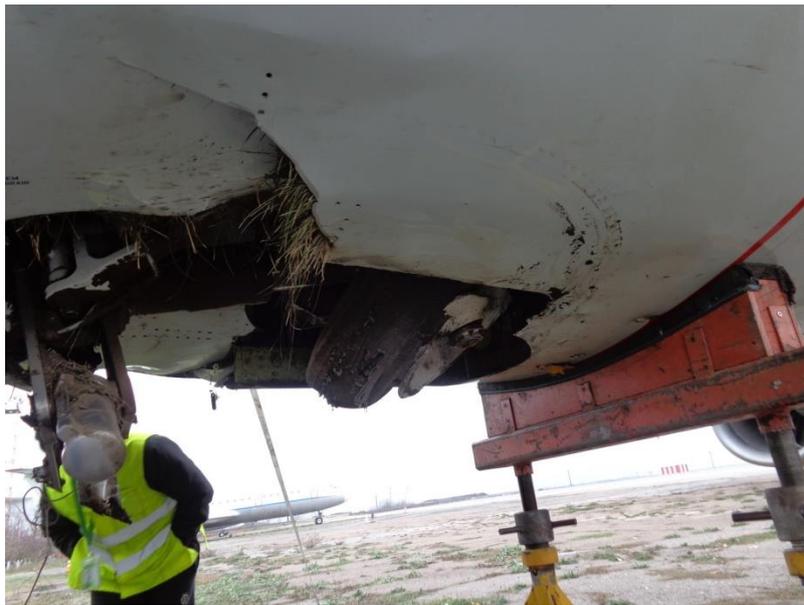
Photo 2. Destruction of the lower fuselage skinning due to NLG collapse

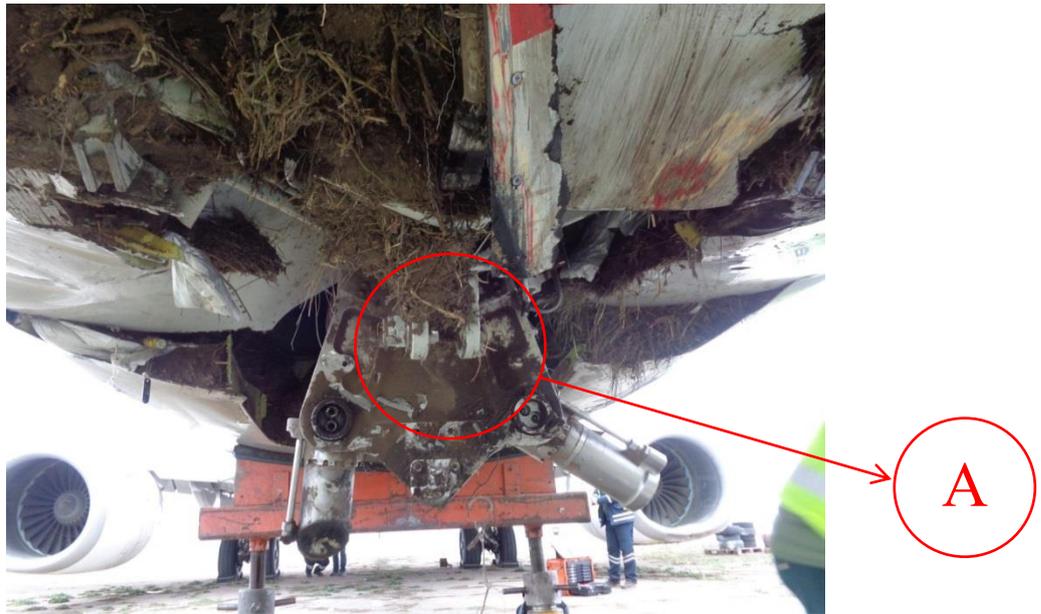
Photo 3. NLG retraction and extension link attachment assembly

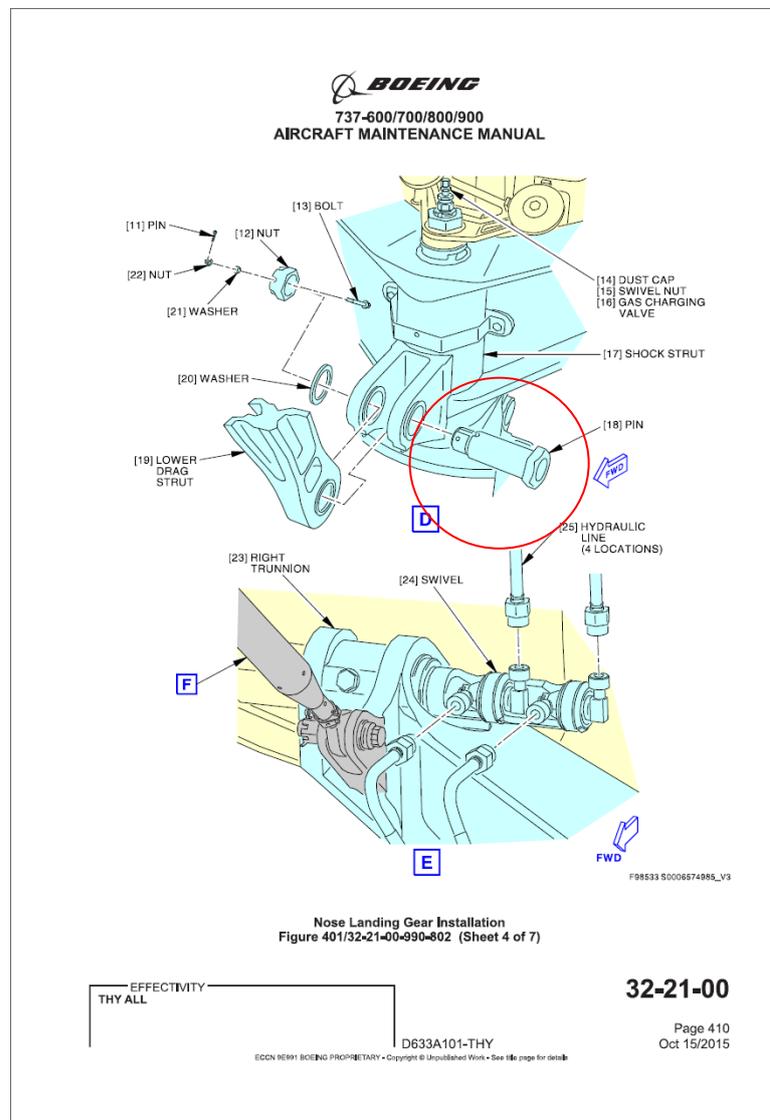
Fig.1

On the soil, at the distance of approximately 125-130 m from the NLG exit point of the left side boundary of the runway, the investigation team found the remains of a bolt (Photo 4, 5) of the NLG retraction and extension link attachment assembly (AMM 32-21-00 p.410 [18] PIN) (Fig.1).

**Note:** Upon exit of the aircraft nose landing gear to the soil with the destroyed left wheel turned to the right, the NLG retraction and extension link attachment assembly suffered off-design loads due to deepening into the soil during 120-130 meter movement, which led to NLG collapse backward vs. the flight direction, and aircraft nose section sinking down onto the ground.

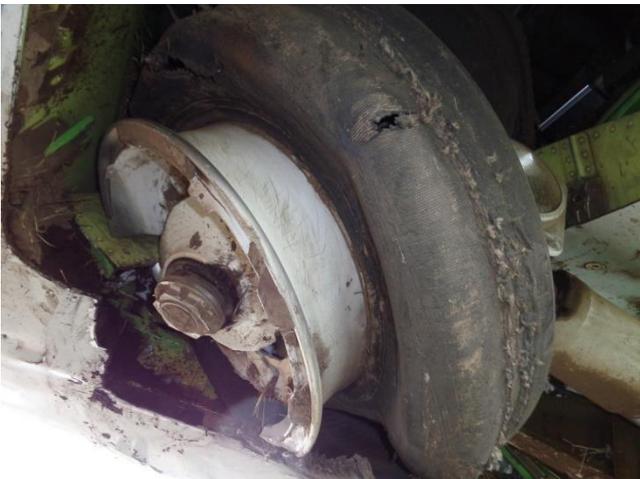
- destruction of the left wheel and left and right tires of the NLG (Photos 6, 7);

*Note: The condition of the tires indicates that the NLG wheels were turning and skidding when the aircraft was moving, and the NLG was turned to the right of the aircraft movement direction.*

Photo 6. NLG left wheel destruction

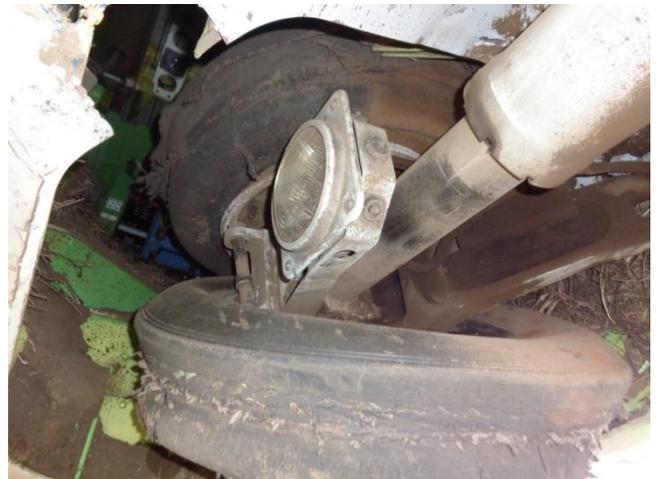
Photo 7. NLG tire destruction

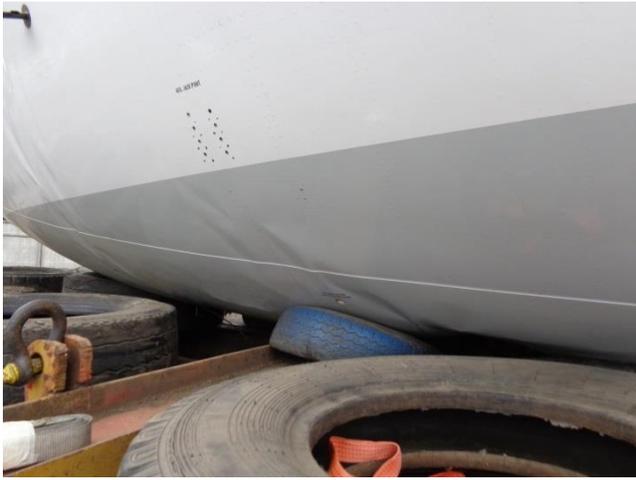
- deformation (corrugations) of the lower left and right skin of the fuselage nose section, deformation of bulkheads and stringers STA 178 to STA 259.5 (Photos 8, 9);

Photo 8. Lower nose part of the aircraft  
(left one)

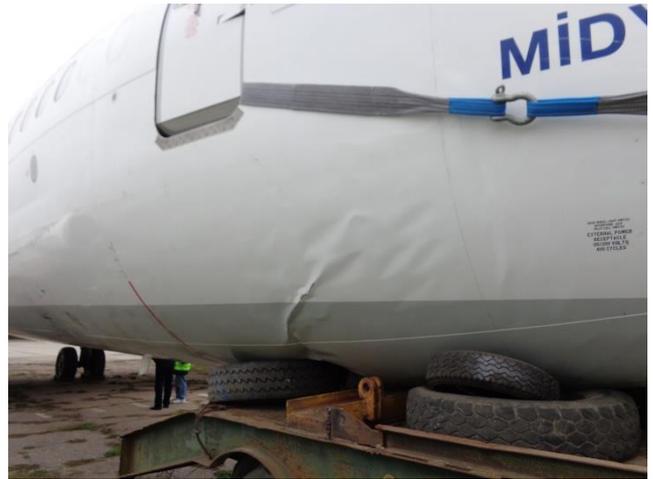
Photo 9. Lower nose part of the aircraft  
(right one)

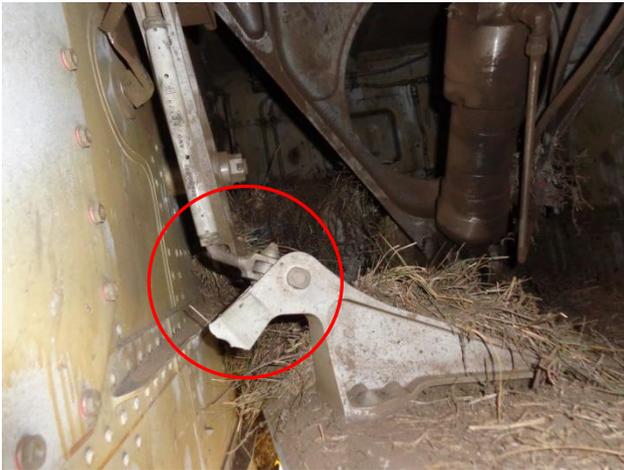
- destruction and damage of the NLG door extension-retraction mechanism and damage of NLG doors (Photos 10, 11, 12);

*Note: destruction of the NLG door extension-retraction mechanism took place after NLG collapse and aircraft nose section sinking down onto the ground.*

Photo 10. NLG right door attachment and  
retraction-and-extension assembly

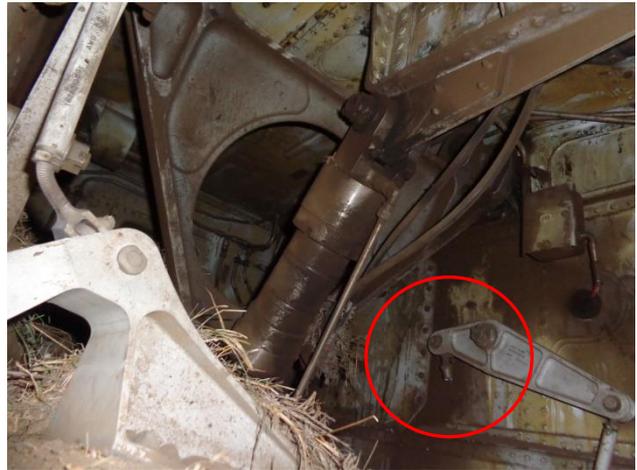
Photo 11. NLG left door retraction-and-  
extension mechanism assembly

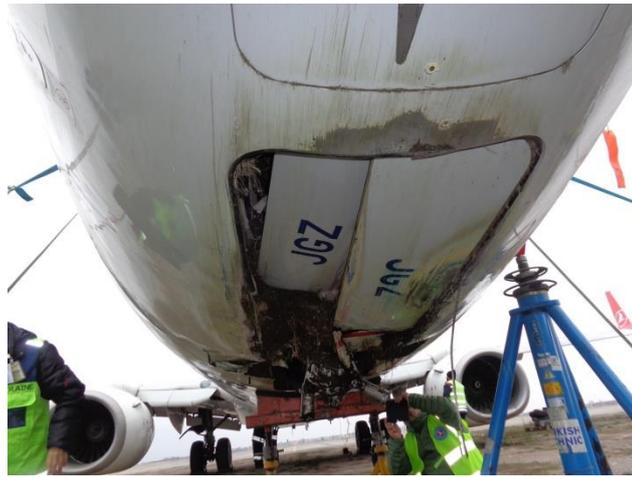
Photo 12. Damage to NLG doors

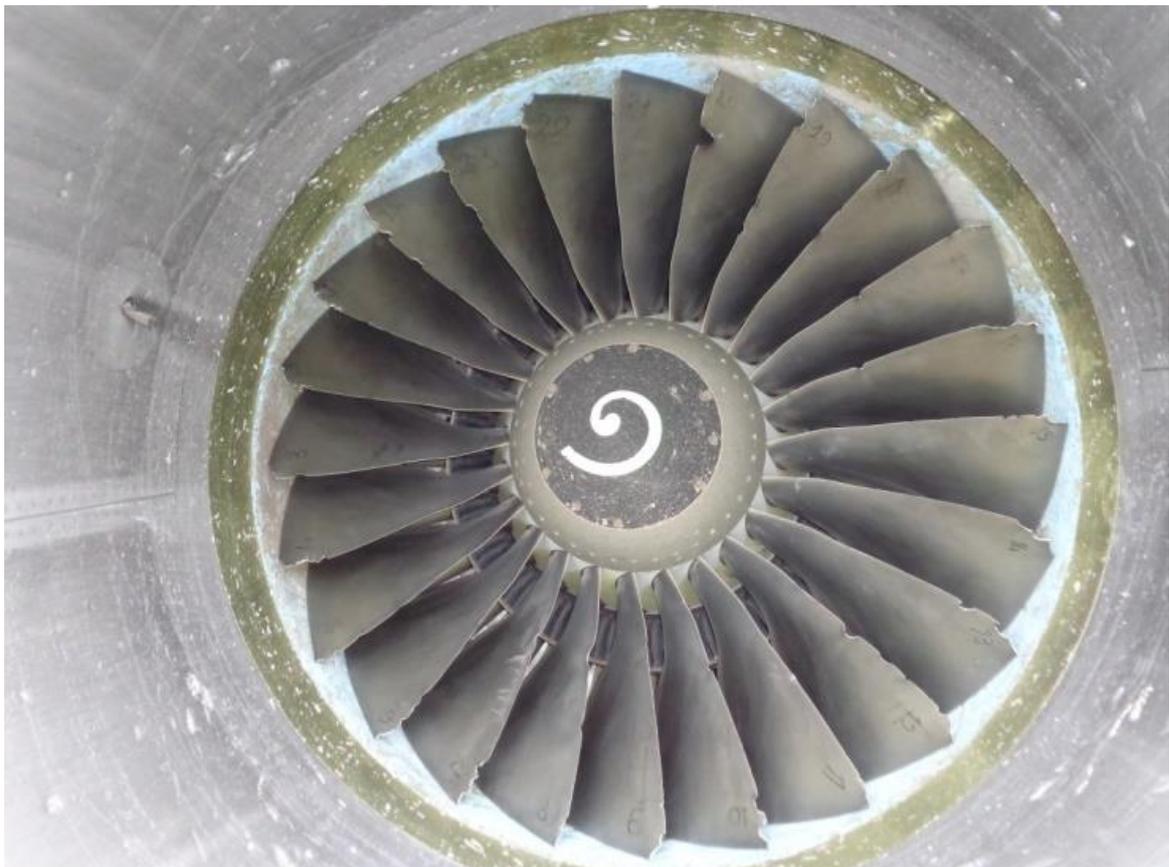
- multiple damage of the acoustic panel and blades of the engine fan No.1 (Photo 13.)

*Note: Damage to the acoustic panel and fan blades of the engine No.1 occurred due to foreign objects penetration into the running engine as a result of NLG deepening into the soil and movement after the aircraft exit from the runway and left engine contact with the ground.*

Photo 13. Damage to the acoustic panel and all blades of engine No.1

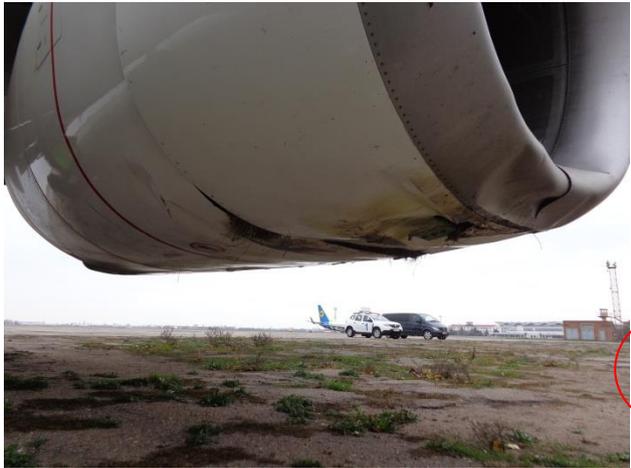
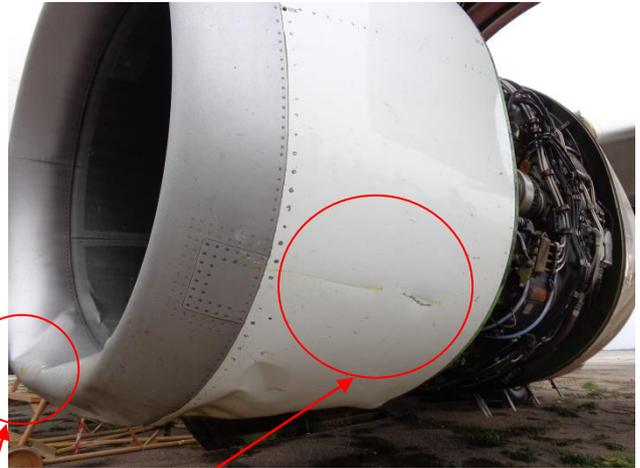
- damage to the inlet guide vanes, left side and bottom of the composite skin of the hoods of engine No.1 caused by collision with side lights and friction with the soil after the aircraft exit from the runway (Photos 14, 15);

Traces of collision with side lights

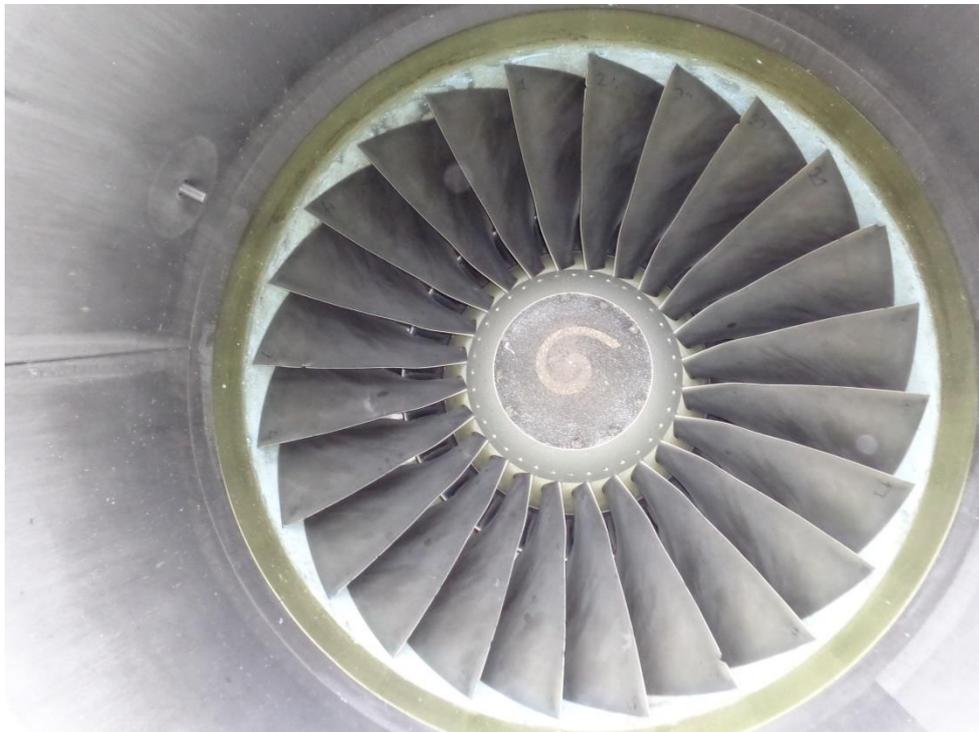
Photo 16

- damage to blades 6, 14, 20, 22, 24 of the fan of engine No.2 (Photo 16);

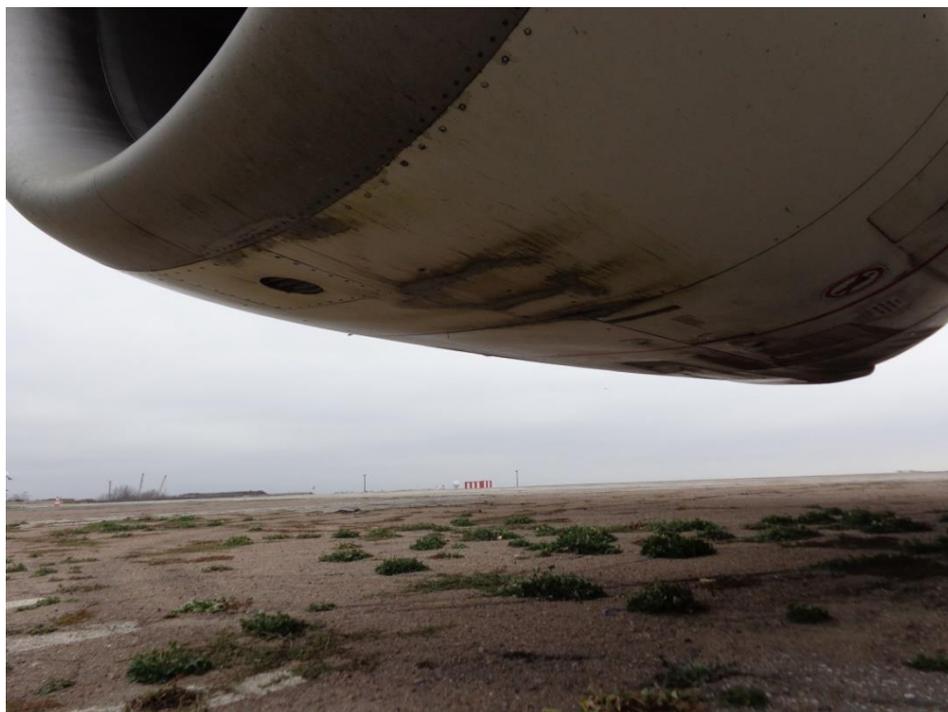
Photo 17

- damage to the composite skin in the lower part of engine No.2 caused by friction with the runway surface (Photo 17).

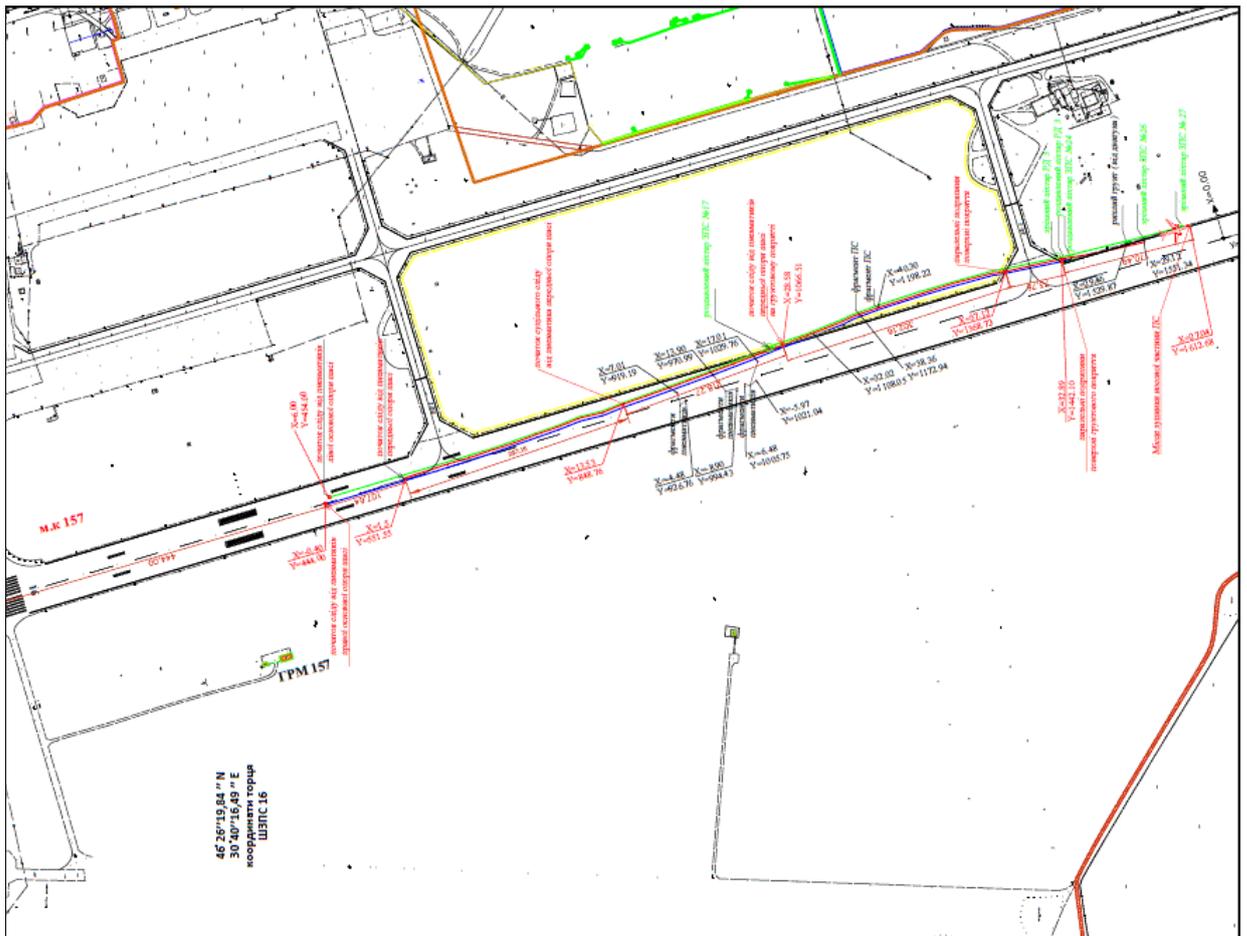
The location of fragments of the aircraft landing gear tires and structural elements is shown below in the sketch of the accident place.

Fig. 2. Sketch of the accident with B-737-800 TC-JGZ operated by the Turkish Airlines, which took place on November 21, 2019, at 18:55 at the «Odesa» Aerodrome

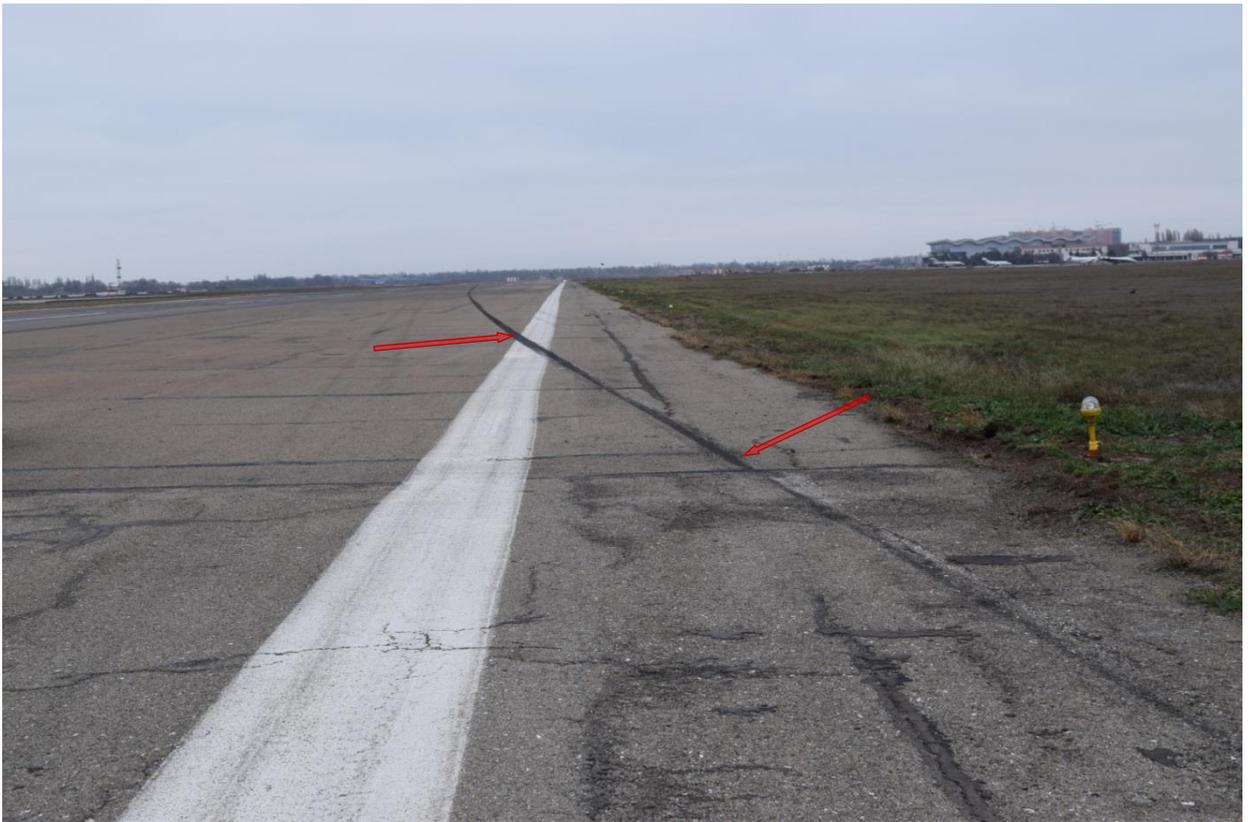
Photo 22. Continuous track of NLG wheels

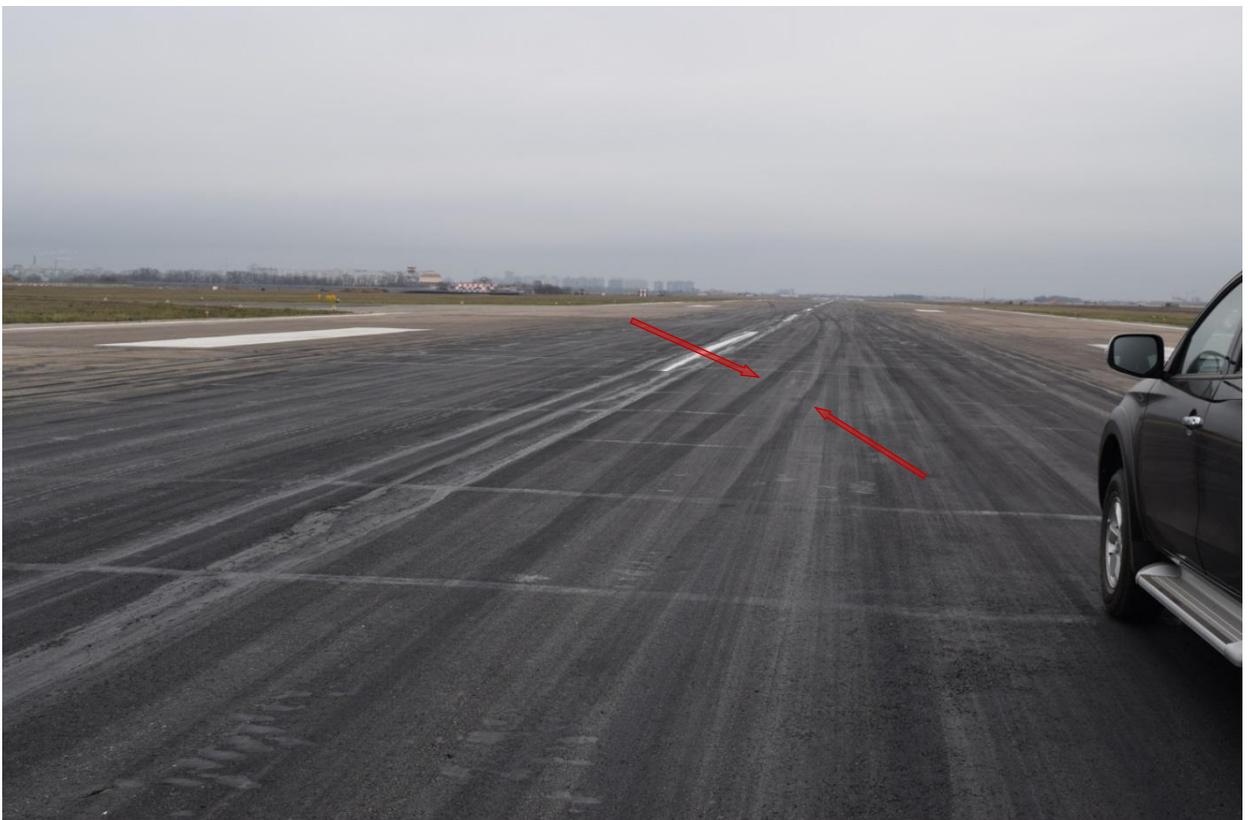
Photo 23. The beginning of the track of the right main landing gear after landing

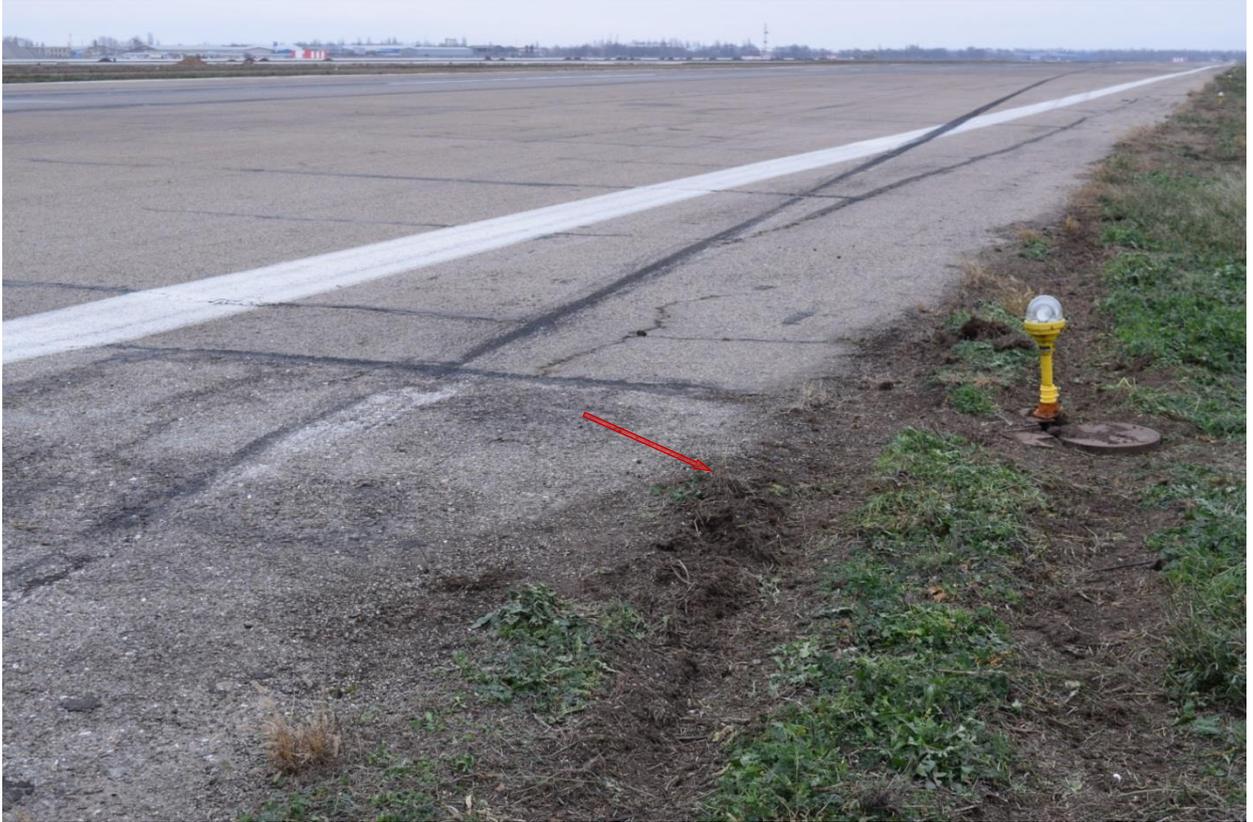
Photo 24 Point of the left main landing gear exit from the runway.

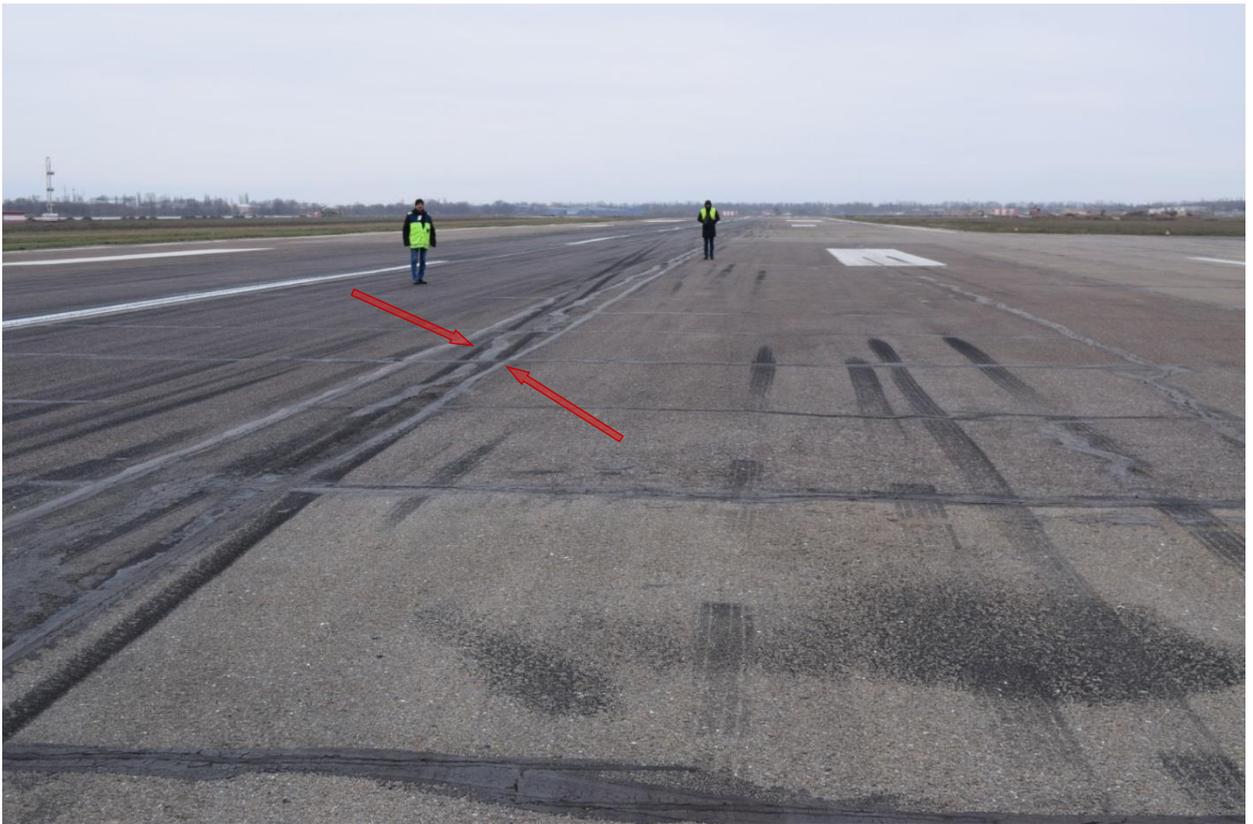
Photo 25. Double track of the nose landing gear

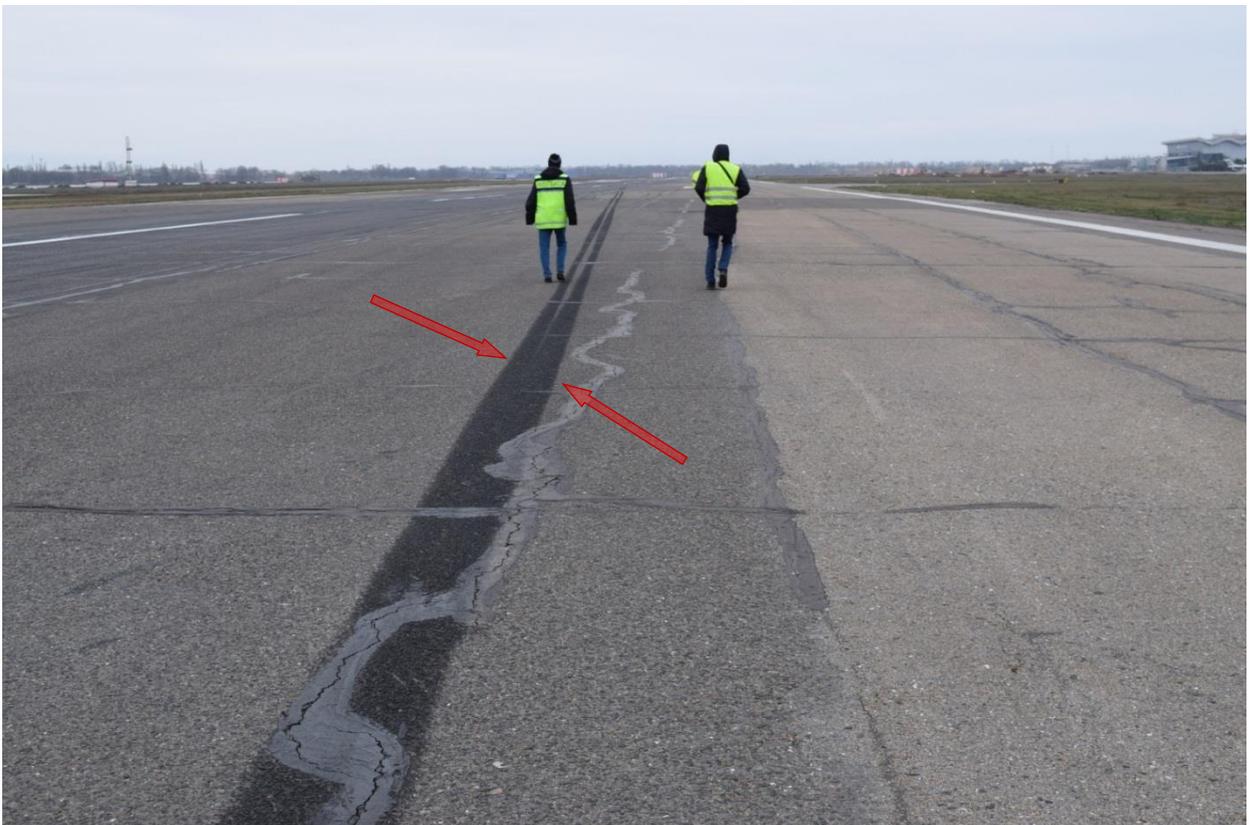
Photo 26. The beginning of a continuous track of the nose landing gear tires  
(beginning of the aircraft skidding)

In his Statement, the PIC notes that, having realized ineffectiveness of the rudder deflection, he took decision to apply "Nose wheel steering" to large angles up to  $78^\circ$ , although FCTM does not recommend using this mode at speeds higher than the steering speed. Despite the fact that the nose landing gear was hydraulically rotated through a significant angle (almost perpendicular to the aircraft movement), this did not allow the aircraft reaching the centerline or position parallel to it. The turned wheel of the nose landing gear began to skid, as seen in the photo, when two black stripes from the tires of the nose landing gear merge into one continuous stripe (Photo No. 26.)
