**NATIONAL BUREAU
OF AIR ACCIDENTS INVESTIGATION OF UKRAINE**

**AIRCRAFT COLLISION WITH THE GROUND DURING LANDING
APPROACH**

AIRCRAFT TYPE: AN-12BK

REGISTRATION NUMBER: UR-CAH

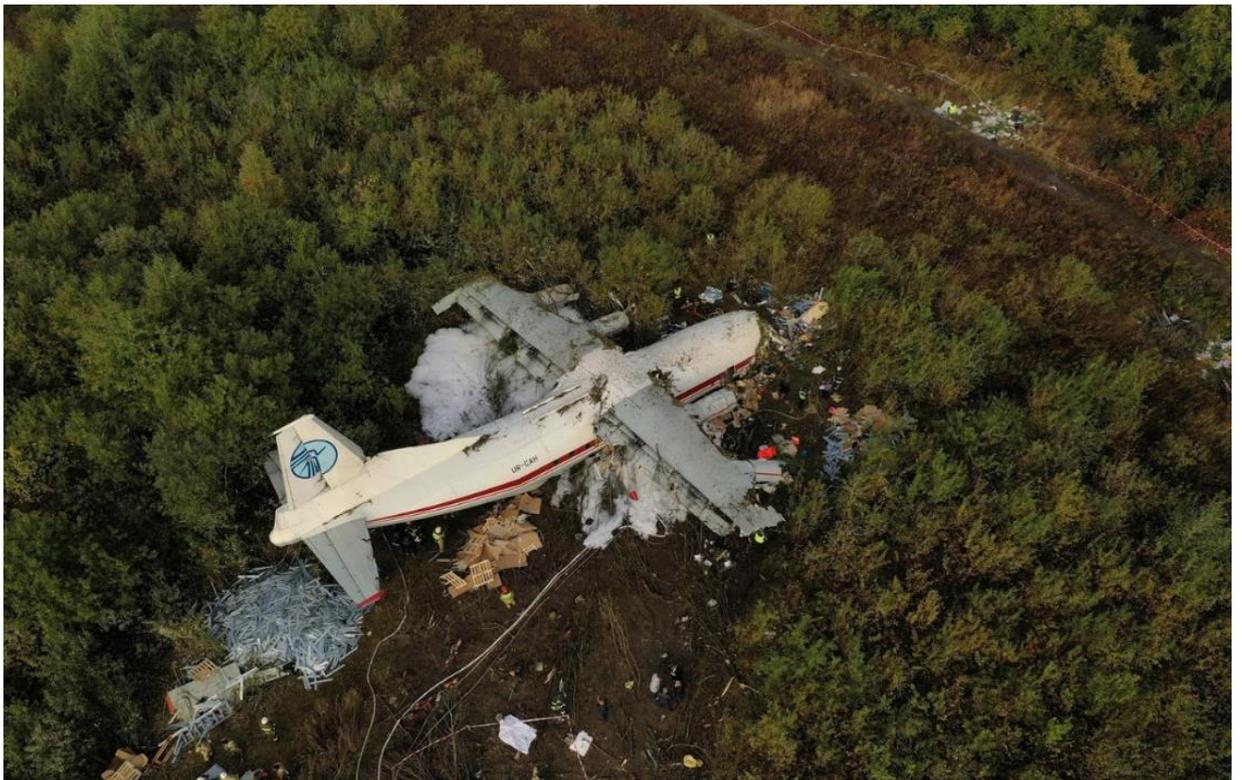
Fig.1 Photo of the aircraft location after the crash

The plane was destroyed as a result of the fatal accident.

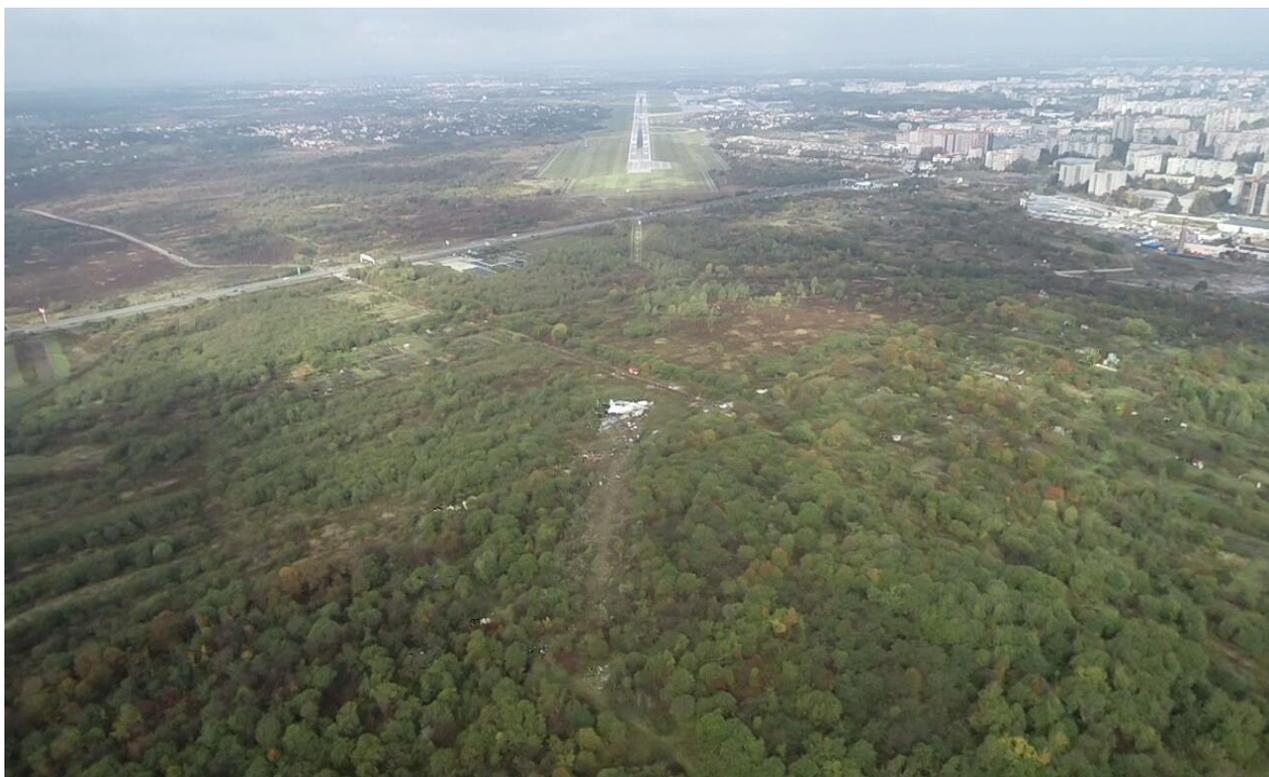
Fig.2 Photo of the aircraft wreckage location

The crash of the An-12 BK UR-CAH aircraft occurred near the Lviv aerodrome. Coordinates of the crashed aircraft location: 49°47.29N 23°59.08E at an altitude of 335 m above sea level, distance of 1117 m from the threshold of RW-31.

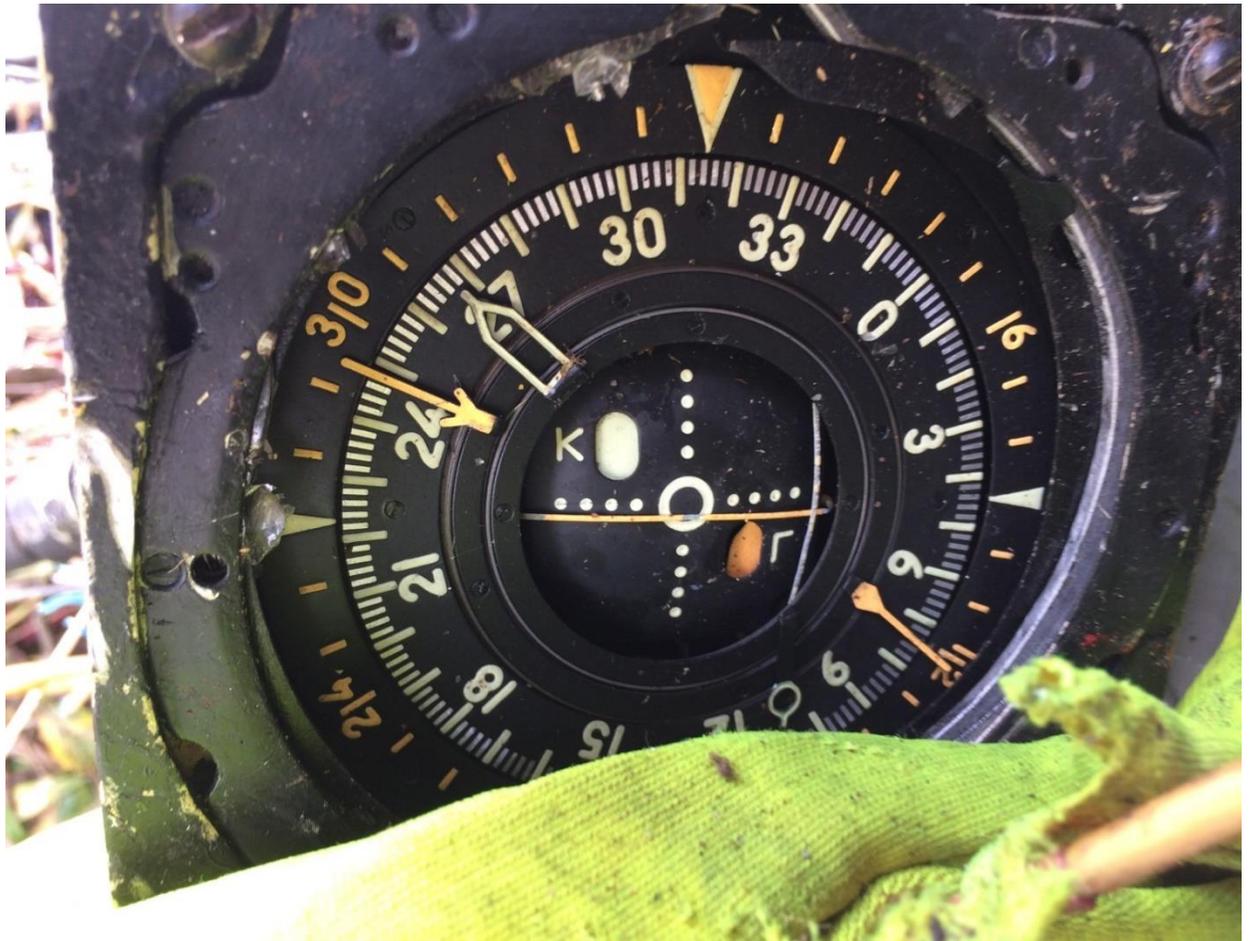
Fig.7 Pointer of the flight control and navigation instrument

When inspecting the accident site, the Investigation Team found devices of the aircraft instrument landing system, and found that the glide slope and heading alarm flags were turned off.
