**NATIONAL BUREAU
OF AIR ACCIDENTS INVESTIGATIONS**

**FINAL REPORT OF INVESTIGATION INTO SERIOUS INCIDENT –
DETACHMENT OF THE NOSE WHEEL AND COLLAPSE OF THE
FRONT LANDING GEAR, DURING TRAINING FLIGHT**

A/C OPERATOR:	Avia-Soyuz Airline LLC
A/C TYPE:	TECNAM P2002 JF
REGISTRATION NUMBER:	UR-ASC
OCCURRENCE SITE:	Mayske Airfield, Synelnykivskyi District, Dnipropetrovsk Region
COUNTRY:	UKRAINE
DATE:	November 1 st , 2021

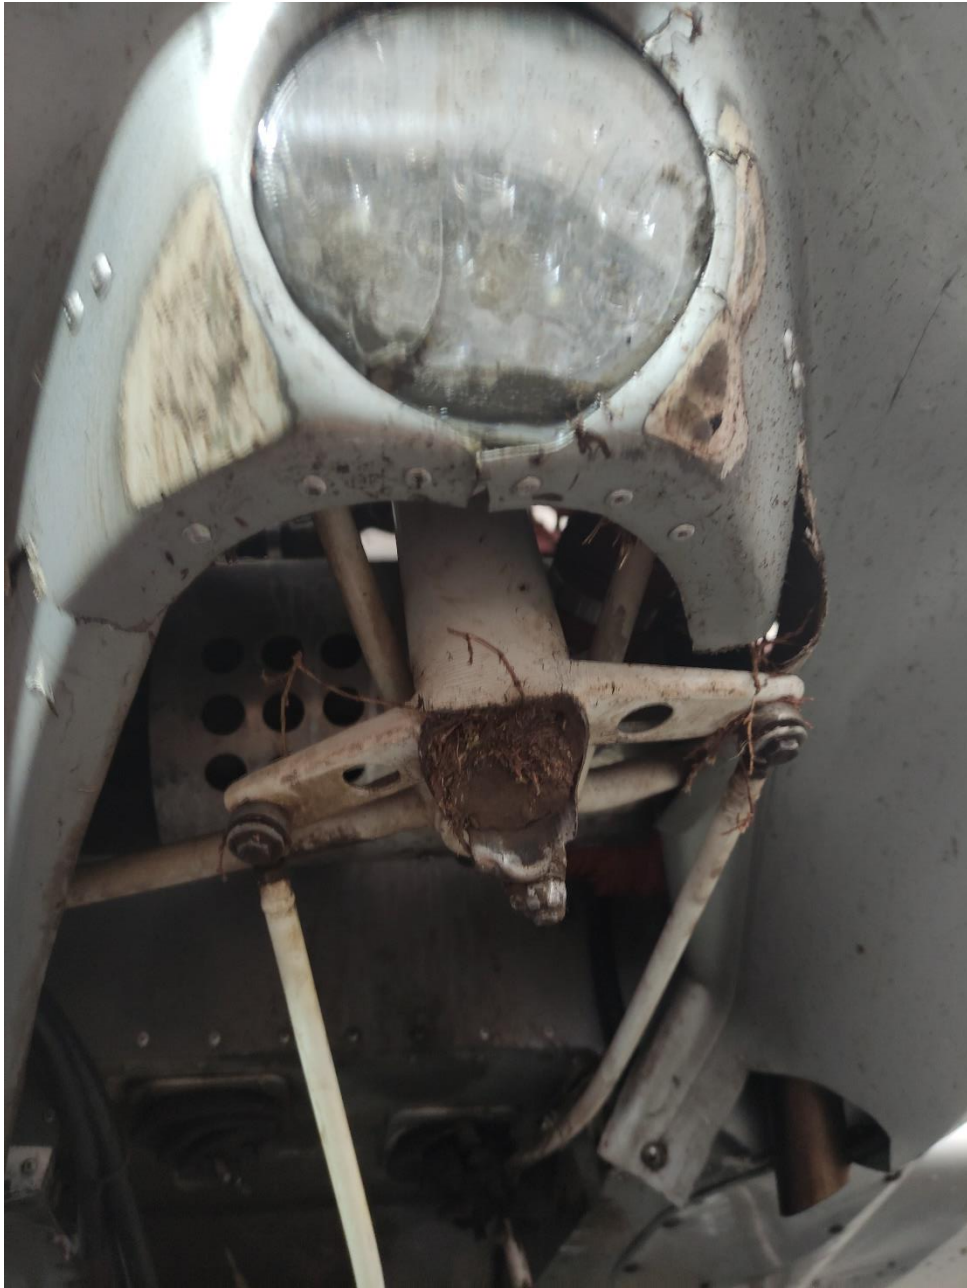
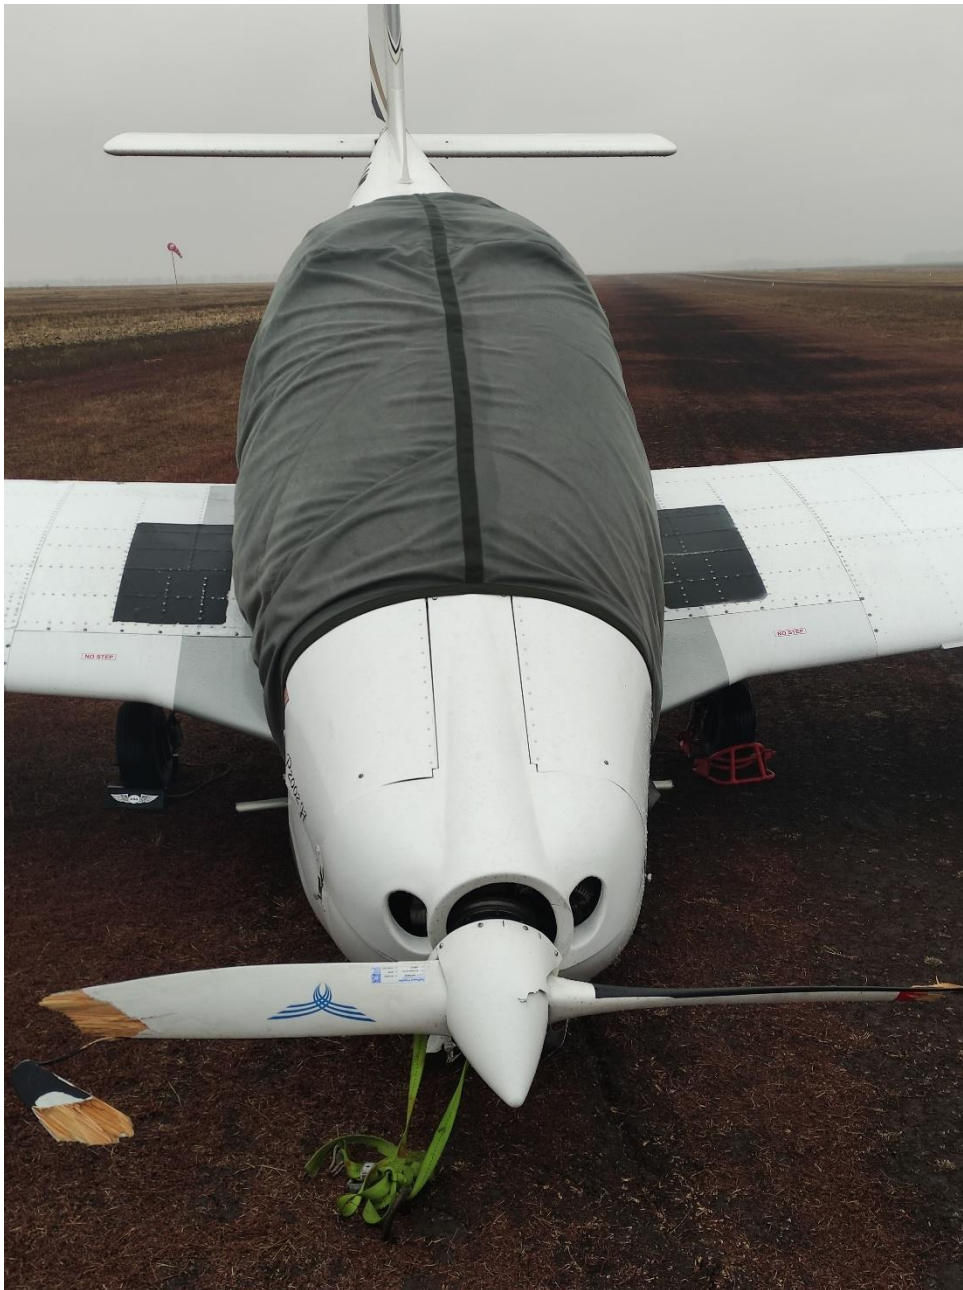
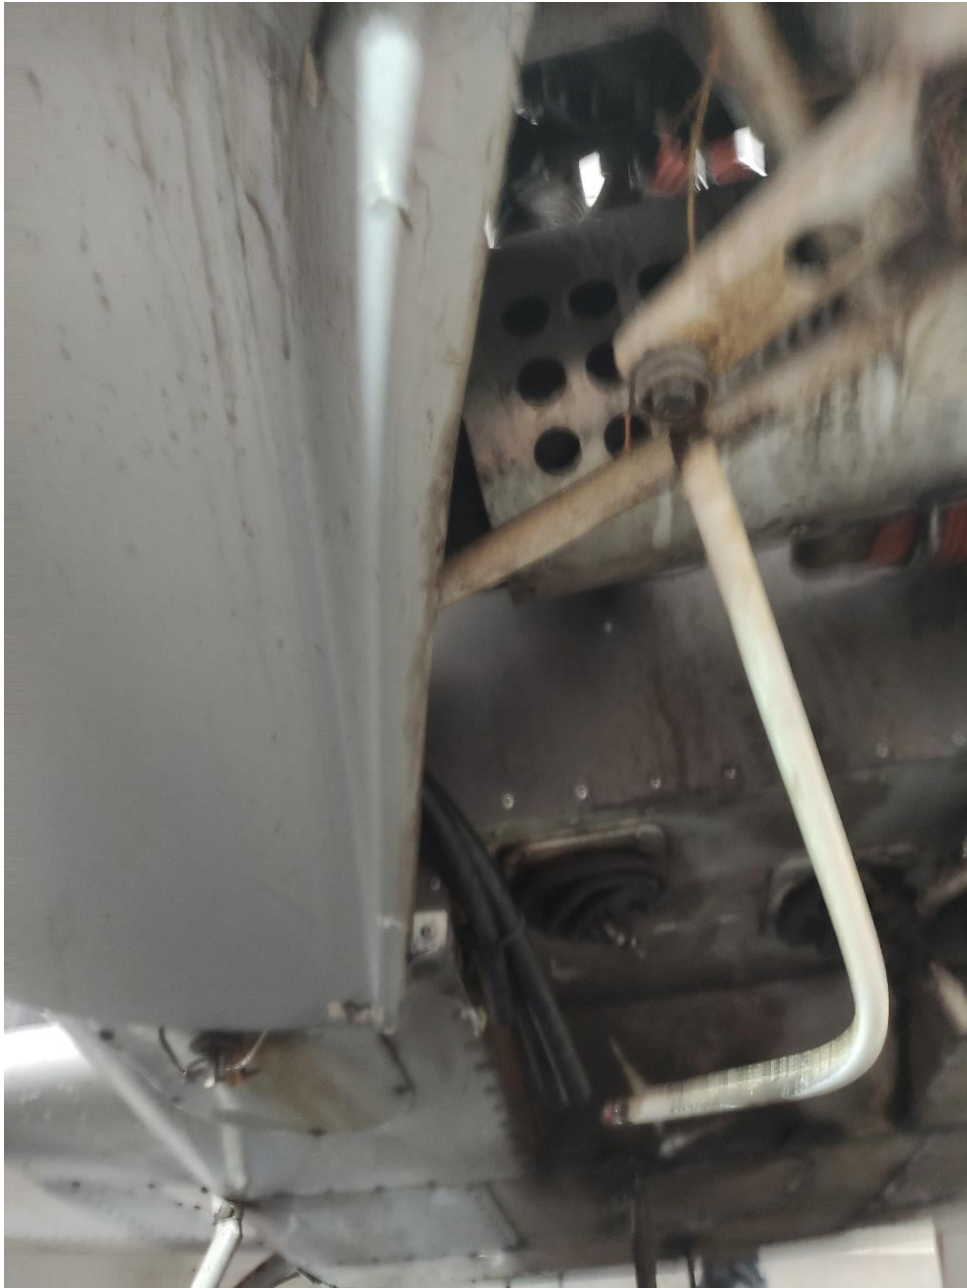
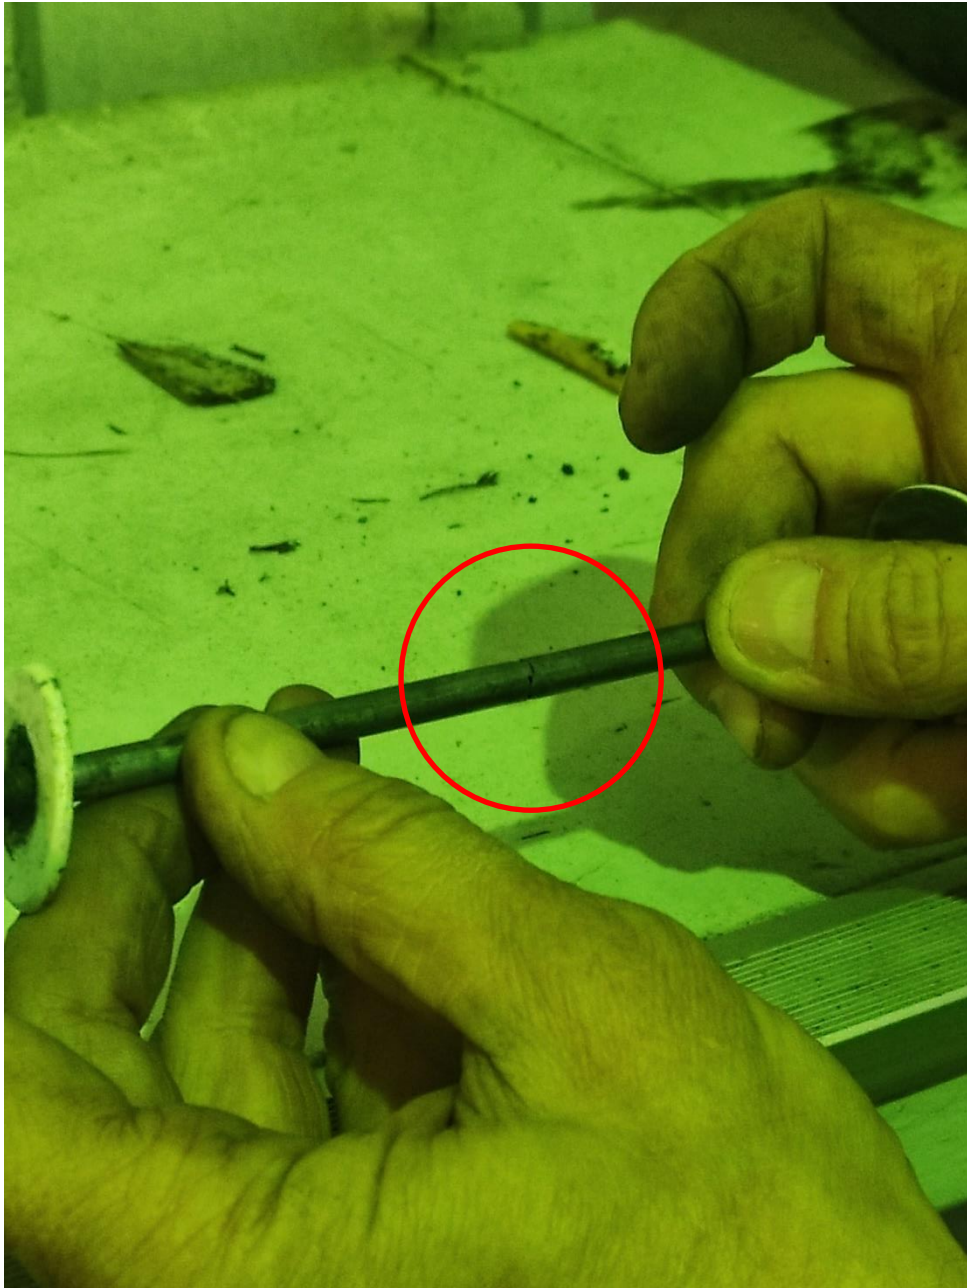
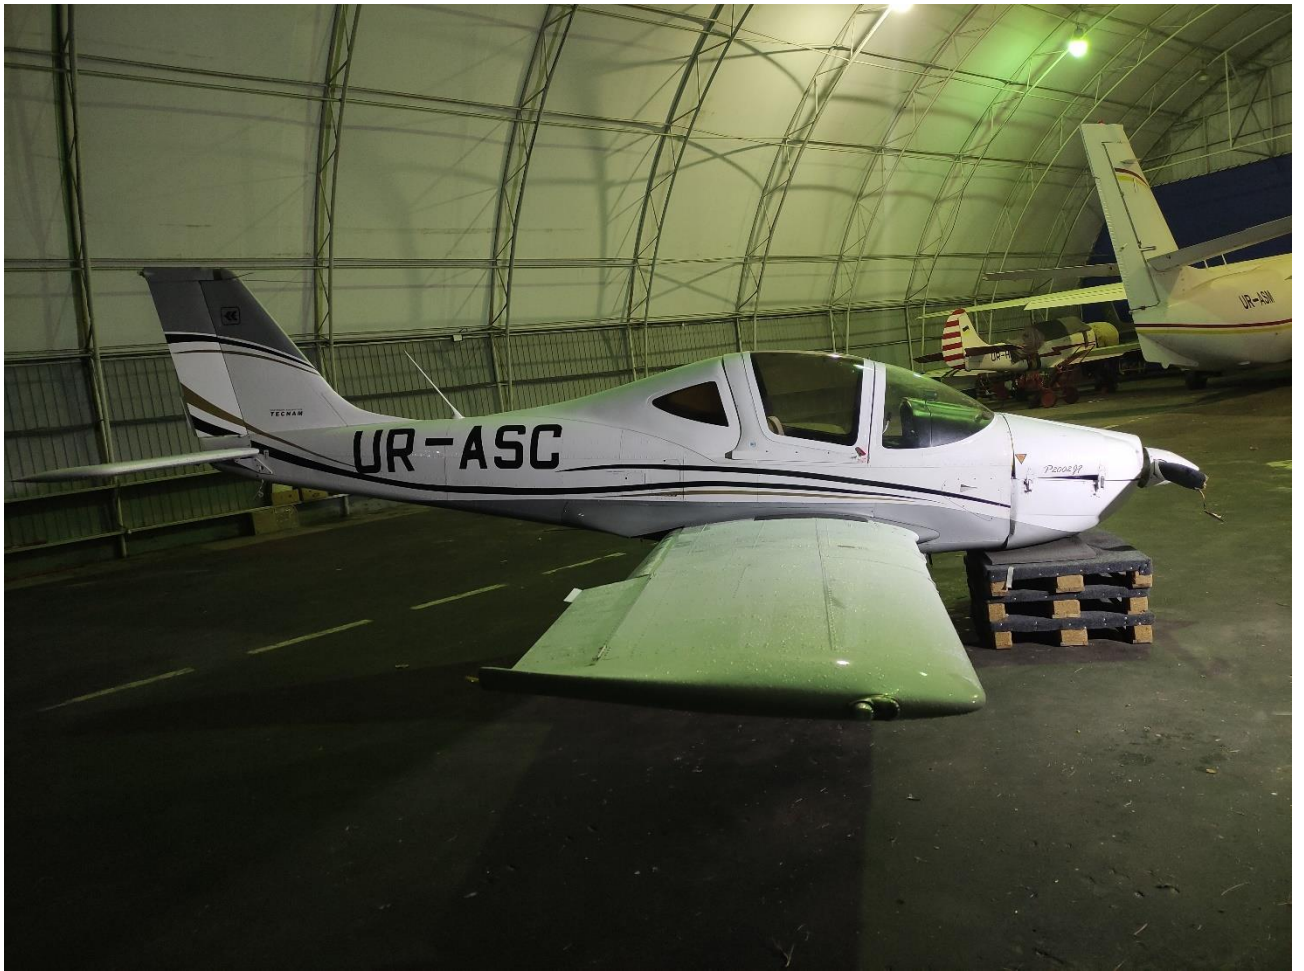
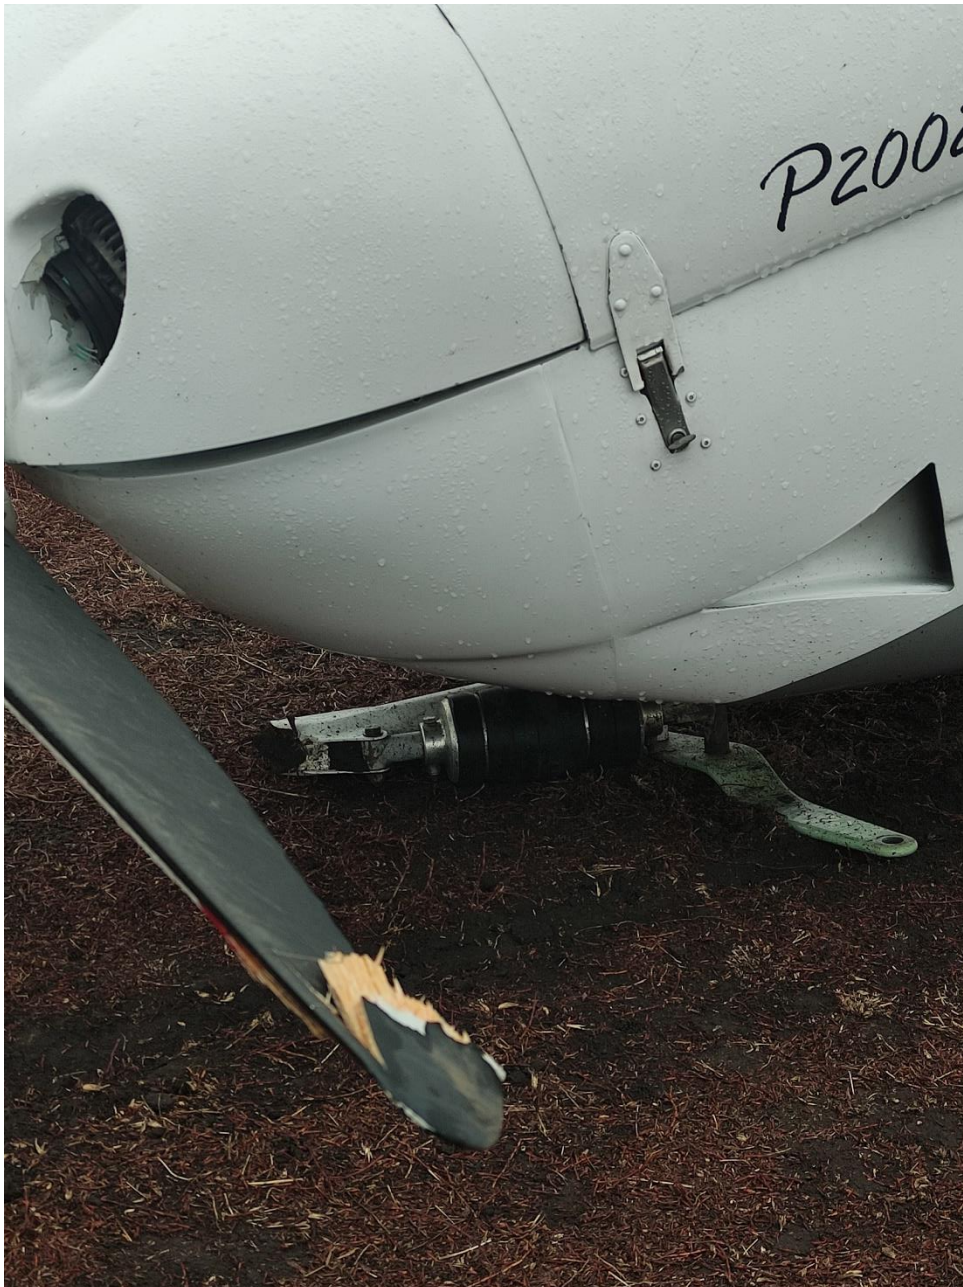
- broken NOSE LANDING LEG P/N 92-8-100-000 at the nose gear wheel levers attachment point;
- detached nose gear wheel;
- damaged nose gear control system;
- broken nose gear WHEEL ROD P/N 92-8-240-7;
- both propeller blades broken;
- damaged upper engine cowl;
- damaged lower engine cowl;
- bent engine mounting frame links.

- Nose landing gear is broken at the nose gear wheel levers attachment point.
- Nose gear wheel rod is broken.
- Nose gear wheel control links are damaged.
- Main landing gear has no damage.

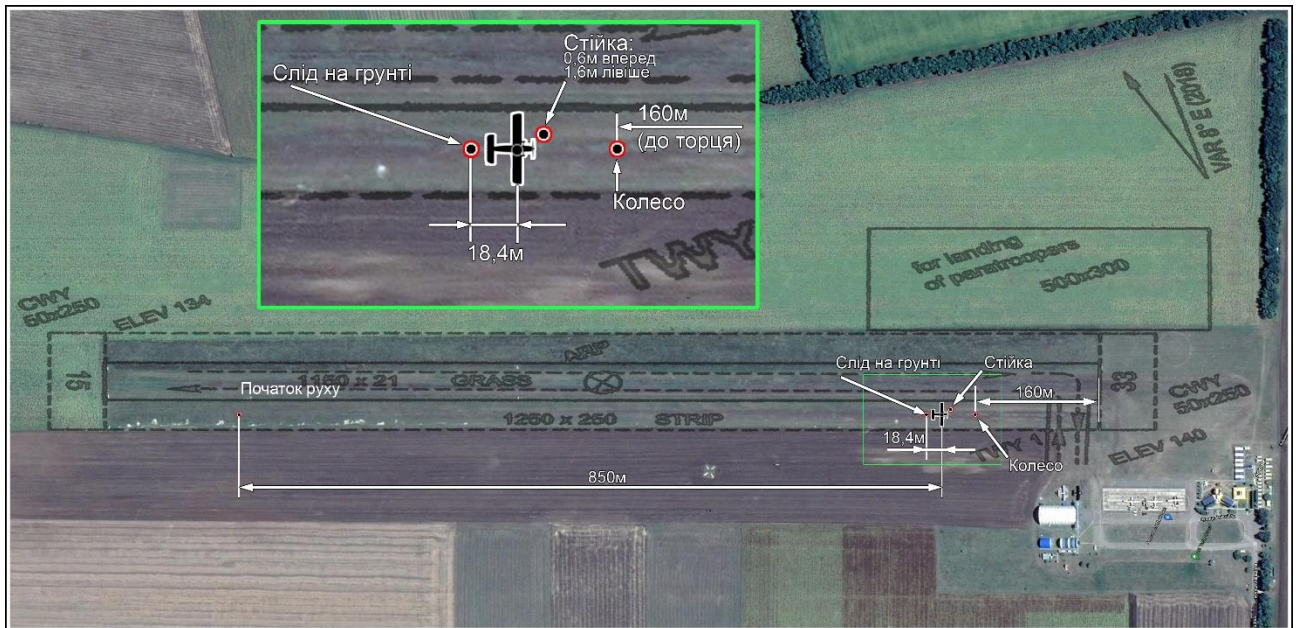
The nose landing gear wheel is at the distance of 40 meters from the aircraft in the direction of the aircraft movement.

The broken nose landing gear leg is near the aircraft.

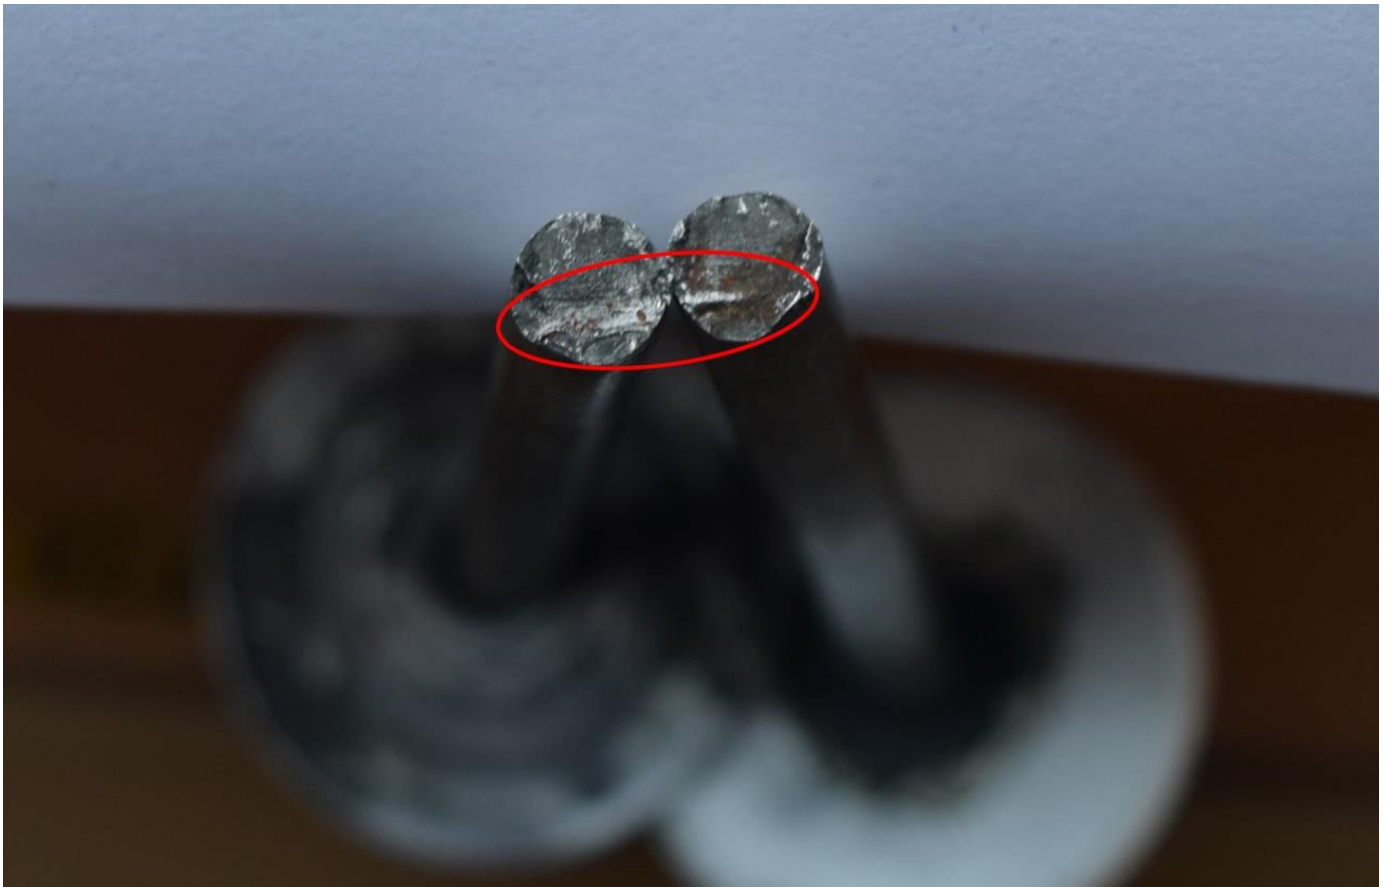
The Investigation Team established that the cause of the serious incident with the TECNAM P2002JF UR-ASC aircraft was the destruction of the nose wheel mounting rod shown on drawing of FIG 3 as itm 8 WHEEL ROD P/N92-8-240-7. Old corrosion of the metal can be seen at the rod fracture points. This indicates that the rod destruction had been taking place for a certain time.

- Conduct a one-time inspection of the nose wheel mounting rod (WHEEL ROD P/N92-8-240-7) for traces of the rod destruction by the instrumental method;
- During the maintenance after 100 flight hours, conduct the inspection of the nose wheel mounting rod (WHEEL ROD P/N92-8-240-7) by the instrumental method.

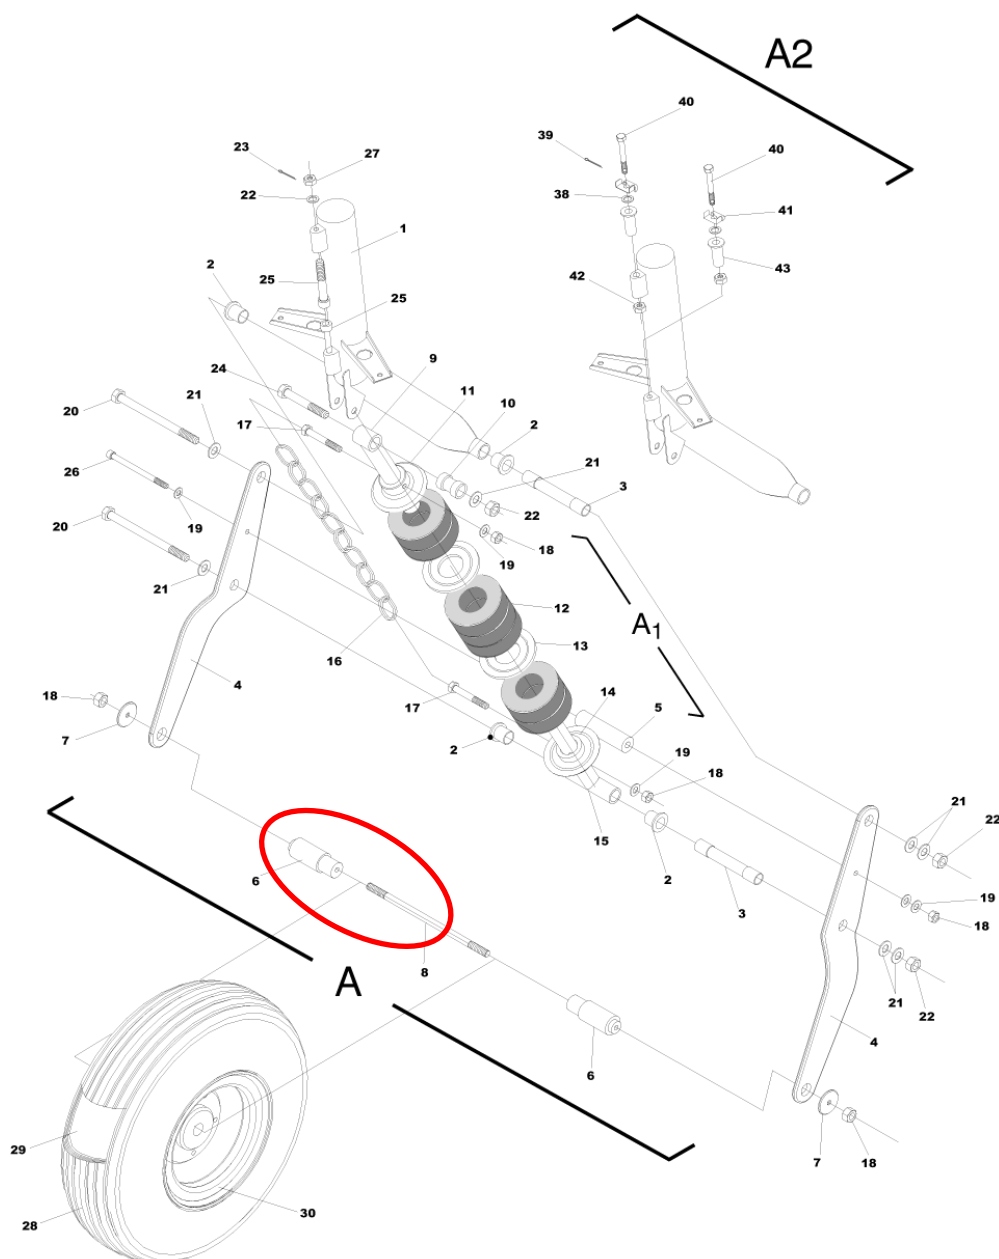
Figure 3 – NLG (sheet 1)

The Investigation Team has established that the cause of the serious incident with the TECNAM P2002JF UR-ASC aircraft, which took place at the Mayske Airfield on 01.11.2021, was the destruction of the nose wheel mounting rod.
