National Bureau of Air Accidents and Incidents Investigation with Civil Aircraft

PRELIMINARY REPORT ON THE RESULTS OF THE INVESTIGATION INTO AN AIR ACCIDENT (A FATAL AIR ACCIDENT)

Accident site:	Sheparivtsy village, Kolomya district, Ivano-Frankivsk region.	Number of the case/investigation:	48/2021
Date and time:	28.07.2021 10:35 UTC	AC registration number:	UR-PAMA
AC type:	WT-10 ADVANTIC	Injuries:	4 persons killed
Flight type:	Sightseeing

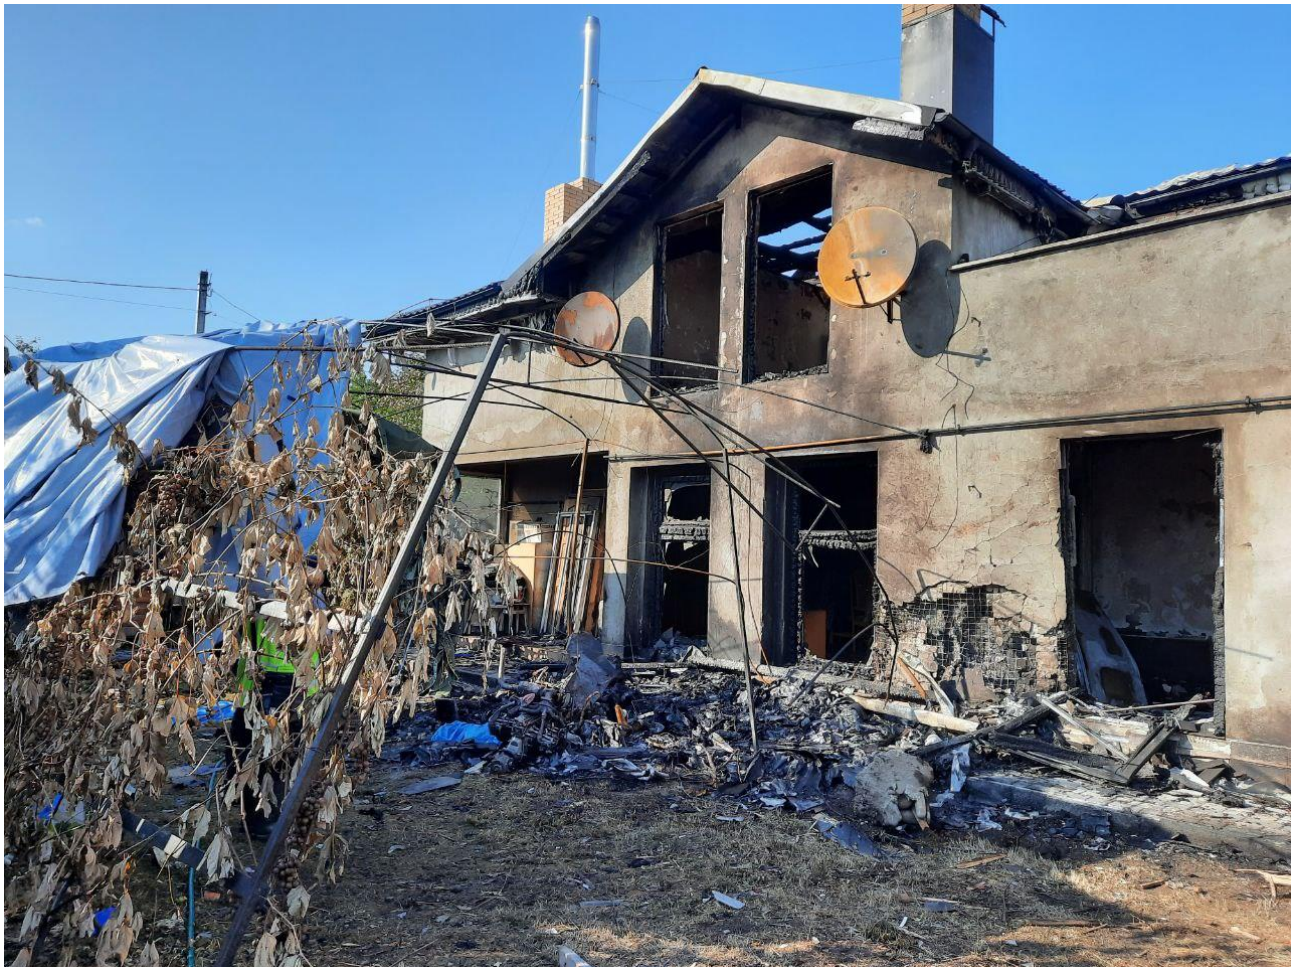
As a result of the fatal accident, there were killed the pilot of the aircraft - a citizen of Ukraine, two tourists - US citizens and one tourist with dual British and US citizenship (according to information received from the NTSB). The aircraft was completely destroyed and demolished by fire, and the house was severely damaged. There were no casualties on the ground.

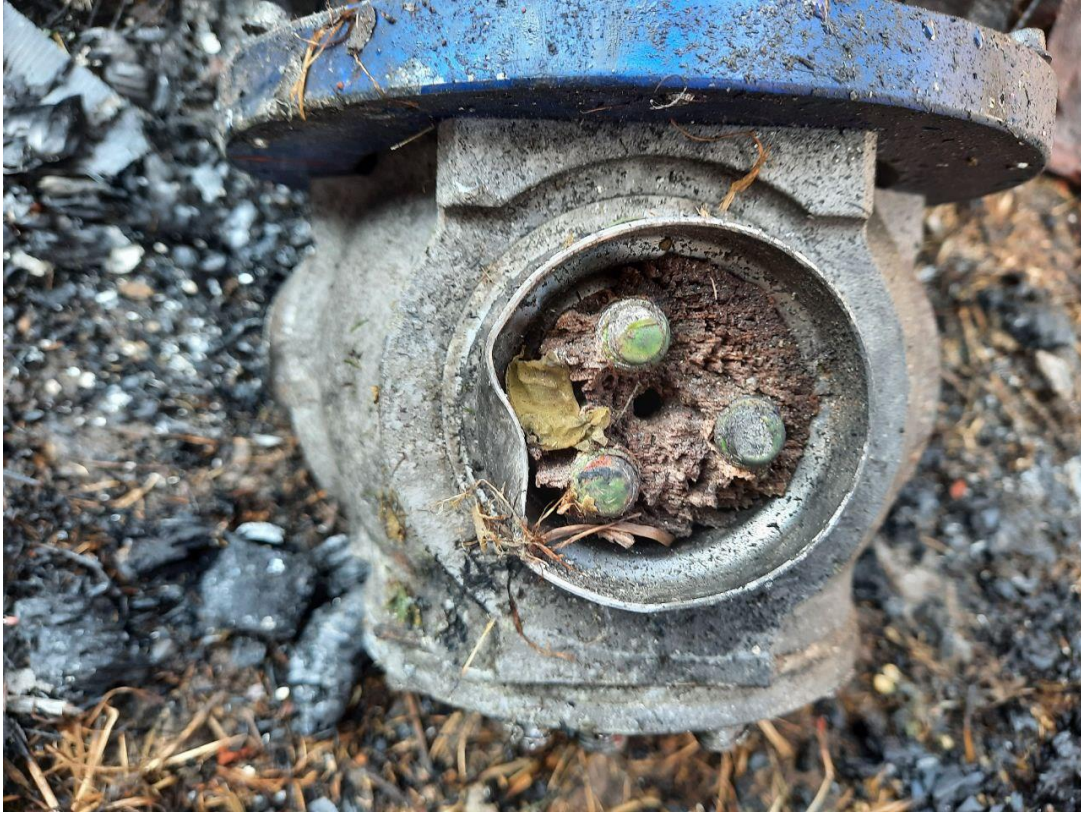
As for the nature of damage to the propeller blades (a specific fracture near the propeller sleeve) and their scattering, the engine was running until it collided with the ground.

(Picture 1 – fracture near the propeller sleeve)

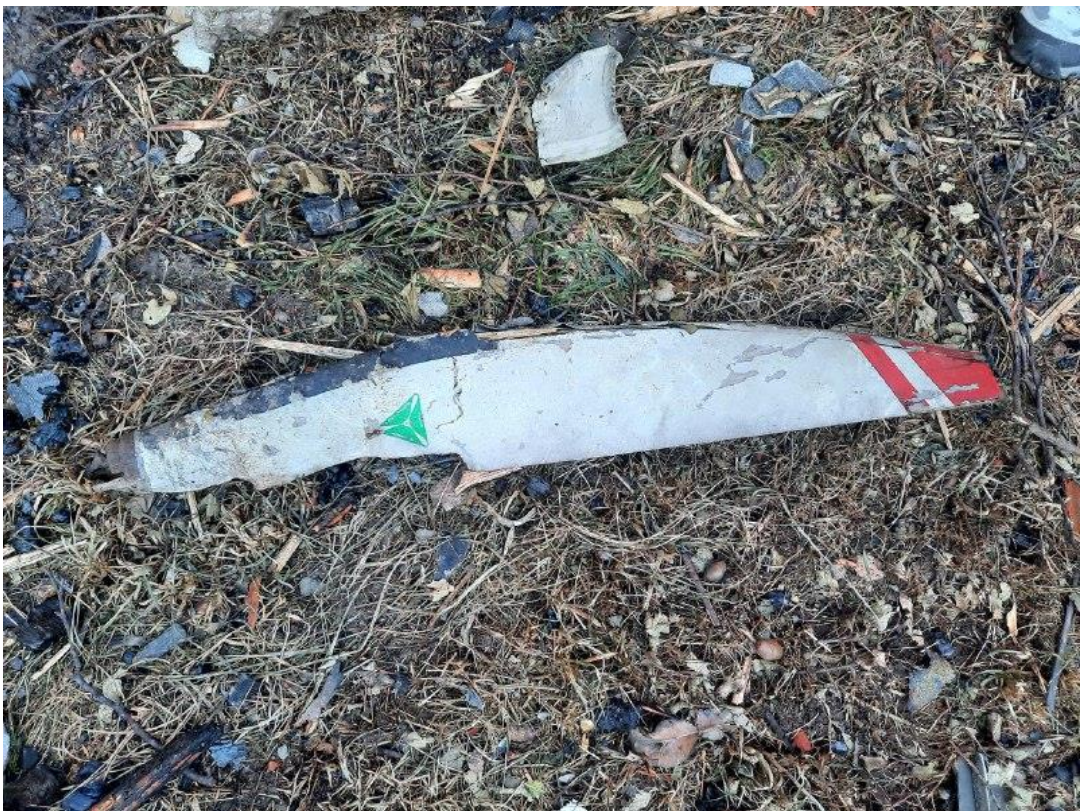
(Picture 2 – a blade fragment)

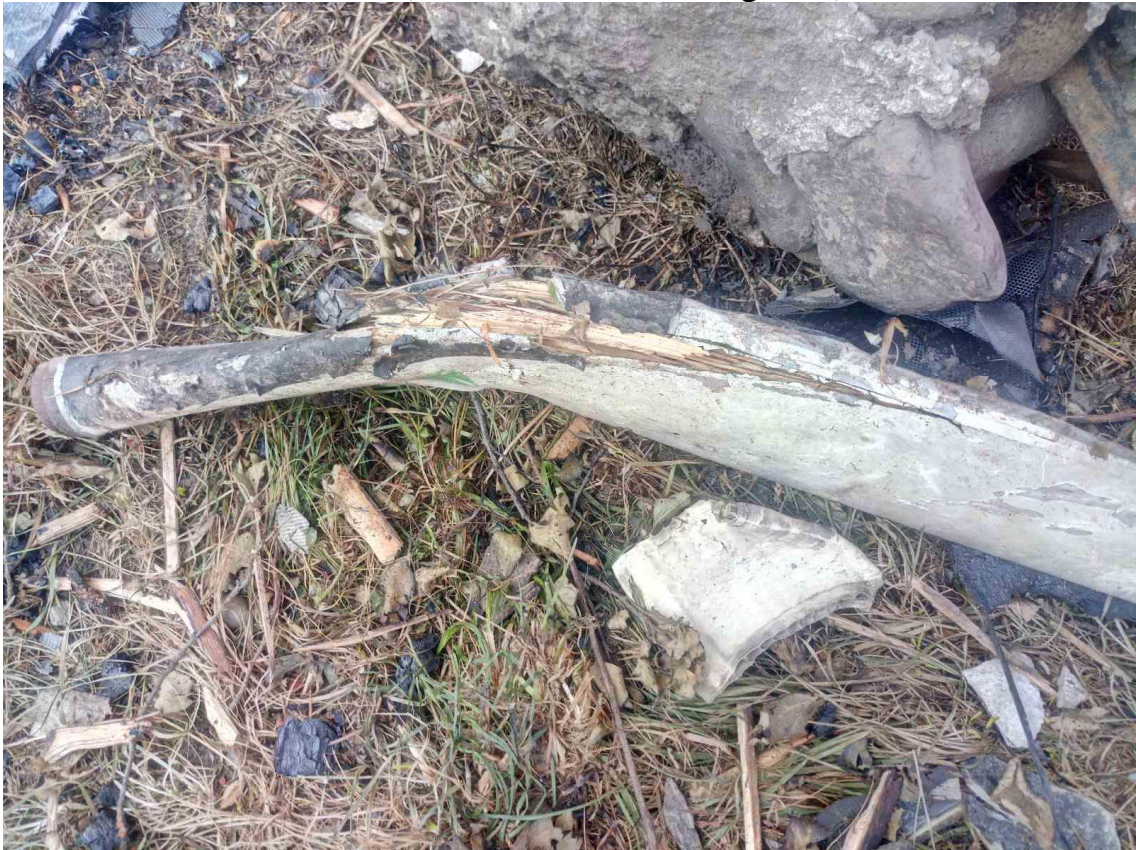
(Picture 3 – a blade fragment)
