**NATIONAL BUREAU  
OF AIR ACCIDENTS INVESTIGATION OF UKRAINE**

**FINAL REPORT**

**RUNWAY EXCURSION AT LANDING  
AT KYIV (ZHULYANY) AERODROME**

<b>AIRCRAFT OPERATOR:</b>	Bravo Airways
<b>AIRCRAFT TYPE:</b>	DC-9-83 (MD-83)
<b>REGISTRATION NUMBER:</b>	UR-CPR
<b>PLACE OF OCCURRENCE:</b>	Kyiv (Zhulyany) Aerodrome
<b>STATE OF OCCURRENCE:</b>	UKRAINE
<b>DATE OF OCCURRENCE:</b>	June 14, 2018

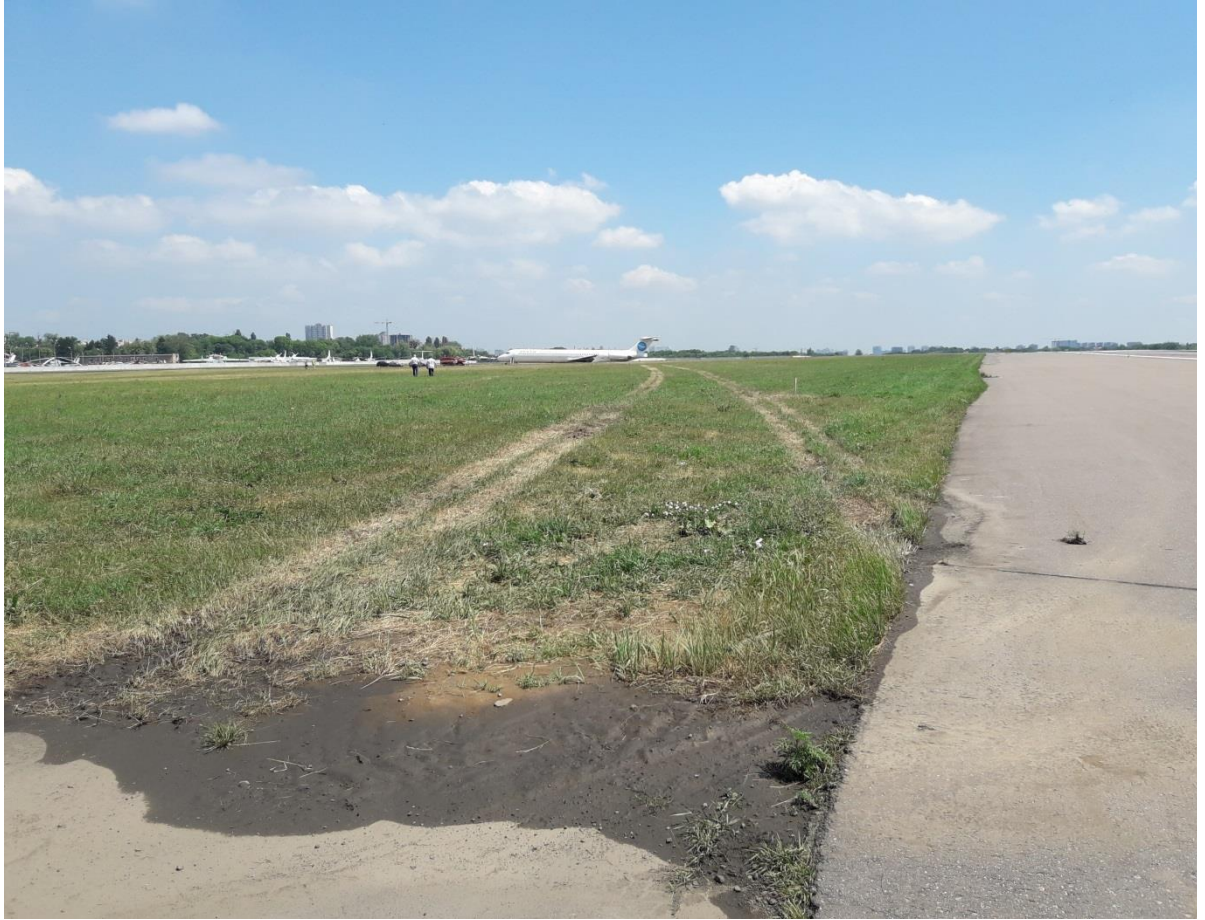
Photo 1

*Aircraft runway excursion site*

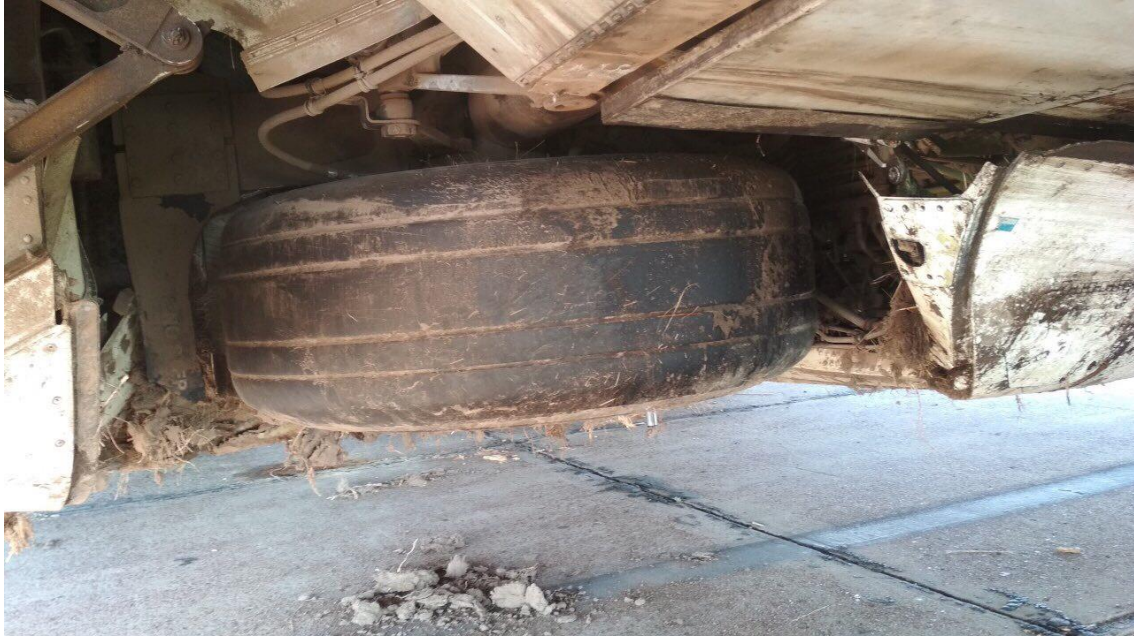
Photo 2

- lower front VHF p/n S65-8262DC10A antenna was broken off (destroyed)
- slat No.1 of the right wing was damaged at the end part (substantial damage)
- flaps fitting fairing – 5 pieces of the right wing were damaged (substantial damage)
- flaps of the right wing, in root section are crumpled, the second part is crumpled with shift (substantial damage)
- main right landing gear MLG p/n5930999-5504 s/n606959 was broken (destroyed), the landing gear door was also broken and jammed by the undercarriage (destroyed) (see Photo)

*Location of main right landing gear destruction*

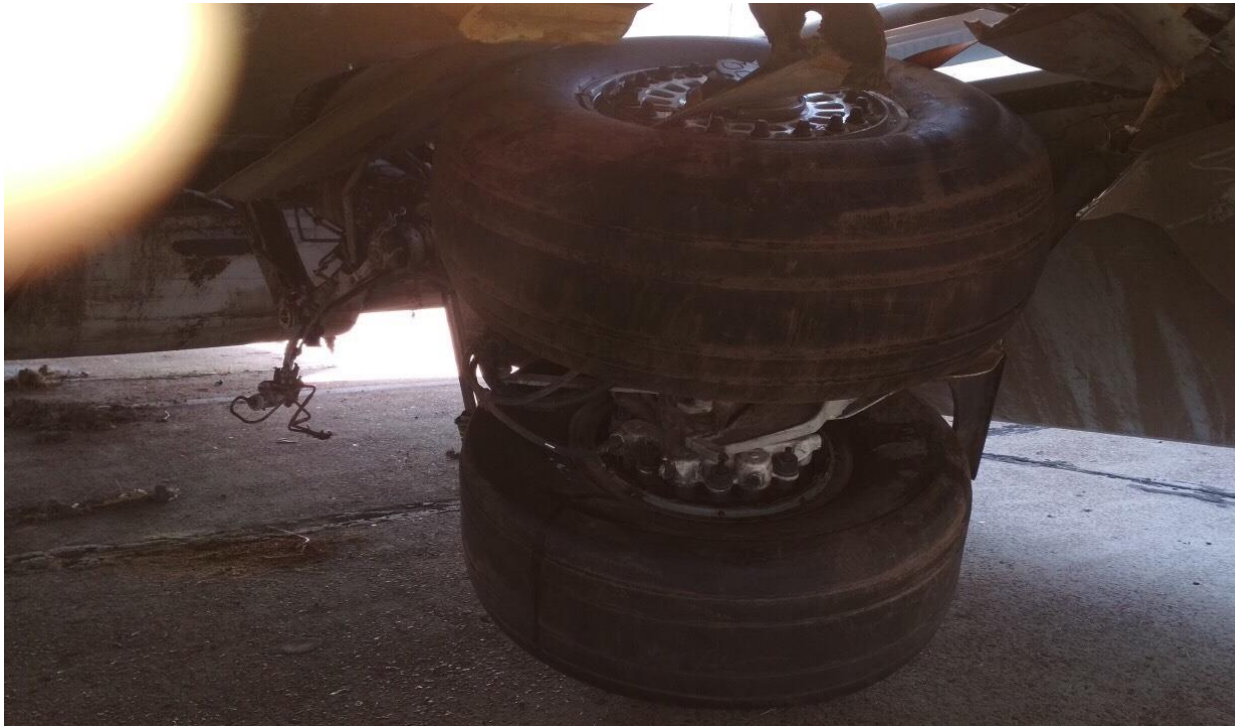
Photo 4

- upper aircraft in root section of the right wing was punched (substantial damage)
- left anti collision p/n 30-1099-1A was broken (destroyed)
- left MLG p/n 5930999-5503 s/n 477753 was broken (destroyed)

*Left main landing gear (LMLG)*

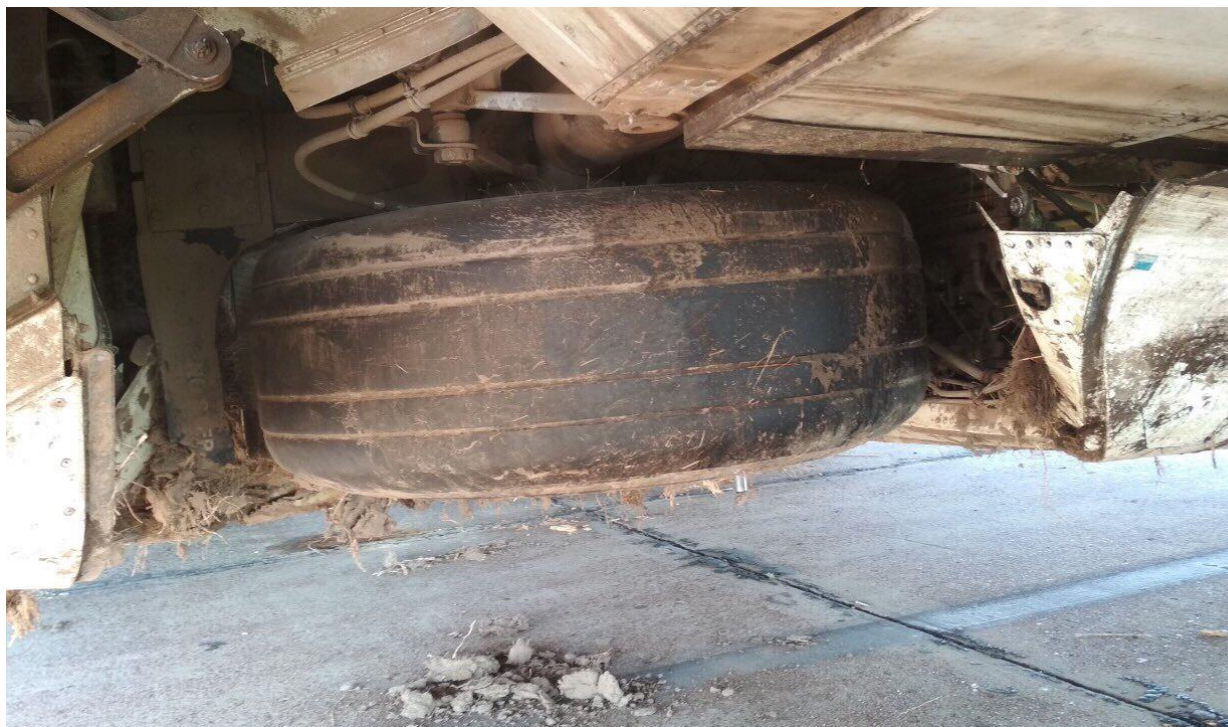
Photo 5

Right main landing gear (RMLG)

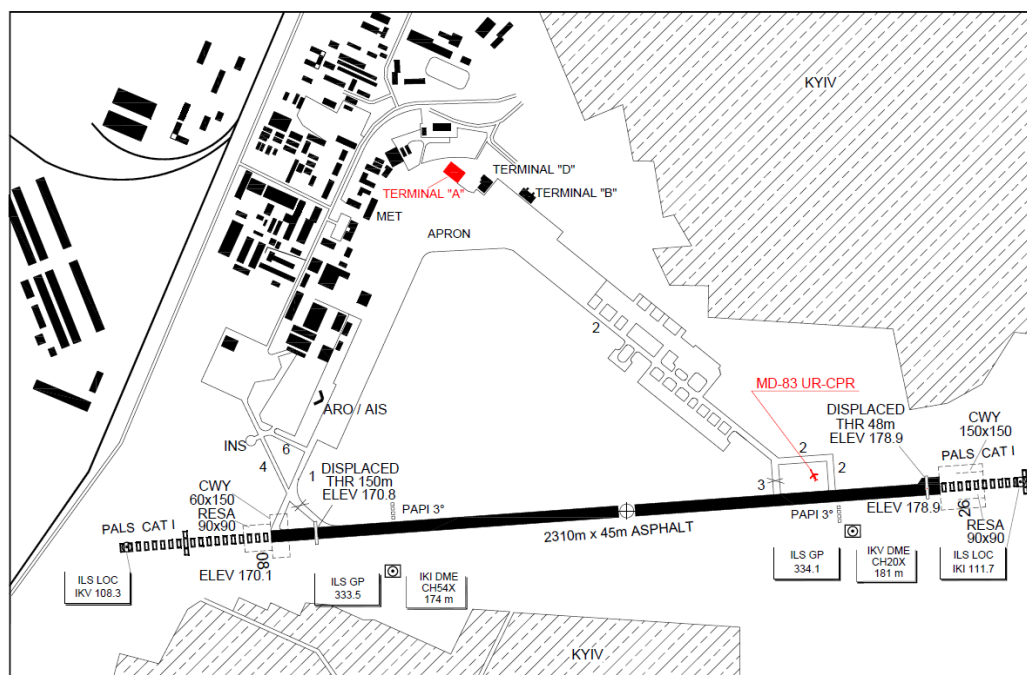
Fig. 2

*Layout of aerodrome elements, terminal A and aircraft position following the runway excursion*

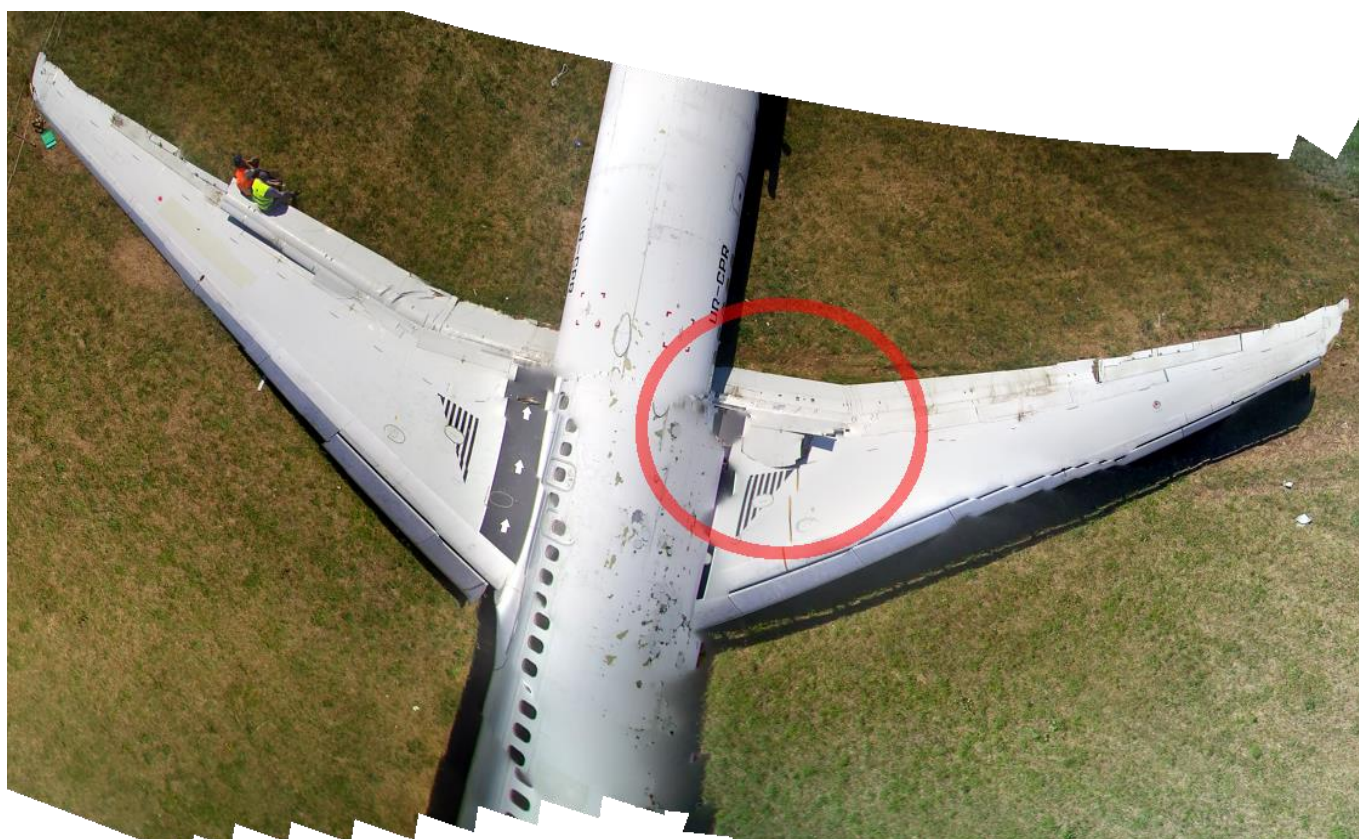
In the process of movement outside the runway, the right main landing gear retracted to the undercarriage bay, and the left main landing gear was broken, which damaged the left wing and spoiler mechanism on the left side (Figure 11), resulting in deflection of the left spoilers, which was recorded by the FDR.

Figure 11.  
*Spoilers damage*
