Press Bulletin №2

On Investigation into Fatal Accident with Aerospool WT10 UR-PAMA Aircraft *(publication for the mass media)*

NBAAI continues technical investigation into fatal accident of the WT10 UR-PAMA aircraft, occurred on July 28th near Kolomyia city, Ivano-Frankivsk region.

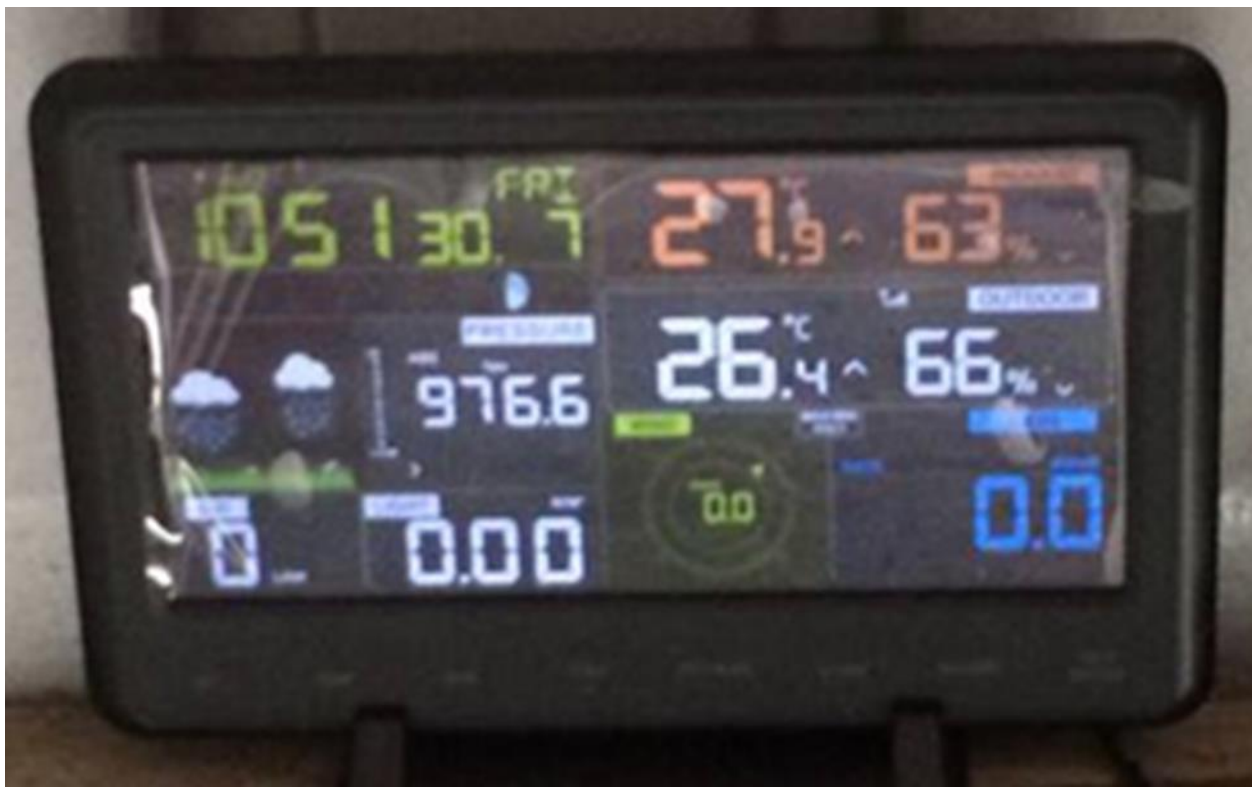
- information about the structure and the actual operations organization of "Kolomyia" airfield, from which on July 28th the flights of the crashed aircraft were performed, has been collected;
- the technical facilities and the hangar where the aircraft was stored and maintained, has been inspected;
- the documentation on the technical operation of WT10 UR-PAMA aircraft has been collected;
- the person who served as the flight supervisor and who carried out a direct radio exchange with the pilot during the flights on July 28th, and the pilot's maintenance assistant have been interviewed and their explanatory notes have been taken;
- information for the meteorological service procedure and the technical means of meteorological observations at Kolomyia airfield on the day of the accident has been obtained;

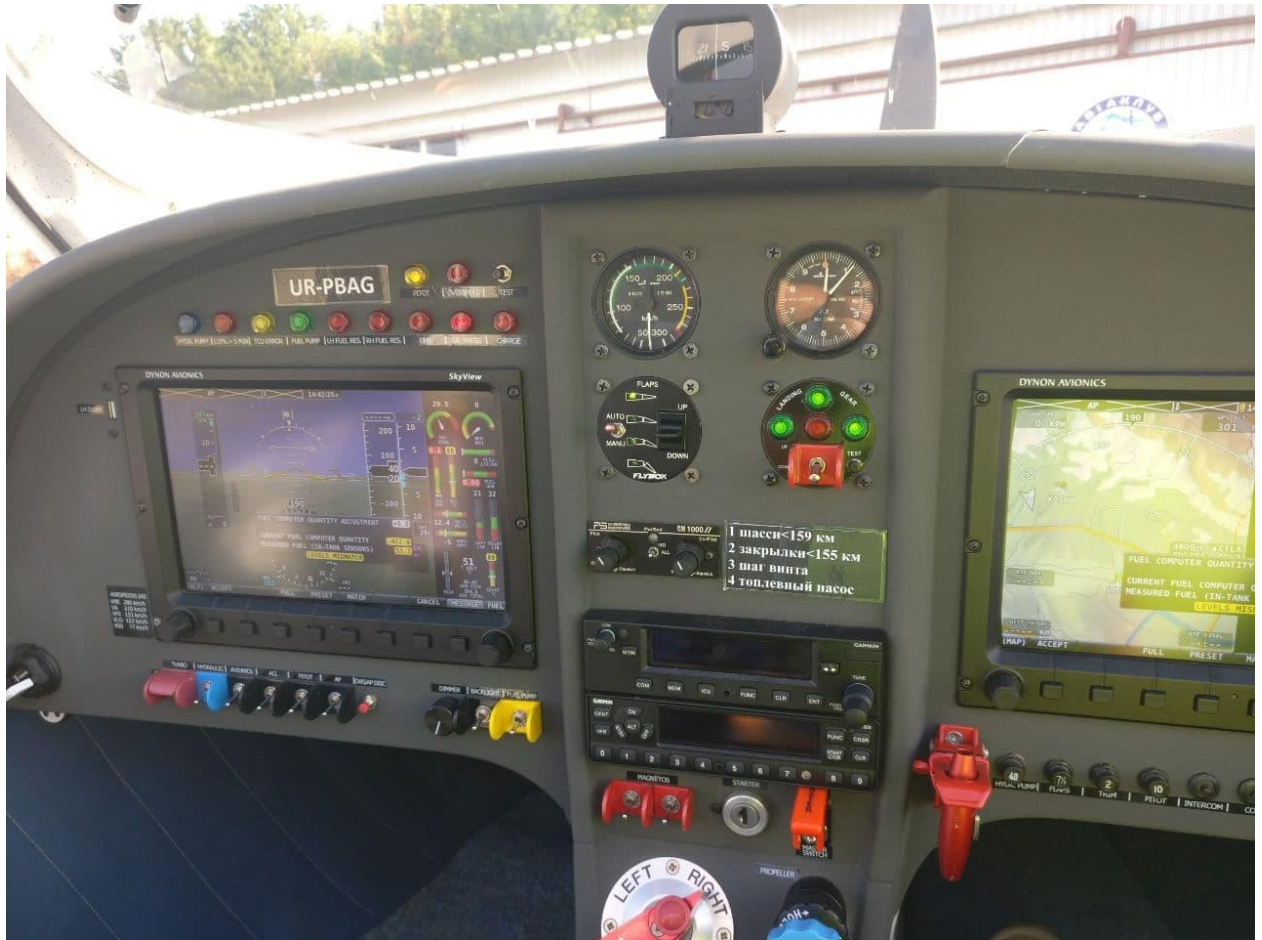
- an expertise on an aircraft of the similar design concerning the aircraft controls, its avionics and the cockpit equipment have been performed.
