Final Report

on the results of the investigation into the fatal accident of a Grumman AA-5 private aircraft, which occurred on 01.05.2020 at “Kamyanka” airfield, Dnipro city.

The investigation of the fatal accident of a private aircraft Grumman AA-5 UR-DCJ, which occurred on 01.05.2020 at "Kamyanka" airfield, city of Dnipro, was conducted by a team appointed by the Order of the National Bureau for Investigation of Air Incidents and Incidents with Civil Aircraft (NBAAI) № 31 as of 01.05.2020.

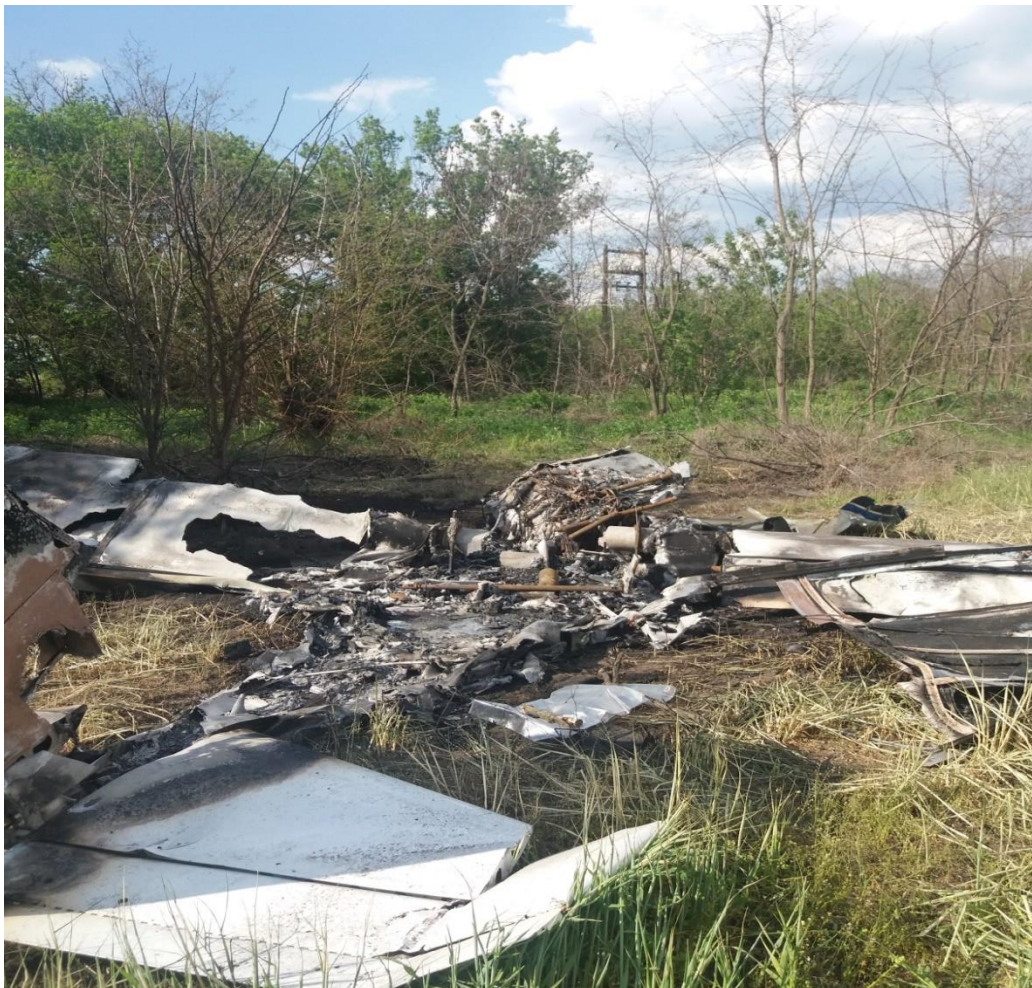
Picture 1

The aircraft is completely destroyed.

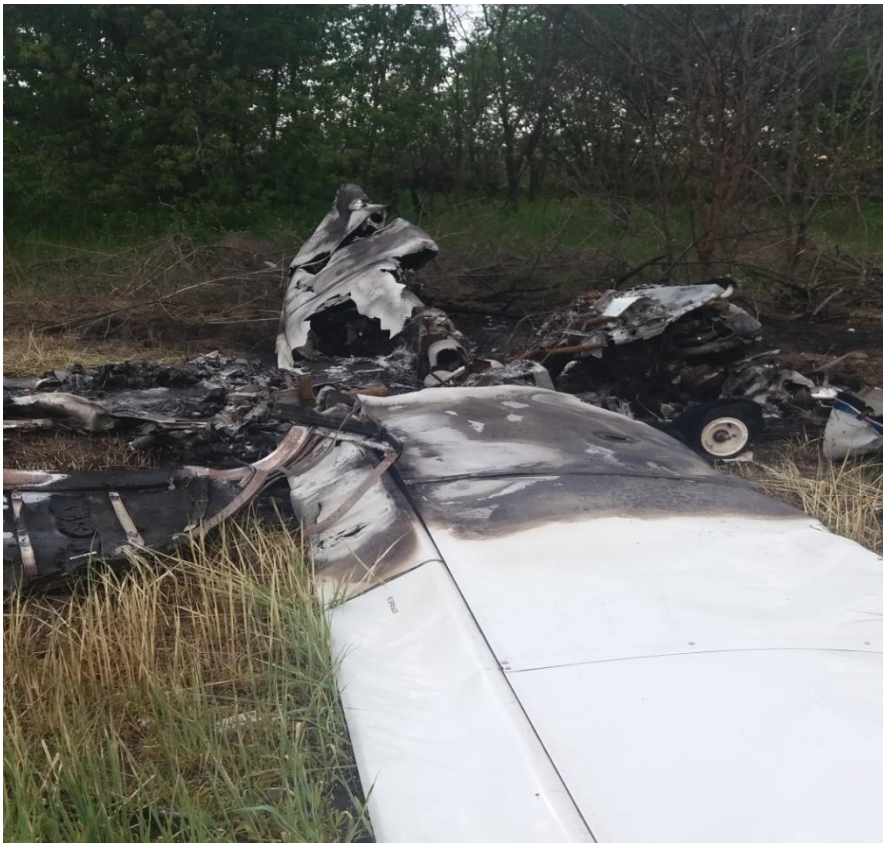
Picture 2

The plane collided with the ground almost vertically. The scatter of the wreckage is 14 meters. The cockpit is destroyed. The engine is detached and is in front of the cockpit. The propeller is connected to the engine. One propeller blade is bent and the other one is intact. After the plane crashed, it caught fire. As a result, for the fire the aircraft engine and the cockpit were burned up.

The root part of the left wing (at the location of the fuel tank) is completely burned, the root part of the right wing has marks of burns. The fuselage of the plane burned down. The tail of the plane burned up.

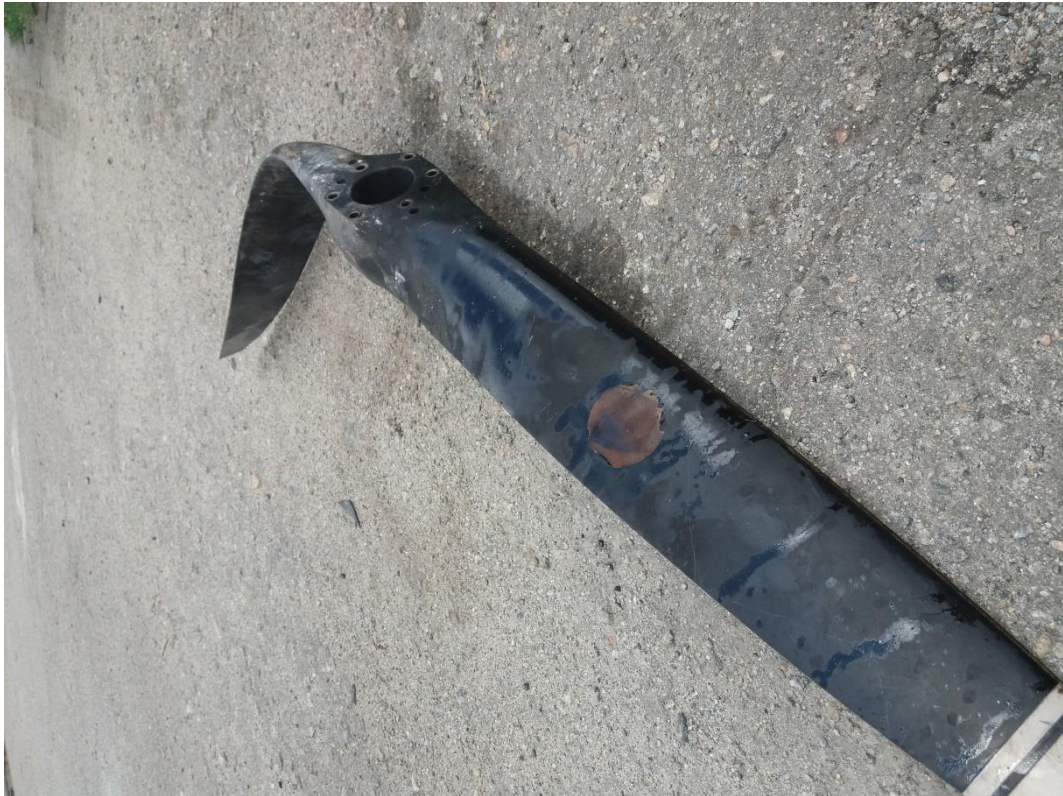
Picture 3 (damage to the propeller)

The examination of the wreckage revealed that one propeller blade was bent and the other intact. This indicates that the propeller was in self-rotation mode when it collided with the ground (ie, the aircraft engine was not running).

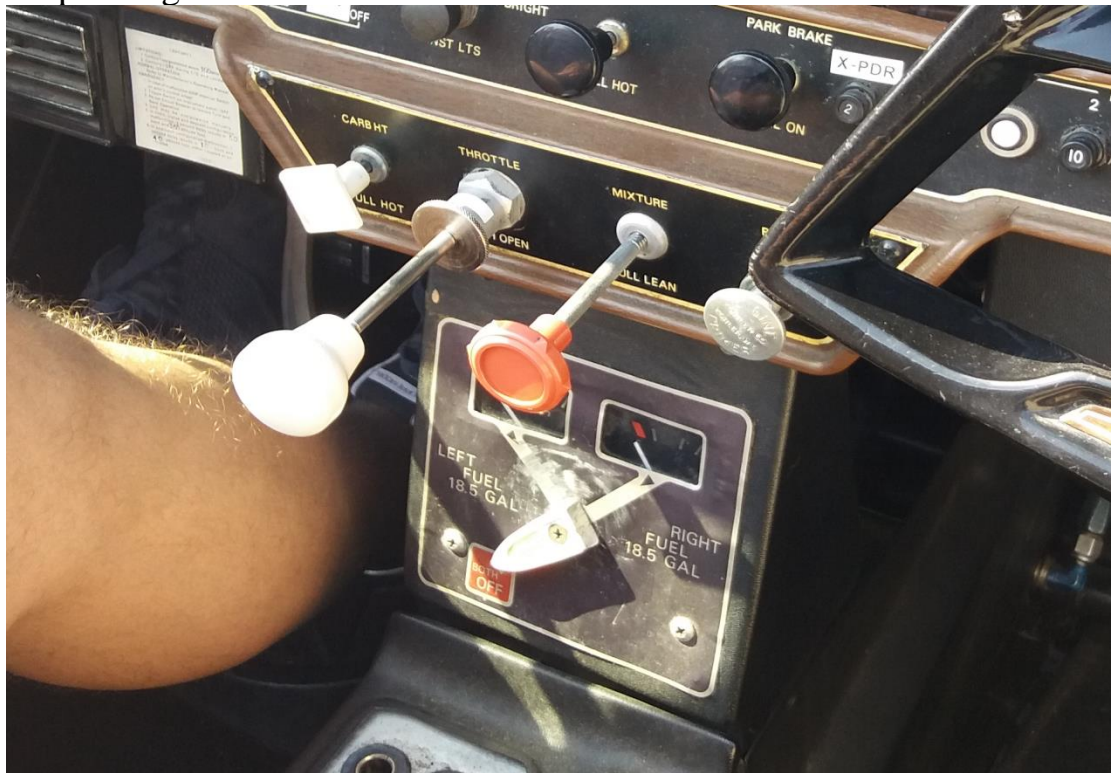
The fuel valve in the cockpit is located at the bottom of the central control panel. The fuel system does not have an audible alarm as for the end of fuel from the corresponding fuel tank to which the fuel valve is switched.

Picture 4 (location of the fuel valve on Grumman AA-5 aircraft)

3.3.1 Operators of the Grumman AA-5 aircraft should take into account the peculiarity of the aircraft's fuel system during the operation (impossibility to supply fuel to the engine from the left and right tanks at the same time) and permanently monitor fuel consumption by the tanks..

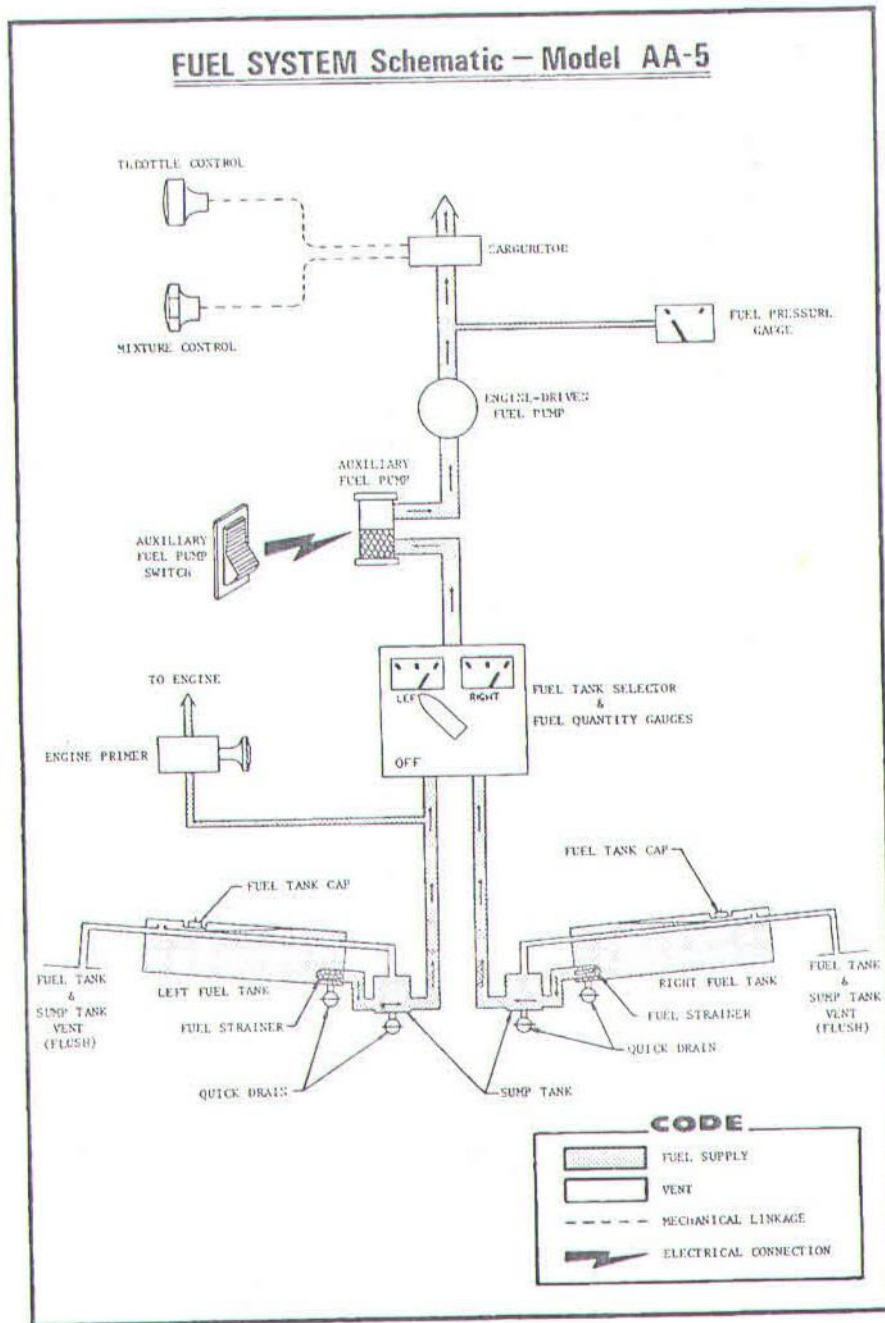
Figure 1

Layout of the fuel system of Grumman AA-5 aircraft)

Note: according to the design of the fuel system of the Grumman AA-5 aircraft, the fuel valve switches the fuel supply to the fuel pumps of the engine either from the right fuel tank or from the left one, the function of fuel supply to the engine simultaneously from the both tanks is not available.

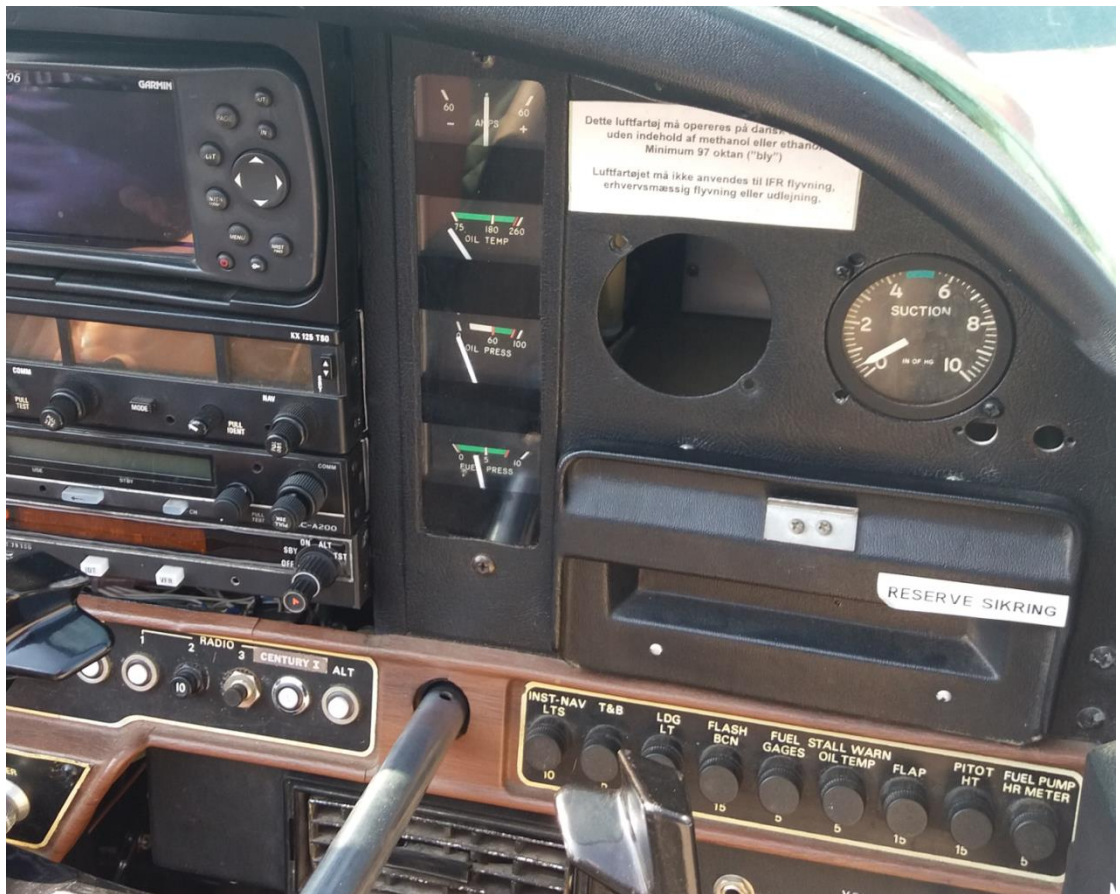
Picture 5 (section of the engine instruments of Grumman AA-5 aircraft)

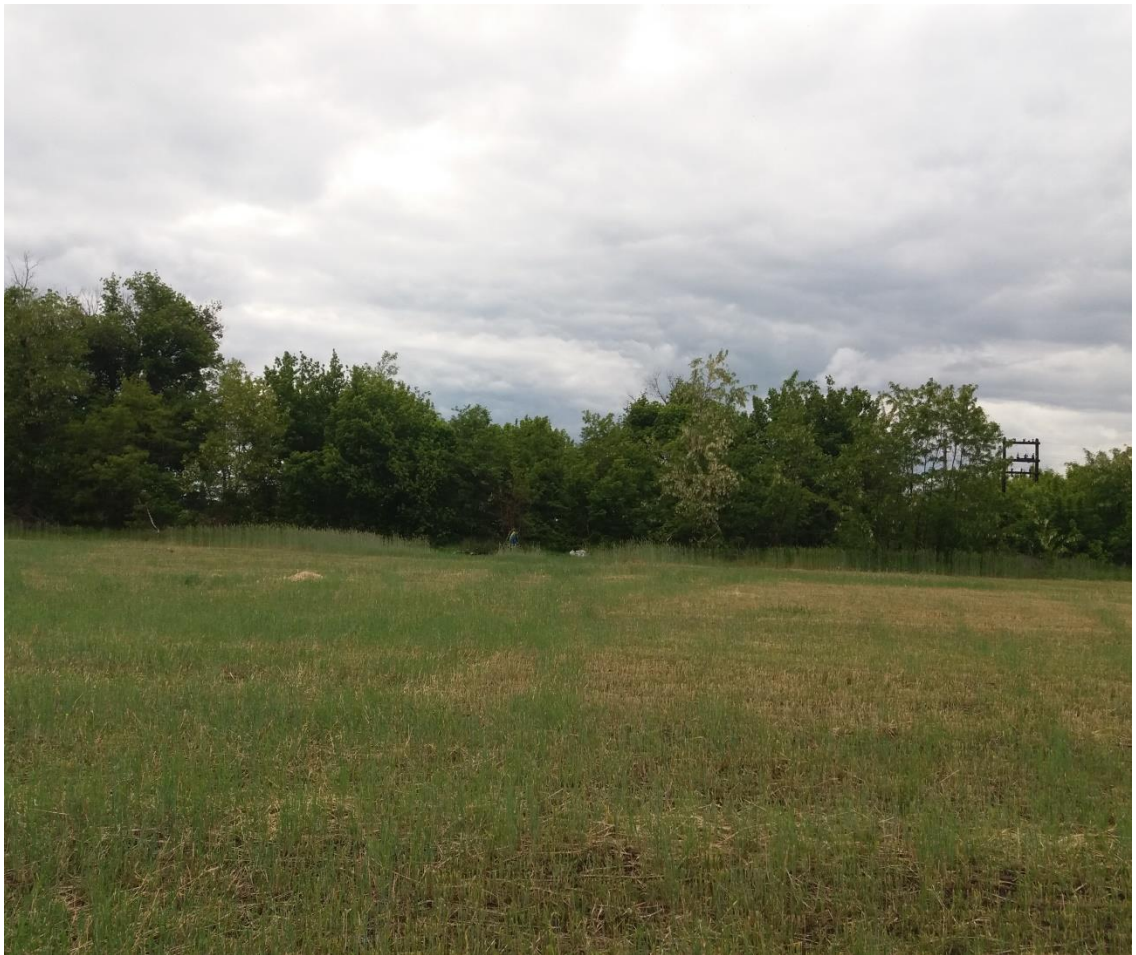
When inspecting the fatal accident scene, the team found that the plane crashed in front of the forest strip (Picture 3) which is in the end of "Kamyanka" airfield, behind the forest strip were LET wires followed by a plowed field were located.

Picture 6 (place of the aircraft impact with the ground)

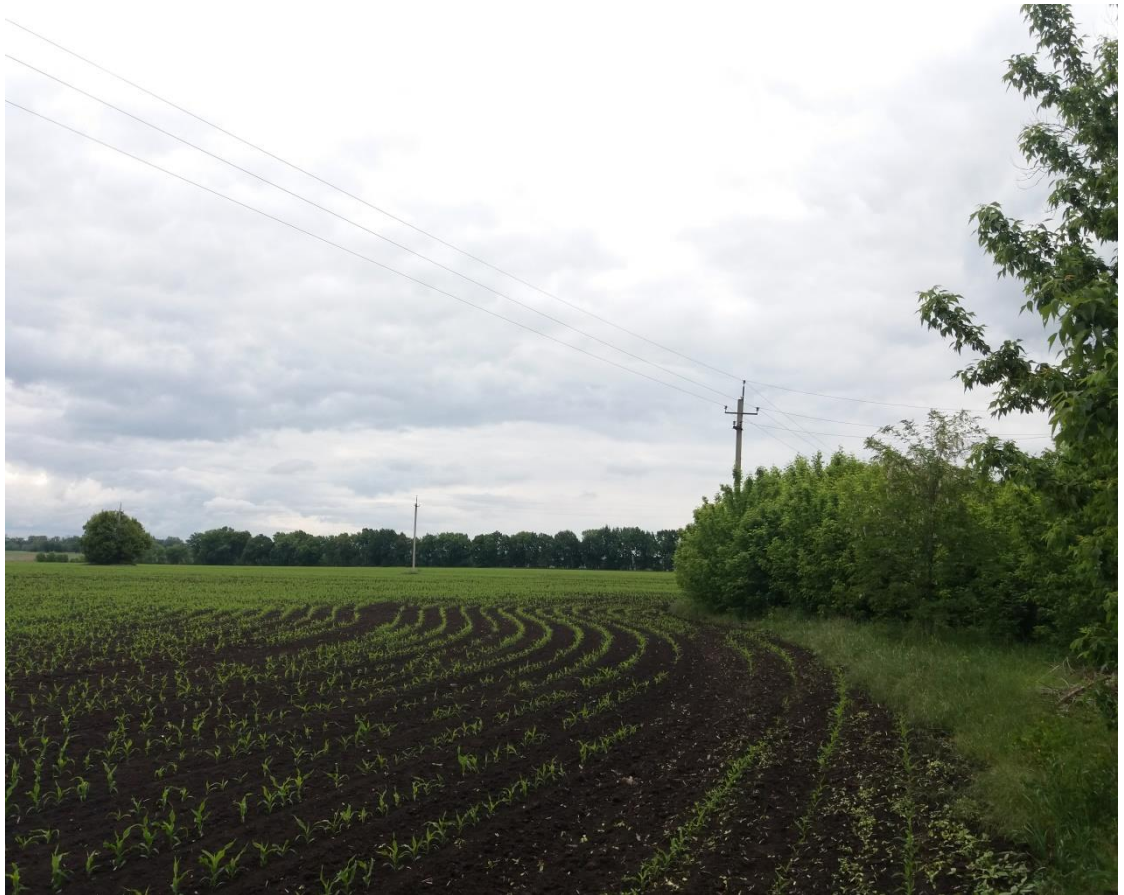
Considering that landing in front of him could lead to the destruction of the plane, the pilot who flew the plane, in order to save the plane, decided to land on "Kamyanka" airfield with a course being opposite to the takeoff. The recording of a video camera installed in the cockpit shows the pilot, who was on the left pilot's seat, trying to switch the fuel valve to another fuel tank.

Picture 7 (the field, a possible location of the forced landing)
