FINAL REPORT

on Investigation into Fatal Accident with Y1 "Dolphin" UR-OAP Aircraft
of the State Enterprise "Odesa Aviation Plant", which Took Place on 17.06.2020 at
9:14 UTC During Test Flight Operation in Odesa Aerodrome Area

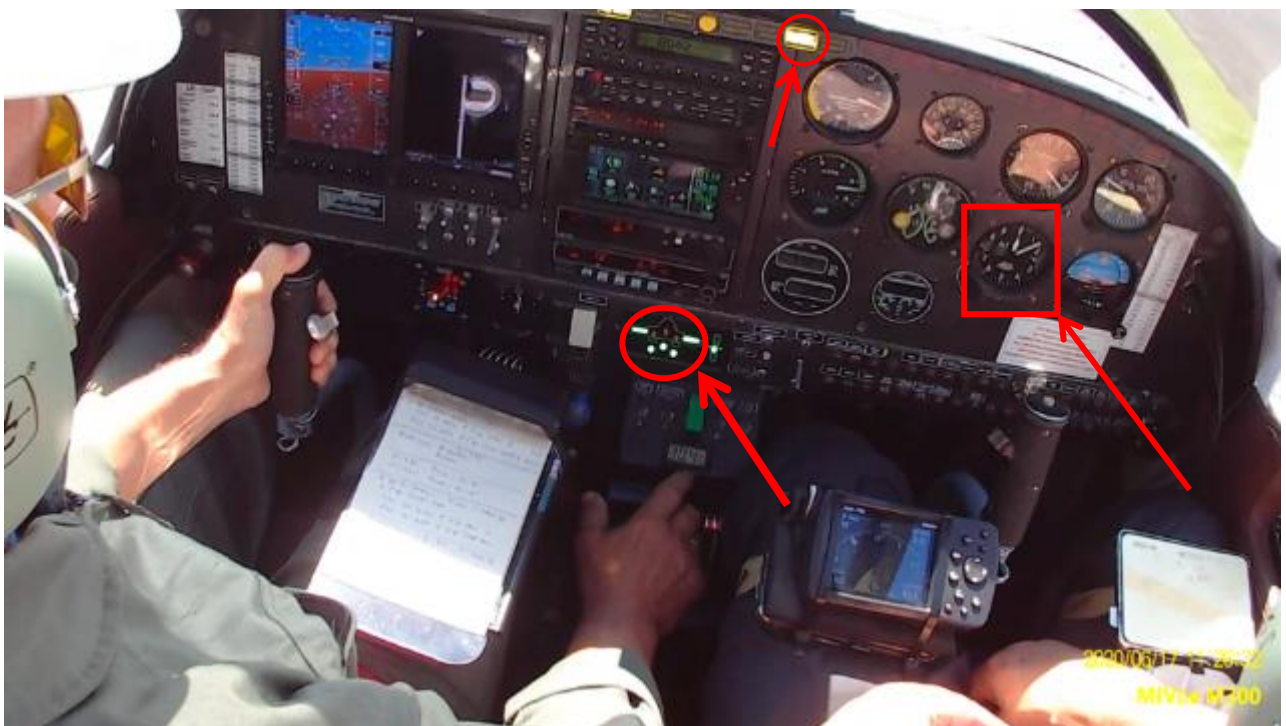
(Photo 1)

At 11:26:32, "flaps down!" display turned on. Photo 1.

Note. This display lighting up means that the landing gear *was not retracted!!!*

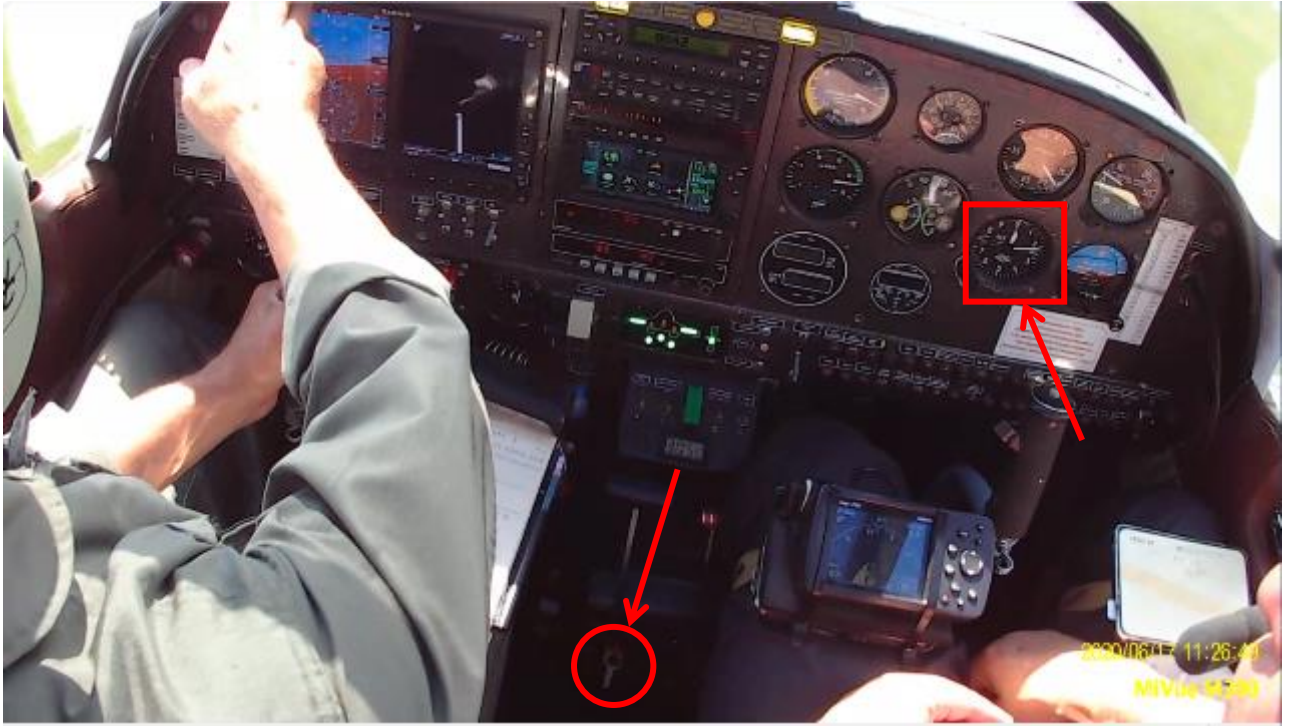
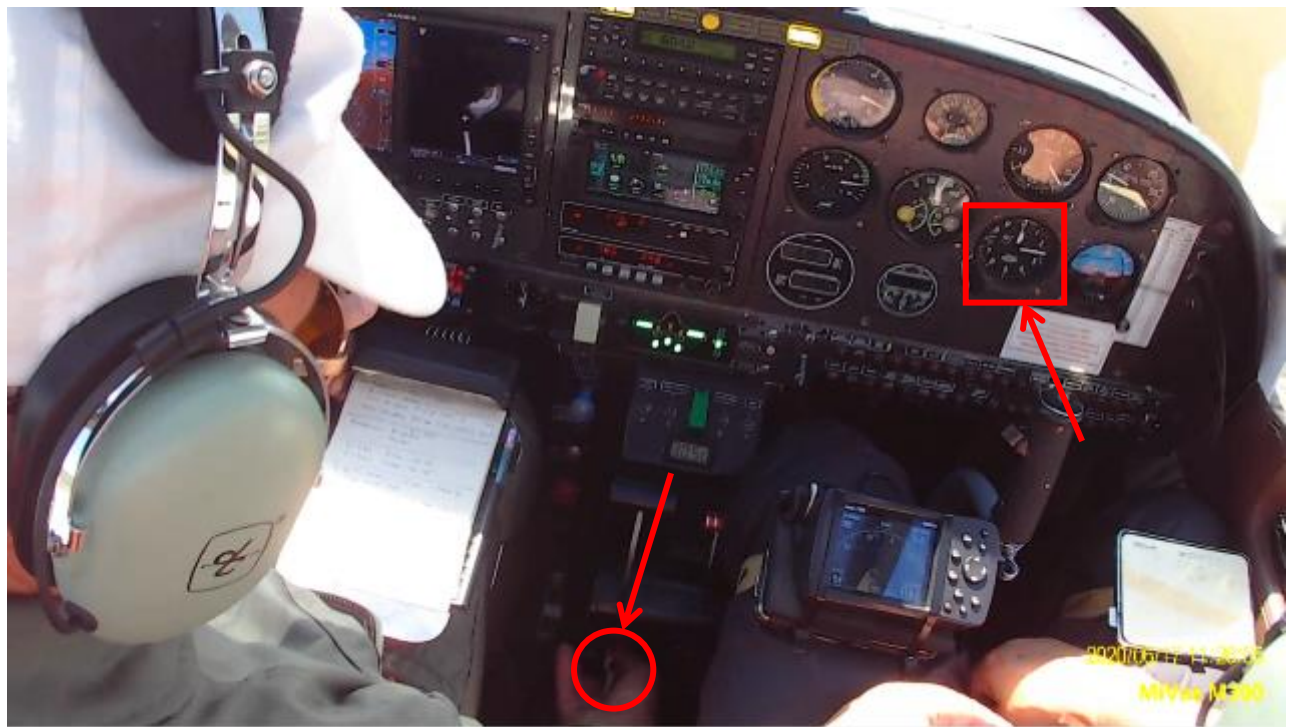
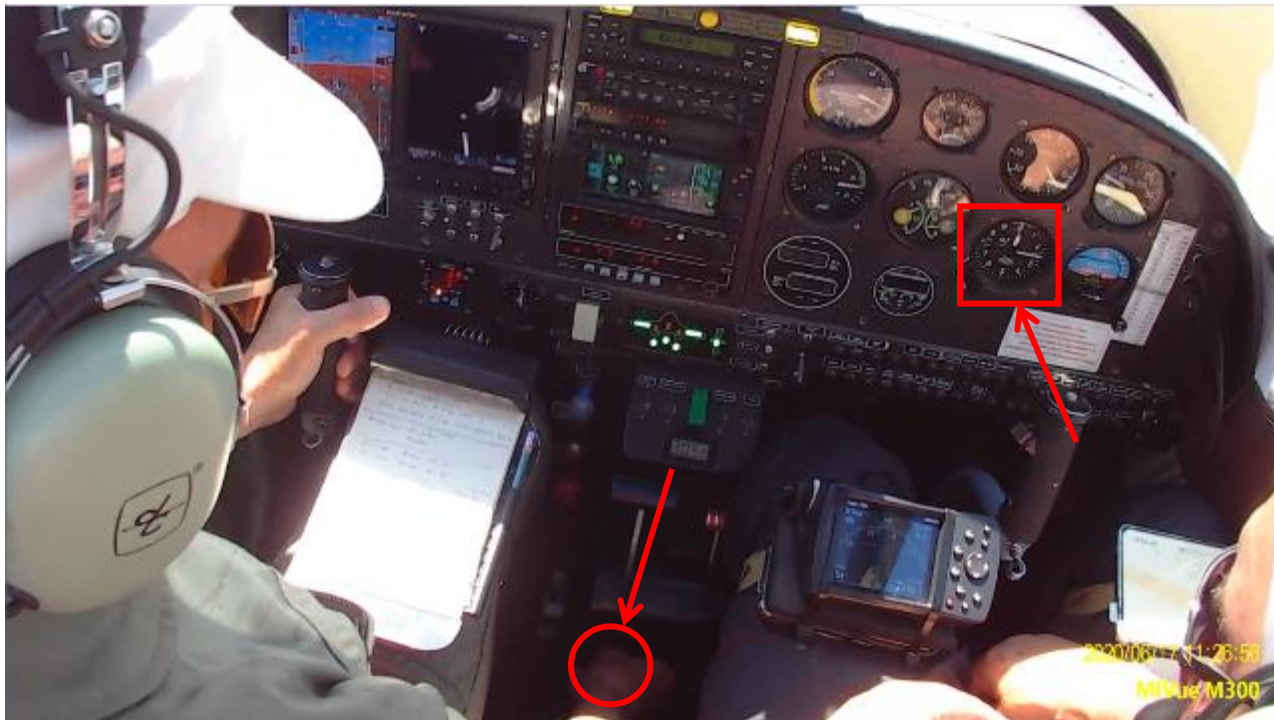
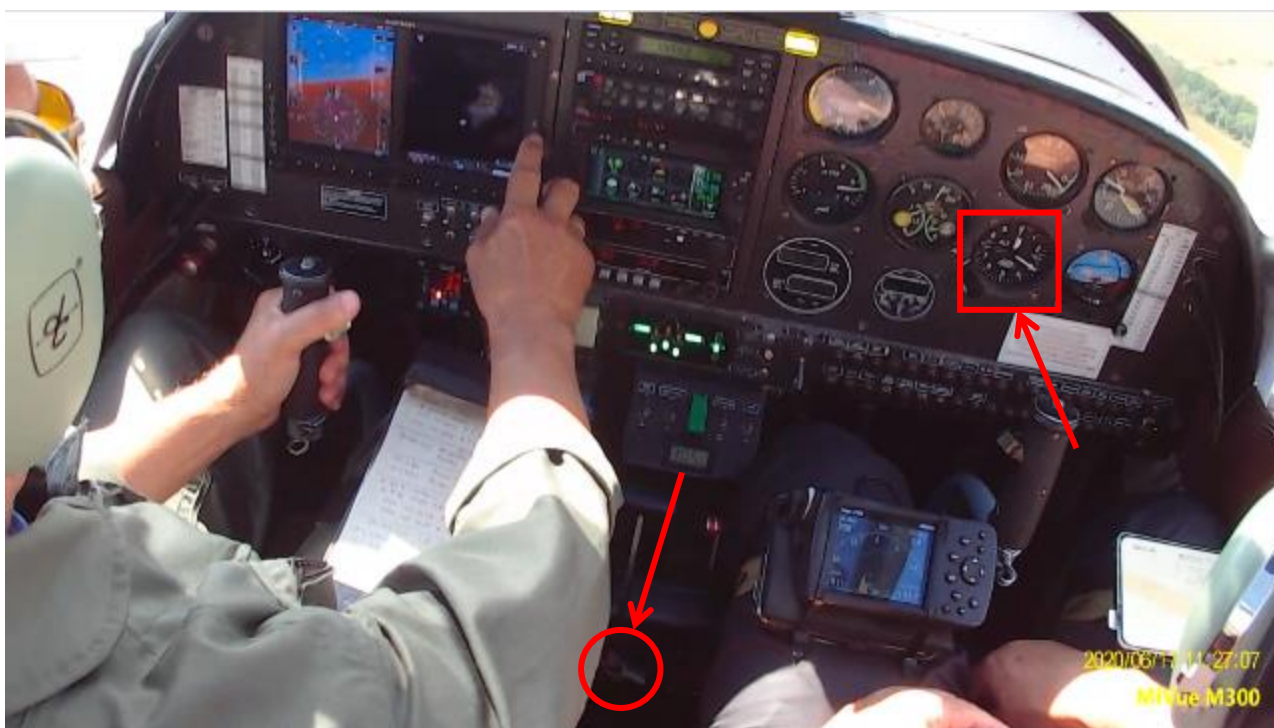
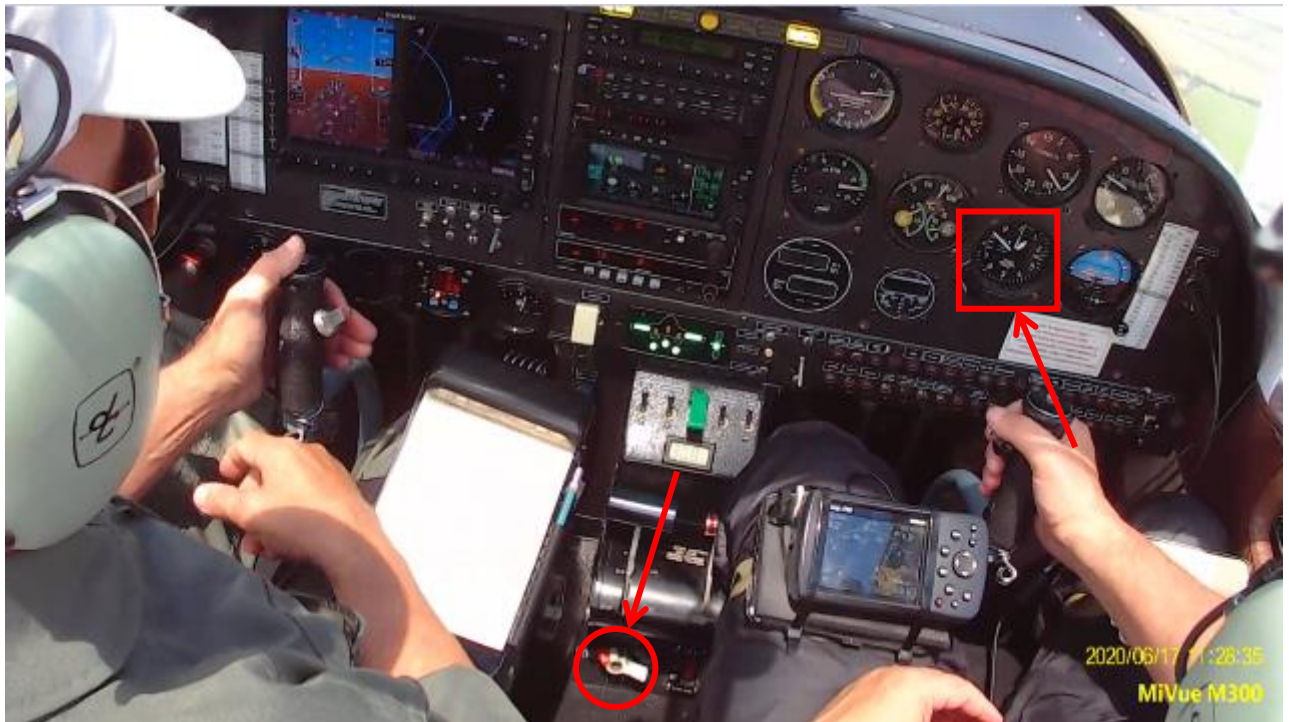
At 11:26:58, PIC switched the fuel tank selector valve to the "Left Tank".

The process of switching the fuel tank selector valve from the "Left + Right" to the "Left" tank position. Photos 2,3,4,5,6.

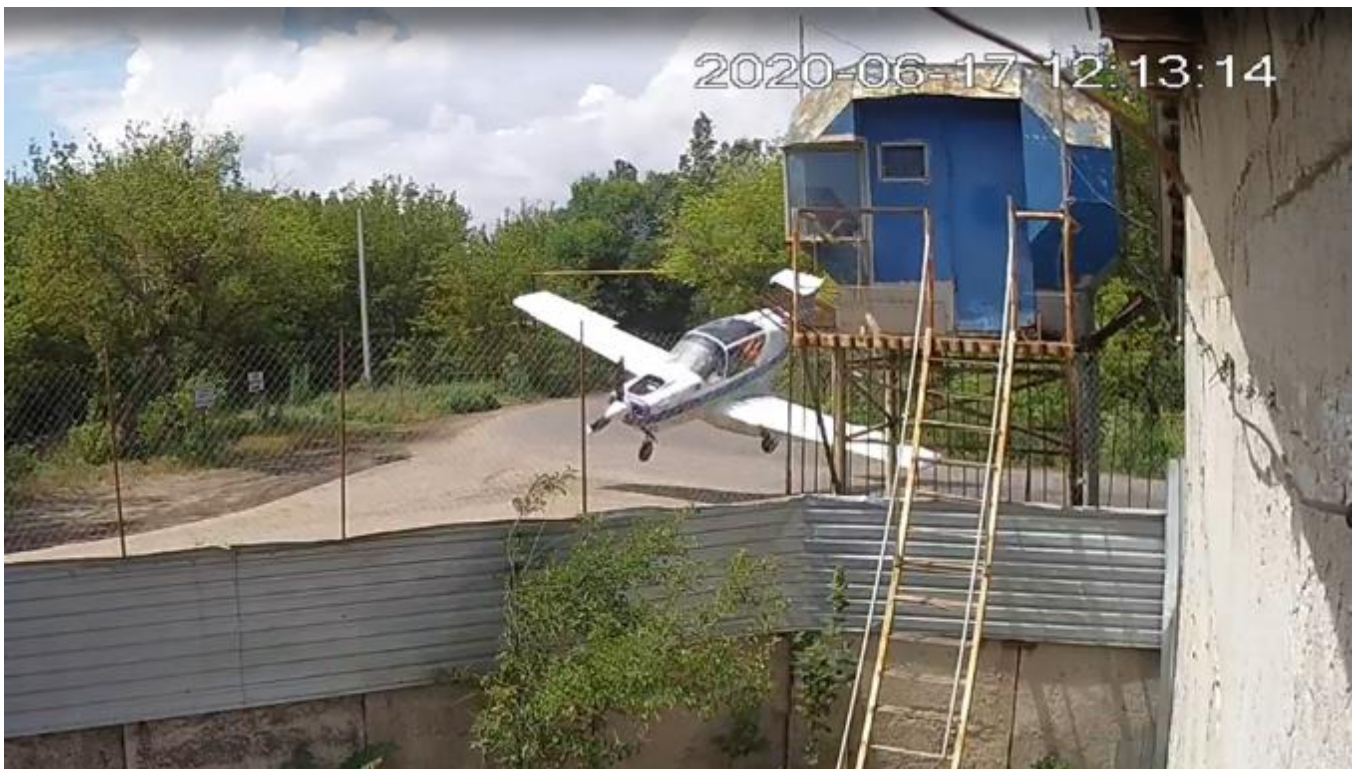
(Photo 7)

The last minute of the plane's flight was recorded by CCTV located in a private territory next to the alley. The descent was carried out with a left bank, onto the left landing gear and the front landing gear simultaneously with a high vertical speed.

- plane flies with a left bank of 10-15°;
- aircraft front and main landing gear are extended;
- flaps are deployed at an angle of 20° (configuration for aircraft takeoff);
- propeller does not rotate, the engine does not operate;
- descent trajectory is very steep;
- at a hard touchdown, wheels are completely flying away from the main and front landing gears;
- 2 propeller blades are destroyed. The third blade is partially damaged.
- separation of the propeller spinner from the engine shaft;
- ground impact resulted in the aircraft cockpit hood tearing off. The hood flips over in the air and falls in front of the aircraft on the ground;
- aircraft fuselage is moving by inertia along the road.
- left and right parts of the wing and flaps are being deformed.

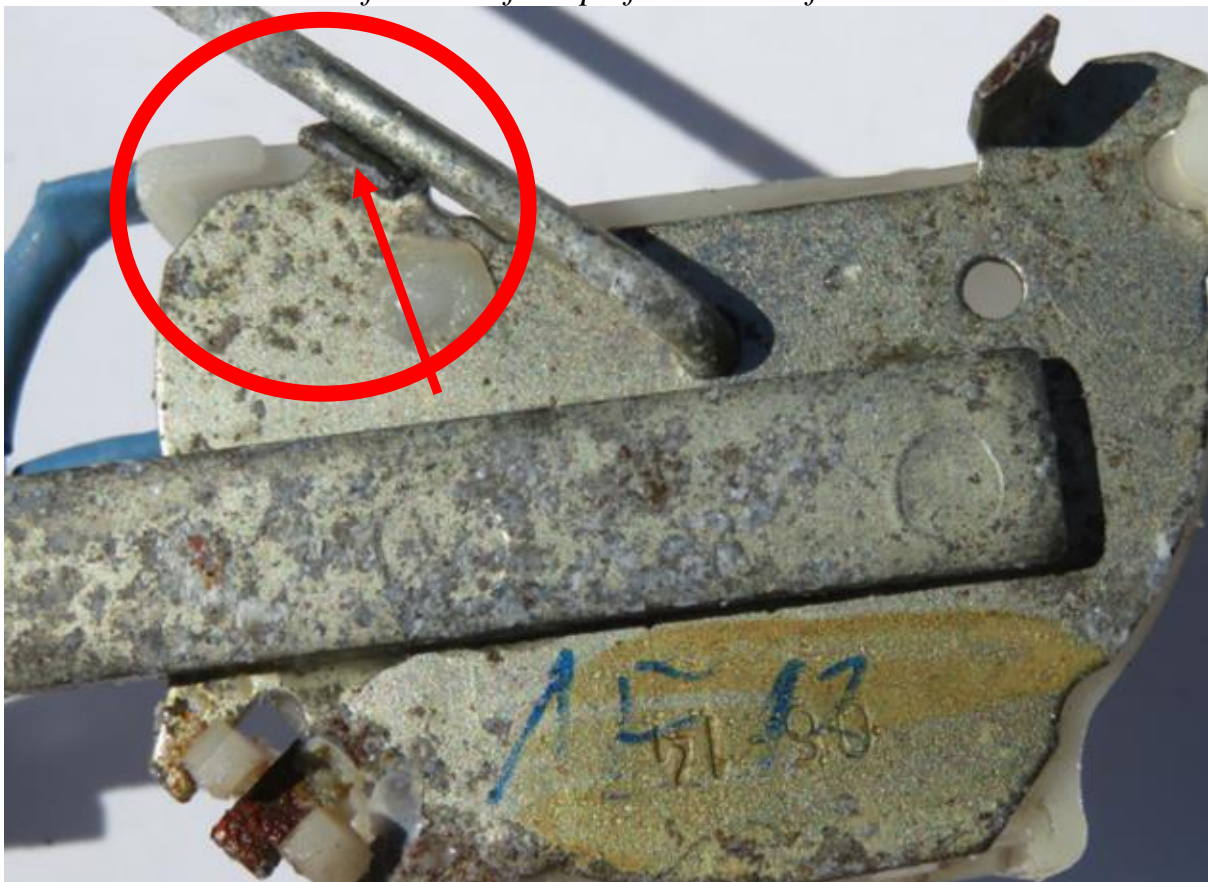
(Photo 11)

At inspection of the fuel system elements, a malfunction of the fuel quantity indicator sensor of the left fuel tank was detected. The float mechanism of the sensor *was blocked* in the upper position, which caused the indicator of the fuel quantity in the left tank to give false, overestimated readings, and caused not to decrease during the flight.

Deformed left stop of the sensor float lever.

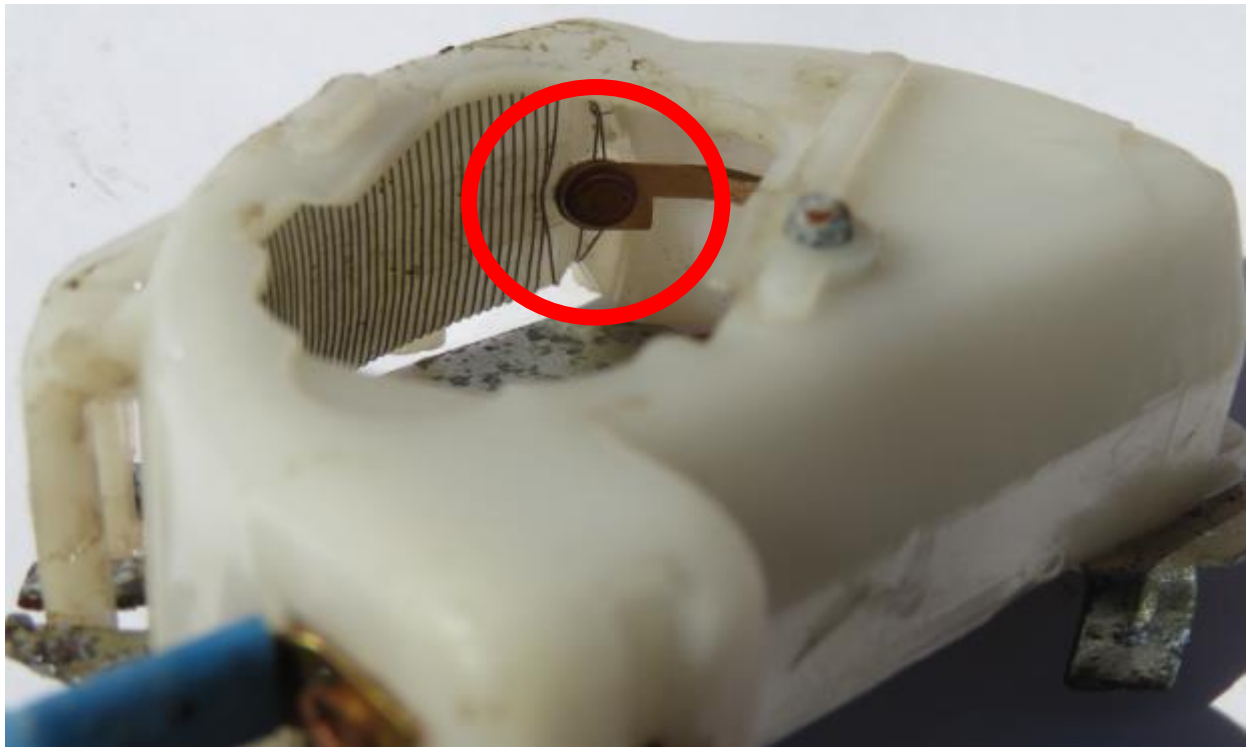
(Photo 12)

The sensor potentiometer wiper is "blocked" in the upper position and is retained in this position by the turns of the potentiometer wire.

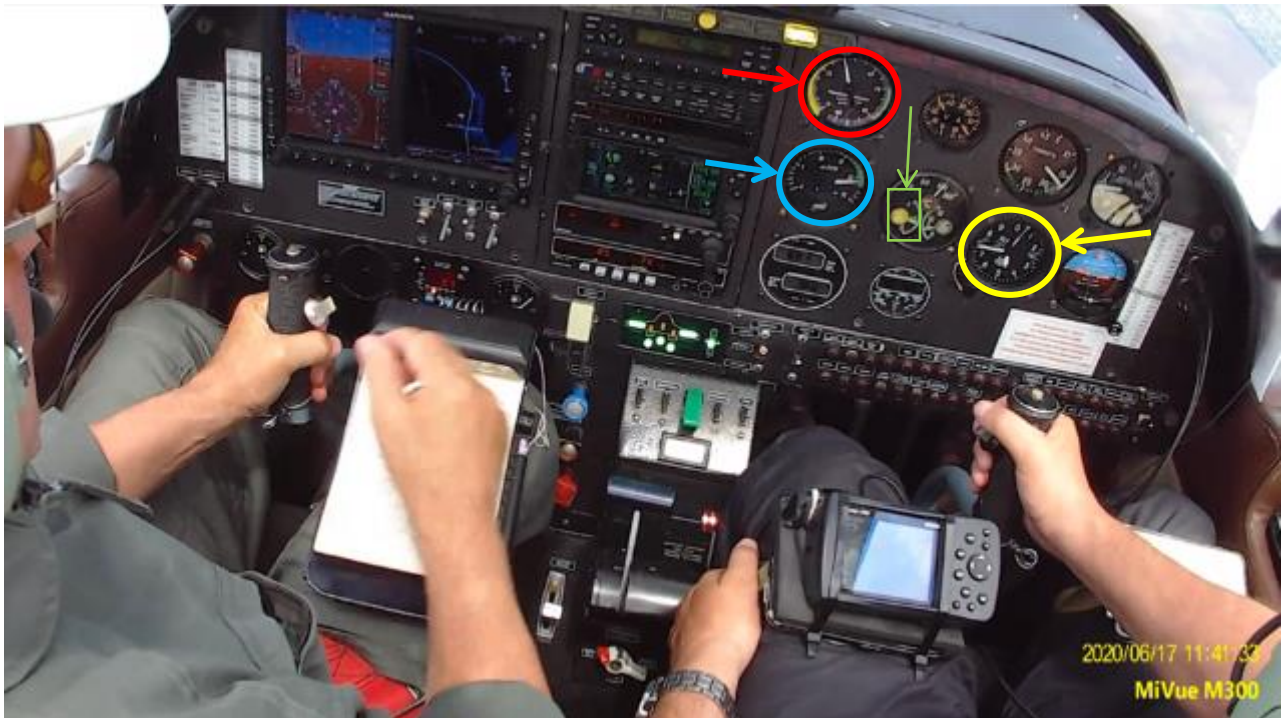
(Photo 13)

At 11:41:33, signs of engine starvation appeared: engine rpm drop, air pressure drop in the manifold, fuel pressure drop and a characteristic sound of a significant engine power loss due to lack of fuel in the left tank. It took place at the flight altitude of 4750 feet.
