**NATIONAL BUREAU
OF AIR ACCIDENTS INVESTIGATION OF UKRAINE**

FINAL REPORT

**GROUND IMPACT
OF
SCHROEDER FIRE BALLOONS GmbH G42/24
HOT AIR BALLOON**

REGISTRATION NUMBER: D-OWUE

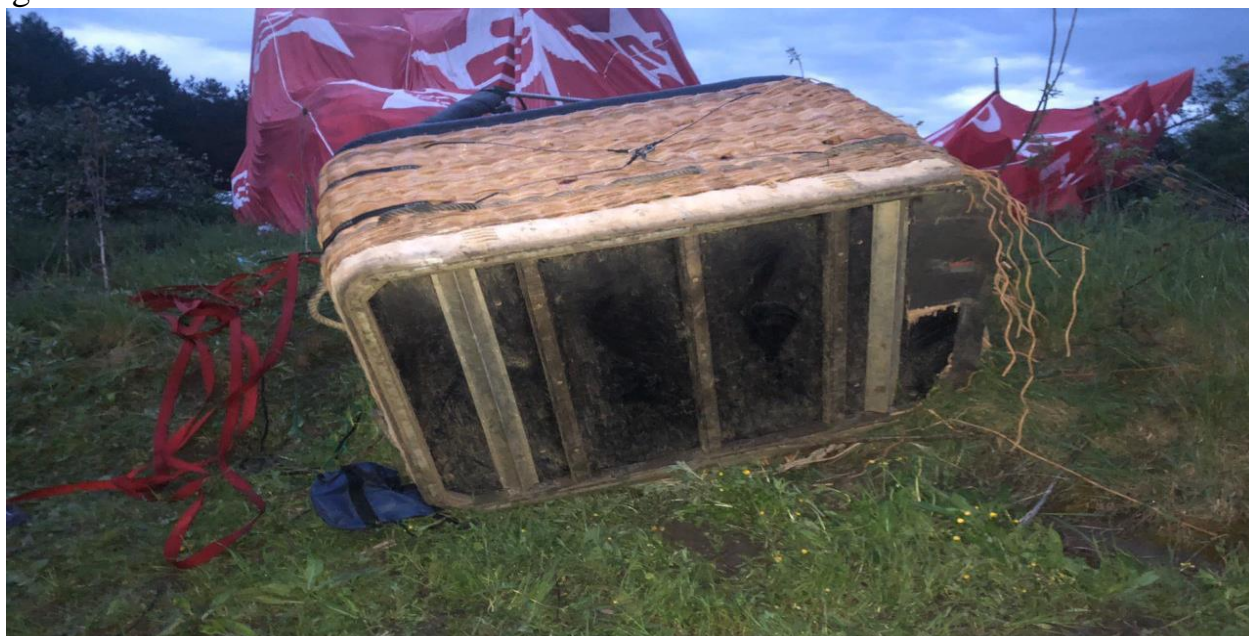
The HAB collided with the ground with the further passenger basket (gondola) overturn. When the HAB impacted the ground, four passengers were thrown out of the basket, as a result of which one person was killed, and the pilot and four passengers were seriously injured. The AC suffered significant damage.

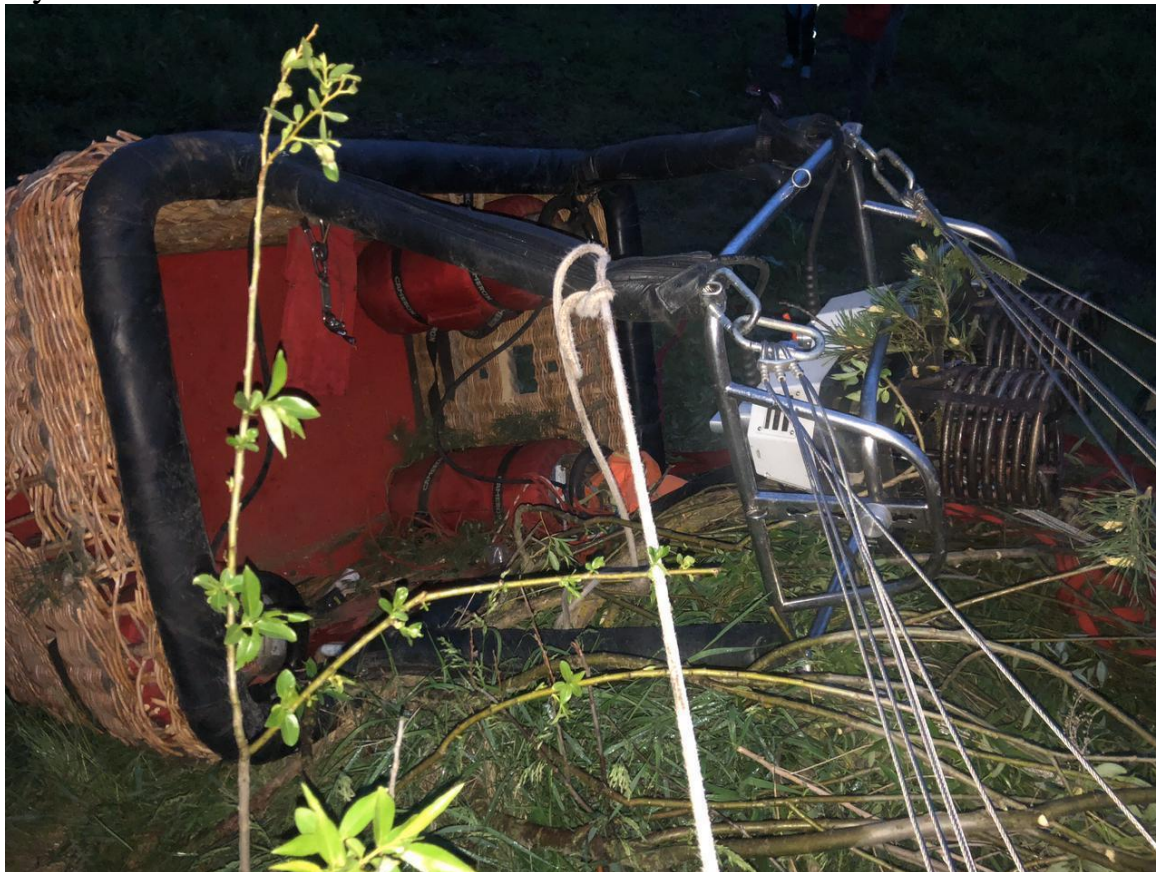
Figure 1.

This led to an early surface touchdown and ground impact, as a result of which, a man fell out from the gondola and the balloon continued to move due to inertia on the remaining lifting force and stopped after 1340 meters.

Due to the impact, the HAB was seriously damaged and partially destroyed.

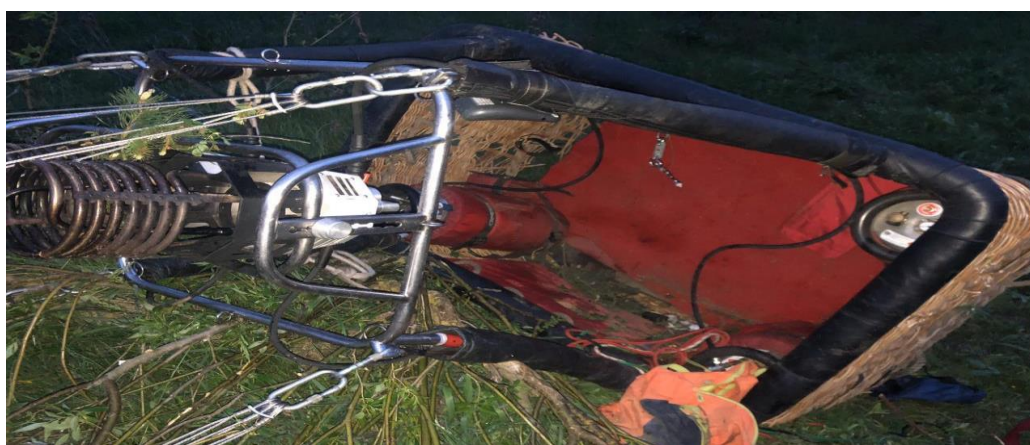
Upon the ground impact, Schroeder D-OWUE HAB suffered significant damage.
