National Bureau of Air Accidents Investigation

INTERIM REPORT ON INVESTIGATION INTO (FATAL) ACCIDENT

Accident site:	Sheparivtsi village, Kolomyia district, Ivano-Frankivsk region.	Number of the case/investigation:	48/2021
Date and time:	28.07.2021 10:35 UTC	AC registration number:	UR-PAMA
AC Type:	WT-10 ADVANTIC	Injuries:	4 persons killed
Type of Flight:	Sightseeing

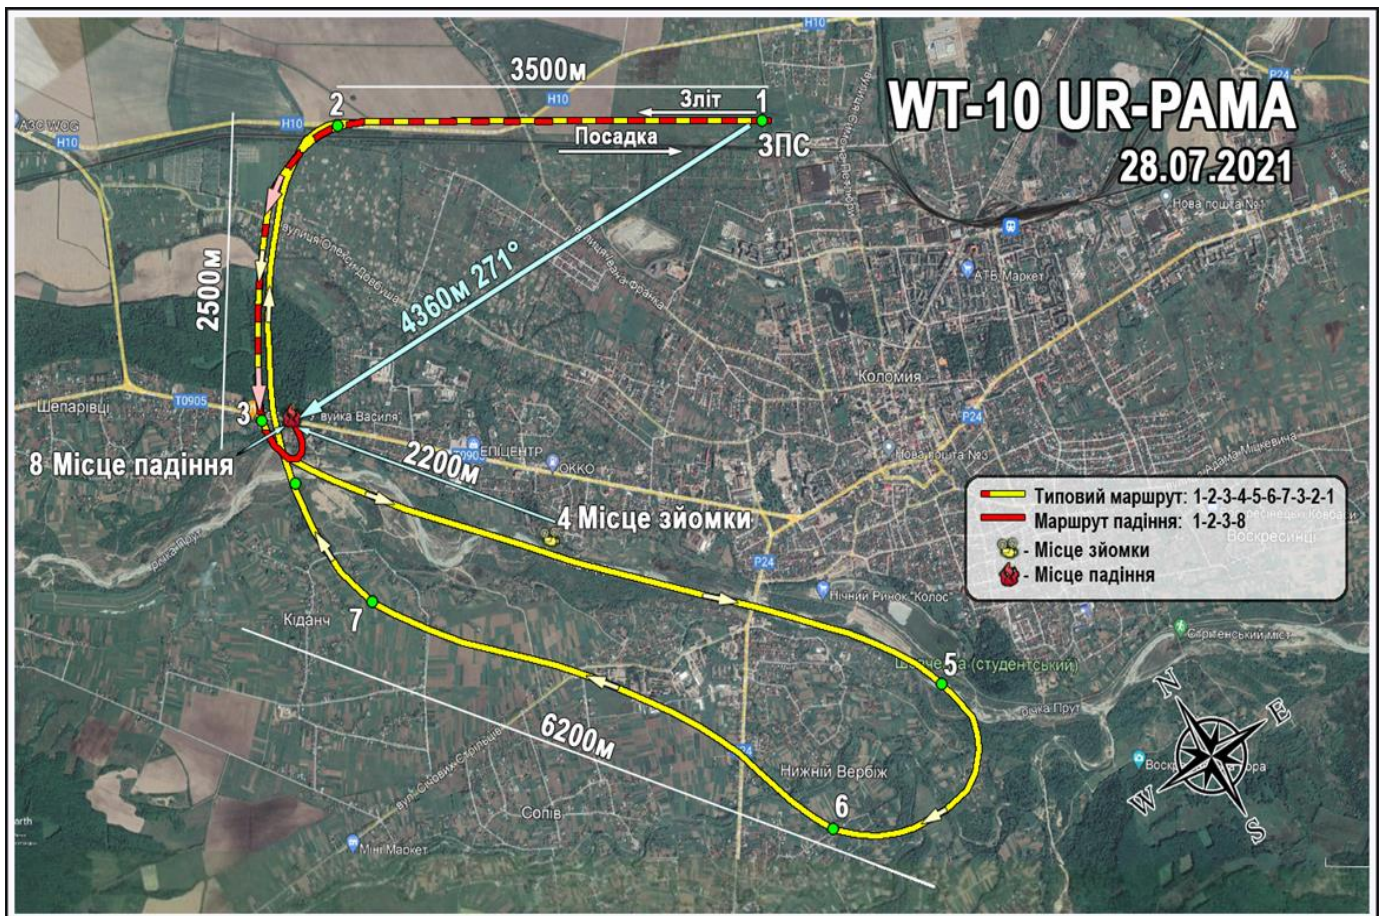
Місце падіння = Ground Impact Location; *Місце зйомки* = Filming Location.

Посадка = Landing; *Зліт* = Take-Off; *ЗПС* = Runway. **In Yellow**: typical route: 1-2-3-4-5-6-7-3-2-1. **In Red**: aircraft crash flight route: 1-2-3-8.

During the flight operation, the PIC used RW 30/12, the take-off was performed with the magnetic heading $MH=299^\circ$, and landing with $MH=119^\circ$. The flight route went through waypoint 1 (take-off point), waypoint 2 (first turn), waypoint 3 (turn over the Prut River) with the subsequent flight over the river bed to waypoint 5. The number 4 on the route indicates the location of eyewitnesses, who filmed the last minutes of the flight.

After waypoint 5, the aircraft performed a right turn through waypoints 6, 7, 3, 2 and 1 back to the Airfield for landing and change of passengers.

The last flight passed through point 1. Approximately in the area of point 2, the aircraft began to lose altitude abruptly, collided with ground obstacles and impacted the ground at the location marked with number 8. The last flight is marked in red on the diagram.
