NATIONAL BUREAU OF AIR ACCIDENTS INVESTIGATION

FINAL REPORT

RUNWAY EXCURSION DURING LANDING

AT KYIV (ZHULIANY) AERODROME

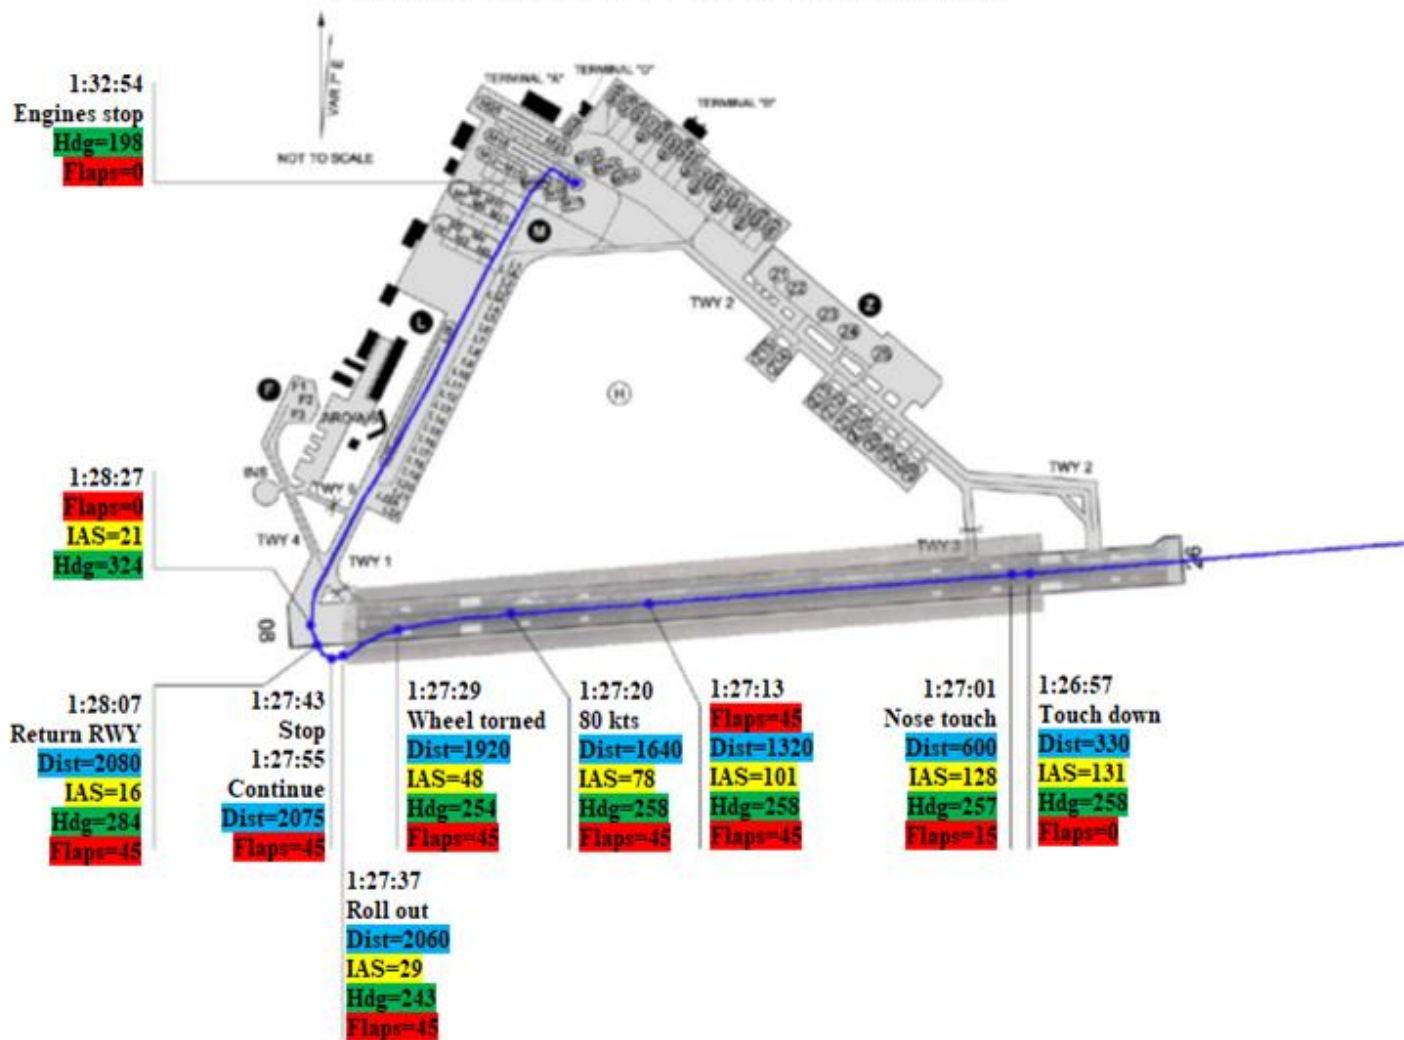
4X-CUZ Aircraft Dynamics at UKKK on 21.05.2021, During Landing Run, Veering off Runway, Taxiing-in to Stand 24

During the landing run, the right wheel tire of the right main landing gear destructed, which resulted in the aircraft veering off RW 26 to the left and continuing movement along the runway edge lights outside the runway. The crew did not report this occurrence to the controller. At 01:28:26 UTC, the aircraft crew returned to the runway in front of the runway end, opposite to TW1, and reported a visual observation of the follow-me car. **Tower controller instructed to contact GND controller.** Then, the aircraft continued taxiing to the Stand behind the follow-me car.
