**NATIONAL BUREAU OF AIR ACCIDENTS INVESTIGATION
OF UKRAINE
(NBAAI)**

FINAL REPORT

**OF INVESTIGATION INTO SERIOUS INCIDENT, WHICH TOOK PLACE
WITH CESSNA C510 AIRCRAFT, NATIONALITY AND REGISTRATION
MARK YR-CMO, ON MARCH 03, 2021, DURING PERFORMANCE OF
FLIGHT EN-ROUTE KYIV (ZHULYANY) – ODESA**

**of Investigation into Serious Incident (Take-Off from Left Shoulder of RW-26),
Which Took Place with Cessna C510 Aircraft, Nationality and Registration
Mark YR-CMO, Operator – CONARG MOTION S.R.L., on March 03, 2021,
During Performance of Flight En-Route Kyiv (Zhulyany) – Odesa**

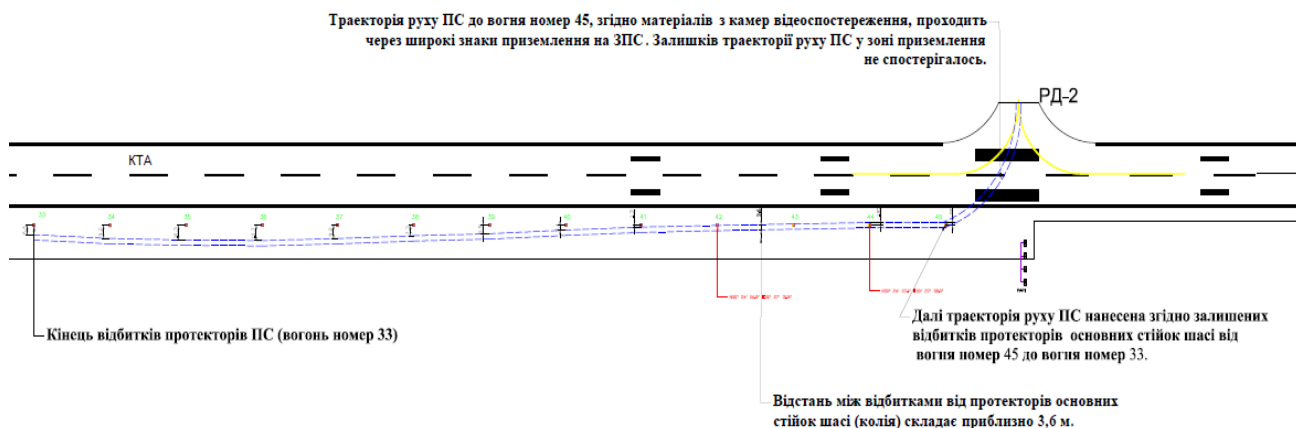
Fig. 1. Sketch of the serious incident with Cessna C510 YR-CMO aircraft.

At taxiing-in RW-26, the aircraft crossed the runway, passed over the edge light No. 45 and took off over the left edge lights of RW-26 (Fig. 1.)

Inscription on the top of the Sketch: Aircraft movement trajectory till light No. 45 according to CCTV passes through wide touchdown marks on the runway. Aircraft movement trajectory remainders were not observed in the touchdown zone.

Inscription on the left side of the Sketch: End of aircraft tread footprints (light No. 33)

Inscription on the bottom central side of the Sketch: Distance between the main landing gear tread footprints (wheel track) is about 3.6 m.

Inscription on the bottom right side of the Sketch: Further on, the aircraft movement trajectory is plotted according to the main landing gear footprints from light No. 45 to light No. 33.

As a result of the encounter, the runway lights No. 44 and No. 42 were destroyed. The aircraft sustained no damage.

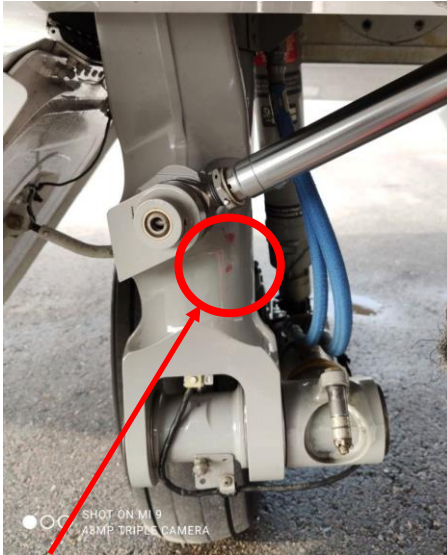
As a result of the occurrence, the plane was not damaged. Upon the aircraft return from UKOO to UKKK and placing at L-17 Stand, an airport inspector, together with a handling company representative, took pictures of the right main landing gear of the Cessna C510 YR-CMO aircraft. Red paint traces of from the spring-loaded markers of the runway edge lights were clearly visible on the right landing gear (Fig. 2).

Fig. 2. Photo of the right landing gear with a red mark from the spring-loaded markers of the runway edge lights.

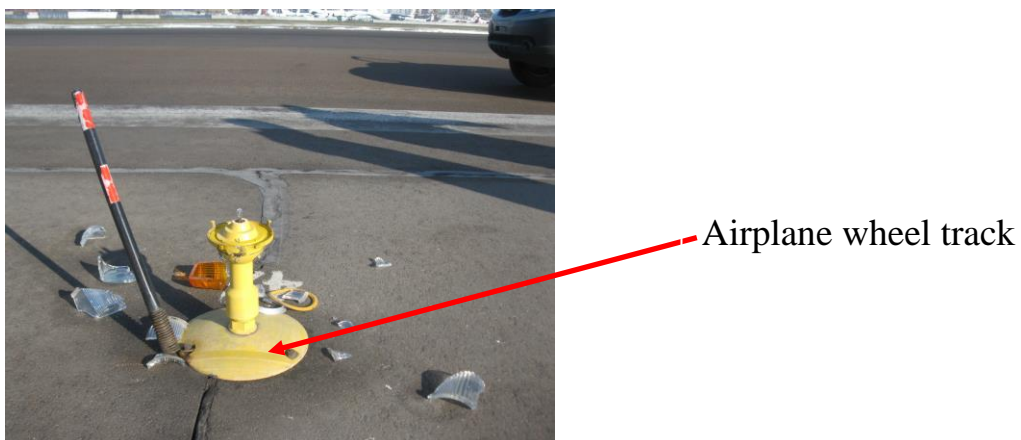
Runway edge light No. 42:

the light upper part is damaged, in particular, the outer and inner dissipating lenses, and their attachments. The track from the aircraft landing gear wheel is visible on the light attachment base.

Fig. 3. Destroyed runway light No. 42.

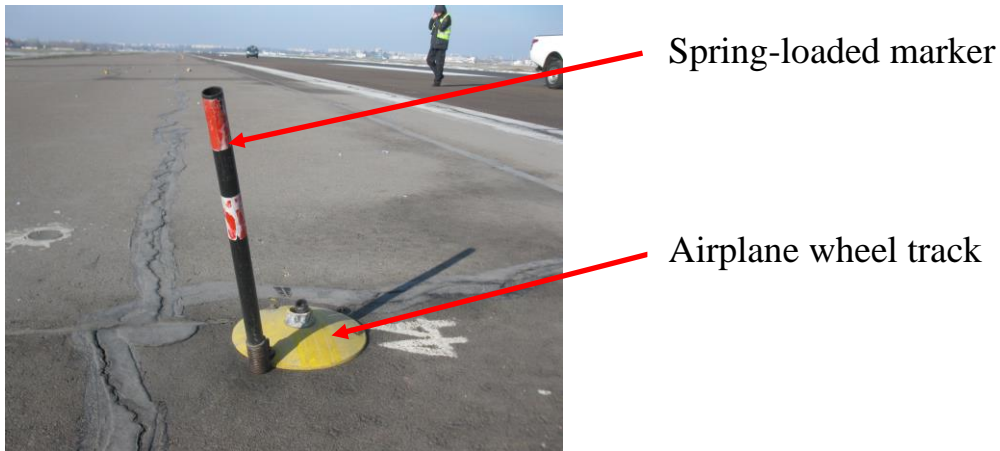
Edge light No. 44:

the light is completely destroyed, the light fragments are scattered in the area between lights No. 44 and 43. On the light attachment base, the aircraft wheel track passing through the center of the attachment base is clearly visible.

Fig. 4. Destroyed runway light No. 44.

3	<p>Figure 4 shows the edge light no. 44 destroyed / missing, but does not show fragment of bulb or protective body. Instead, edge light no. 42 there are damaged fragments of the edge light around its vertical body. Considering the dynamics of the aircraft in take-off phase, it would have been normal for edge light no.44 to be less damage that the edge light no.42. In this case, edge light no. 44 was completely destroyed and scattered towards edge light no.43, and similarly fragments of edge light no. 42 should</p>	Rejected	<p>Figure 4 shows the consequences of destruction of the edge light No.44. This photo was taken after the light fragments had been removed by the airfield staff as foreign objects for safety reasons. Unfortunately, the person, who had first arrived at the occurrence site, did not record the destroyed light, and the flight safety inspection documented by that time the consequences of hitting the light. The same thing happened with the photo of edge light No.42.</p>

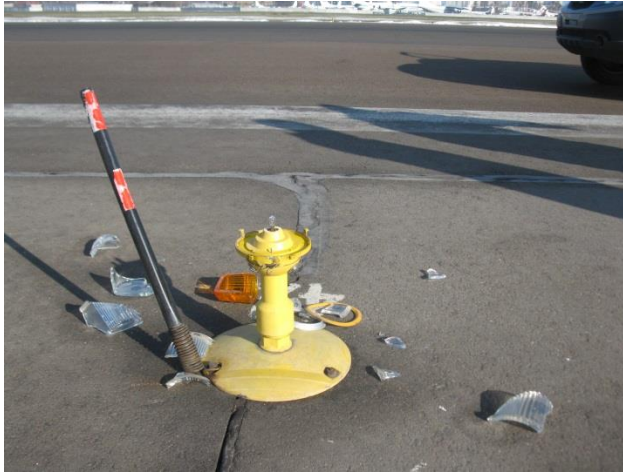
Fig. 5. Photo of damaged runway edge light No. 42

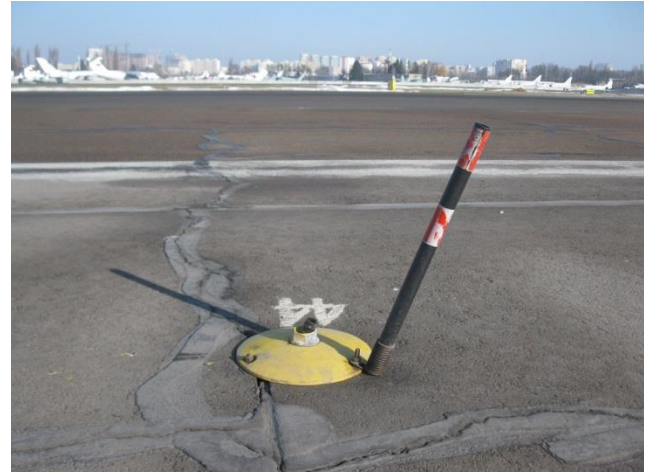
Fig. 6. Photo of the base of the attachment of destroyed runway edge light No. 44

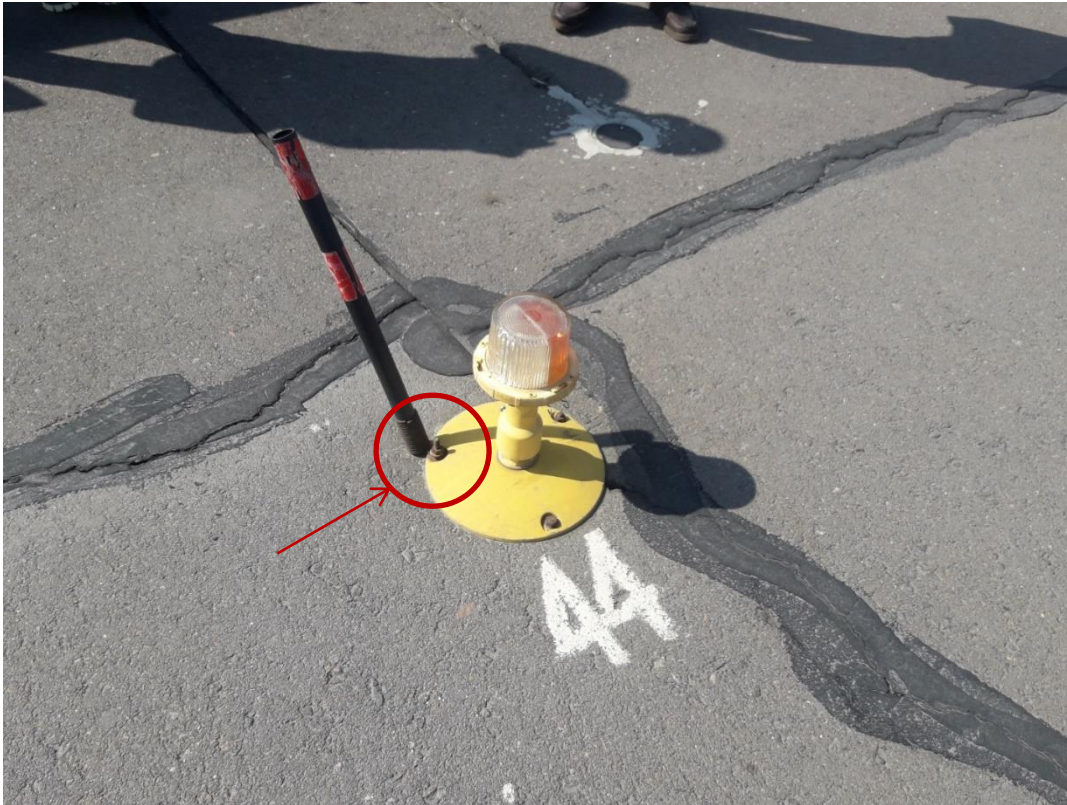
During the runway edge lights inspection on 27.04.2021, the Investigation Team recorded that one of the threaded rods, on which the light attachment base was installed,

protrudes over the base-locking nut; that can damage the tire and pose a hazard in case of encountering the light attachment base.

Fig. 7. Photo of the renewed runway edge light No. 44

As explained by the ELFSS specialists, during the reconstruction of the aerodrome in 2010-2011, threaded 11.5 cm-long rods M10 and the special mastic, which hardened after reaction with a thickener and firmly held the rod in the asphalt pavement, were used to install the elevated-type lights. Three of these rods were used. The light base was then placed on these rods and secured with nuts. The height of the rod above the base body was about 10-15 mm. Over time, the mastic cracks around these rods, which can cause the rod protrusion or bad locking. Thus, there are no restrictions on the height of the rod above the base body in the aerodrome's technological or instructional documents. That is, during the light maintenance, those parameters, for which there are no requirements in the regulatory documentation, are taken by ELFSS specialists on the basis how they looked at the time of putting into service. In general, the requirements for the personnel's actions during the lights maintenance are described in paragraph 5.3 of Procedure 10 for the inspection, as well as planned and emergency maintenance of visual and non-visual approach and landing aids, and aerodrome electrical system (Part E of the Aerodrome Manual.)

- strict observance of paragraph 5.3 of Procedure 10 for inspection, as well as planned and emergency maintenance of visual and non-visual approach and landing aids, and aerodrome electrical system (Part E of the Aerodrome Manual), in particular, as regards the lights maintenance and replacement, and check of light fitting attachment reliability;

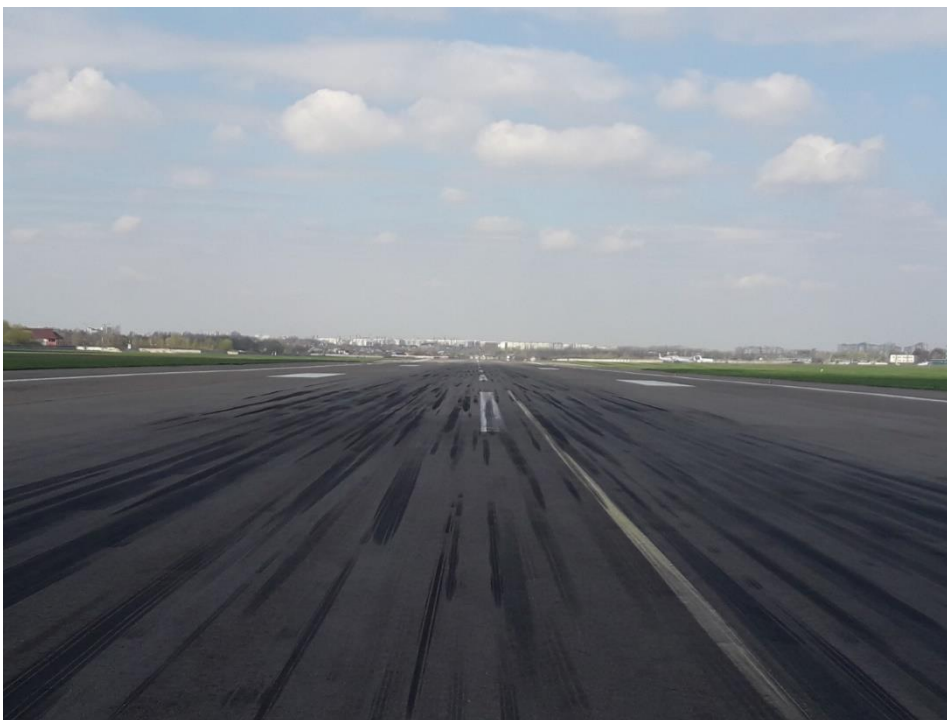
During inspection of the runway and aircraft taxiing routes on 29.04.2021, the Investigation Team noted the fact that marking of the runway centerline, especially in the touchdown zones with both landing headings, is not clear because of the presence of rubber traces on it and requires renewal.

Fig. 8. *Photo of the runway centerline marking state*

At the same time, the Certification Specifications developed for the Aviation Regulations of Ukraine "Technical Requirements and Administrative Procedures for Certification of Aerodromes" contain requirements only for the location and size of the runway centerline. However, there are no requirements for the marking clarity,

brightness, renewal frequency. The airport guiding documents, which regulate the aerodrome service activities and airfield operation procedure, lack the criteria for assessing the state of the aerodrome elements marking, in particular, the runway centerline state.

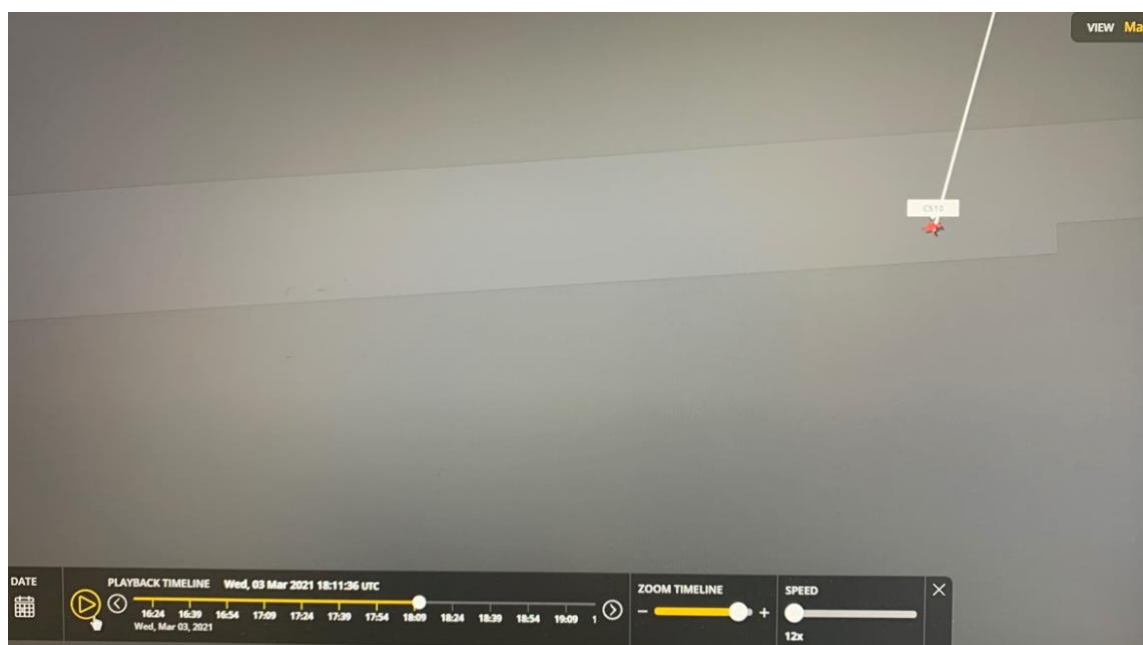
Figure 9. Aircraft movement diagram from Flightradar24 website

Flightradar24 website data, which was used in the investigation, indicates that during taxiing before take-off, the aircraft was significantly shifted to the left of the runway centerline (see Fig. 9).
