**NATIONAL BUREAU
OF AIR ACCIDENTS INVESTIGATION**

OCCURRENCE CLASS:	FATAL ACCIDENT
AIRCRAFT OPERATOR:	Private Person
AIRCRAFT TYPE:	WT10 Advantic
REGISTRATION:	UR-PAMA
OCCURRENCE LOCATION:	Outskirts of Sheparivtsi Village, Kolomyia District, Ivano-Frankivsk Region
STATE OF OCCURRENCE:	UKRAINE
DATE OF OCCURRENCE:	July 28, 2021.

Final Report

**on Investigation into Fatal Accident with WT10 Advantic UR-PAMA Aircraft
Manufactured by AEROSPOOL Ltd (Slovakia), Operated by Private Person,
Which Took Place on July 28, 2021, at Outskirts of Sheparivtsi Village,
Kolomyia District, Ivano-Frankivsk Region, During Recreational Flight.**

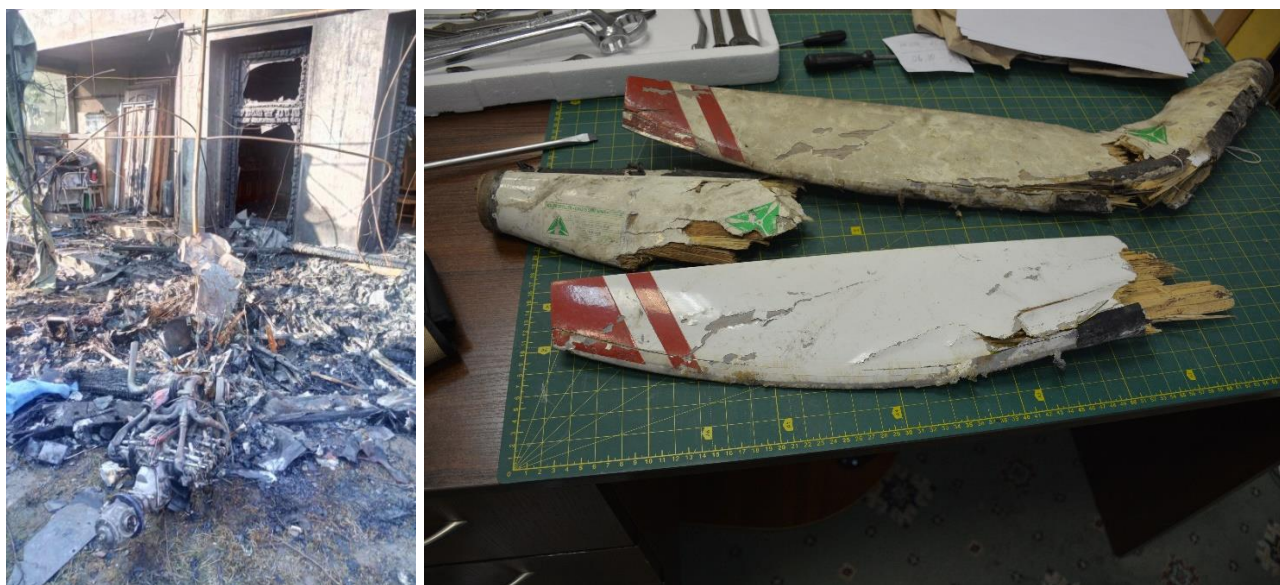
The aircraft impacted the ground on a private yard under the wall of a two-story stone house on the Prut River side. As a result of the fatal accident, the wires of the power line were broken, the power supply to the surrounding houses was cut off, fruit trees were broken and damaged, the roofs and walls of two outbuildings, the wall of a residential building and the metal fence of a private territory were damaged. The wreckage of the aircraft was scattered on the ground in an area of about 600m². During the ground impact, a fire broke out, as a result of which the aircraft completely burned down. Only the engine and some metal parts of the aircraft remained.
