National Transport Investigation Bureau

SERIOUS INCIDENT PRELIMINARY REPORT

Location:	Bor aerodrome (Republic of South Sudan)	Investigation number:	46/2025
Date and time:	23.10.2025, 11:18 UTC	Aircraft registration:	UR-CEP
Aircraft type:	An-26	Fatalities:	None
		Injuries:	None
Flight type:	Cargo flight under UN WFP	Flight phase:	Landing
Report issuance date:	28.11.2025	Translation issuance date:	04.12.2025

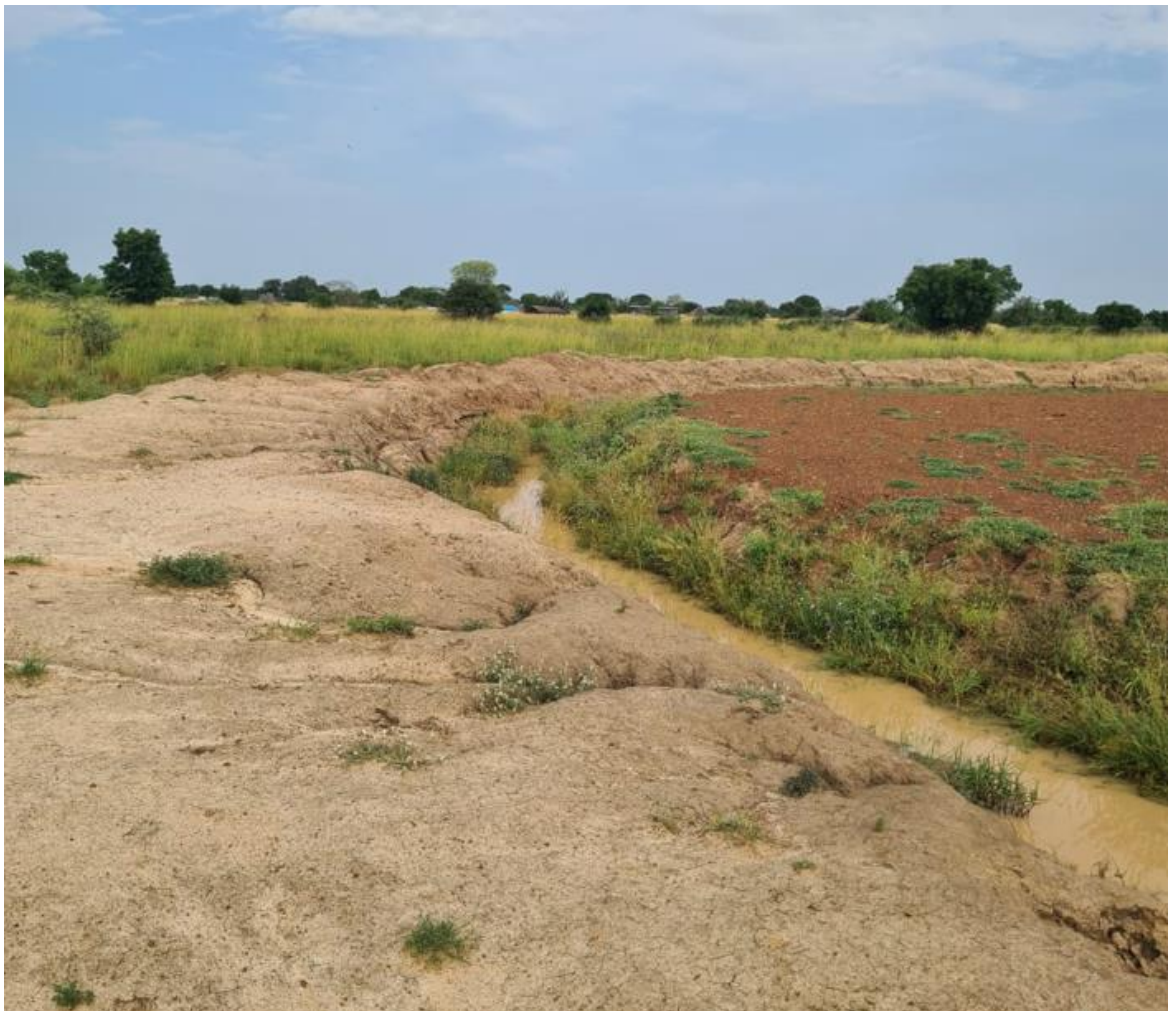
Figure 2 – The drainage ditch in front of RWY01.

Photographs taken in the area of the threshold and end of RWY01 show a drainage ditch approximately 1 meter deep, along the perimeter of the runway, intended to divert water from the runway surface and the landing area. The ditch has soft, eroded edges. To prevent soil collapse and erosion, the ditch walls are sloped and reinforced with grass. Along the outer side of the drainage ditch, small earthen mounds up to approximately 50 cm in height are visible, that are a natural result of ditch clearing rather than artificially created embankments.

According to AAID, the distance from the runway threshold to the inner edge of the drainage ditch is approximately 55 meters. On the outer side of the drainage ditch (Fig. 2), a faint mark is visible, likely from the left main landing gear wheels of An-26 UR-CEP. The distance from the probable point of contact of the left main landing gear with the ground to the runway threshold is approximately 60 meters.

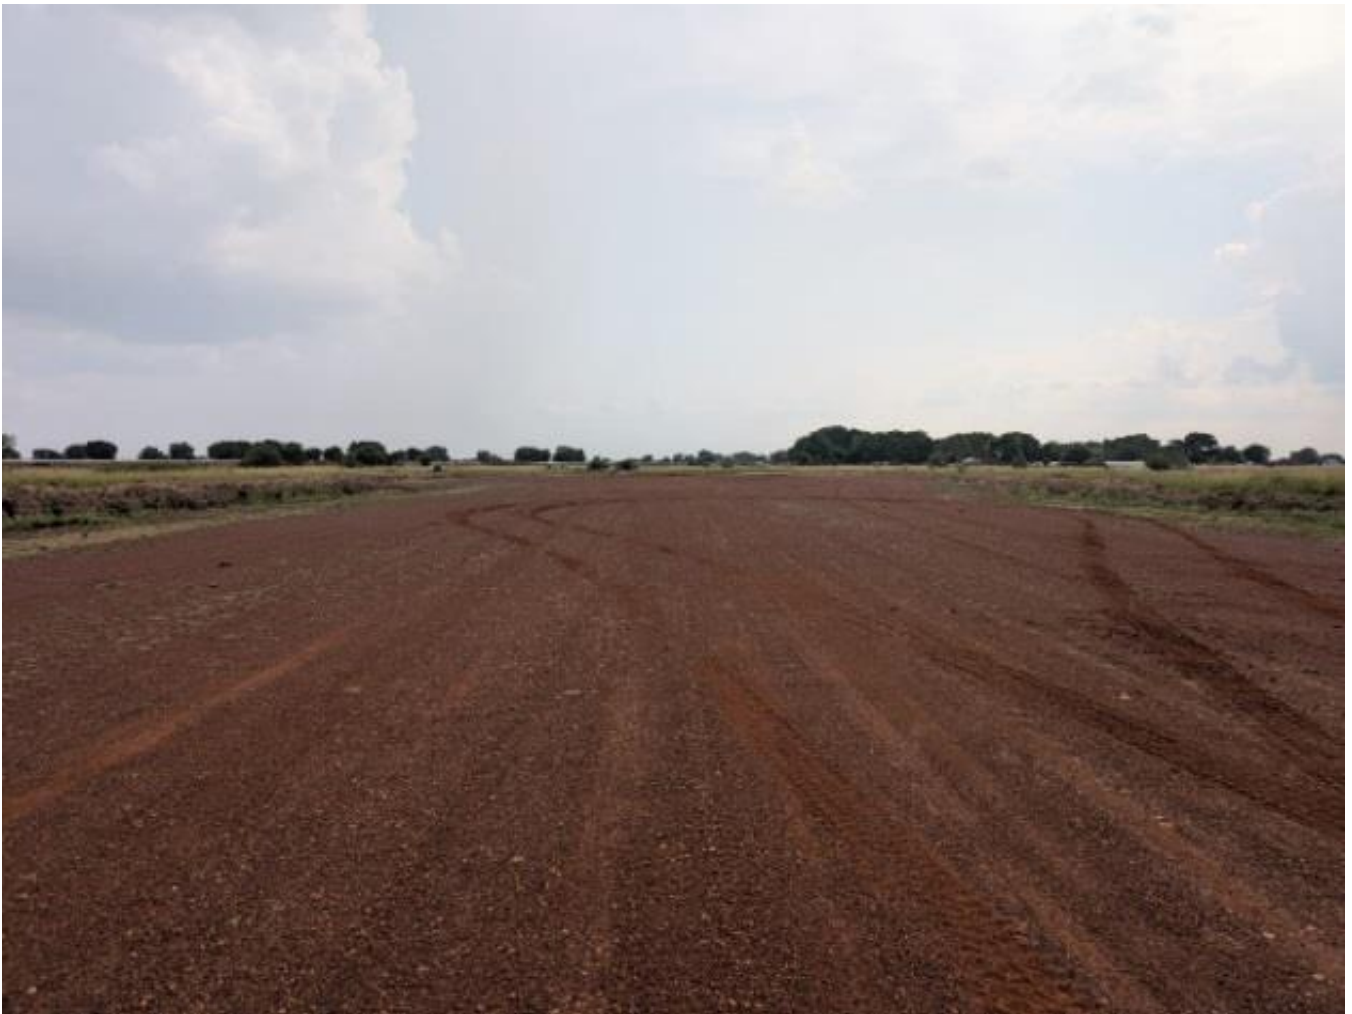
Figure 3 – RWY01 threshold

Photographs taken immediately after the serious incident indicate that the soil was visually dry. The thresholds and surface of RWY01/19 are flat, with uniform color and texture, and no holes. According to a photograph provided by the WFP office, the runway surface softens after rain. In one photograph (Fig. 3), a visible track is not the result of aircraft landing, but of a vehicle turning on the wet runway. Based on the photographs, the runway width, including tracks, is approximately 30 meters, and the

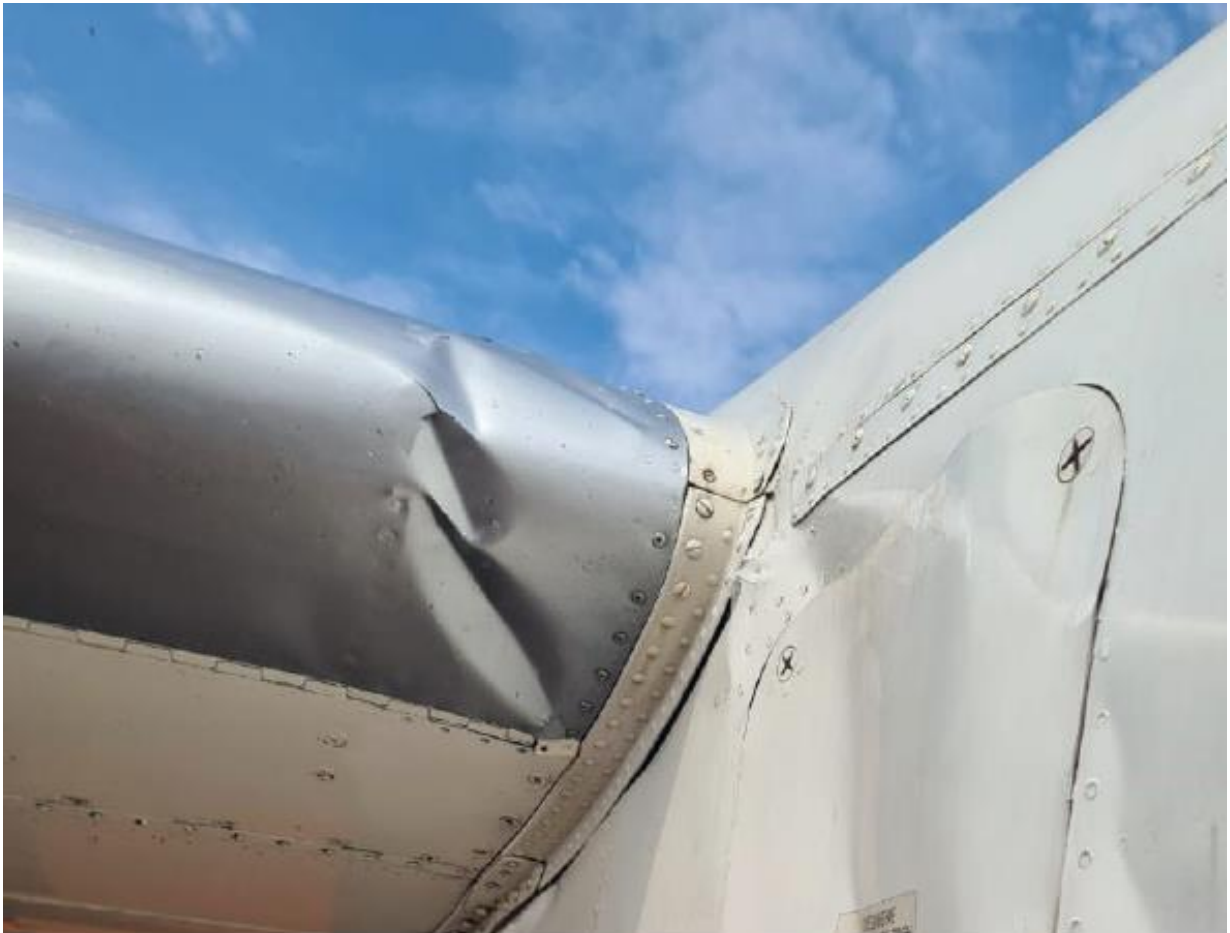
According to FDR data, during abnormal contact with the ground, the aircraft experienced a vertical load factor of 3.08G, resulting in damage of varying severity.

Between 26.10.2025 and 13.11.2025, the operator performed special technical maintenance of the aircraft following a hard landing, in accordance with sections 7.01.00 and 7.01.20 of the An-26 AMM, and an aircraft condition assessment report was compiled. The inspection revealed: deformation (corrugation) of the fuselage skin between frames 17–20 on the left side, measuring 1000x610 mm; deformation of the nose of the left-wing center-section, frames 4–5, 200x370 mm; deformation (corrugation) of the center-section, frames 2–3 and 15–16, left side, 300x250 mm; crack in metal skin, 50 mm long and other damage.

Figure 4 – External damages

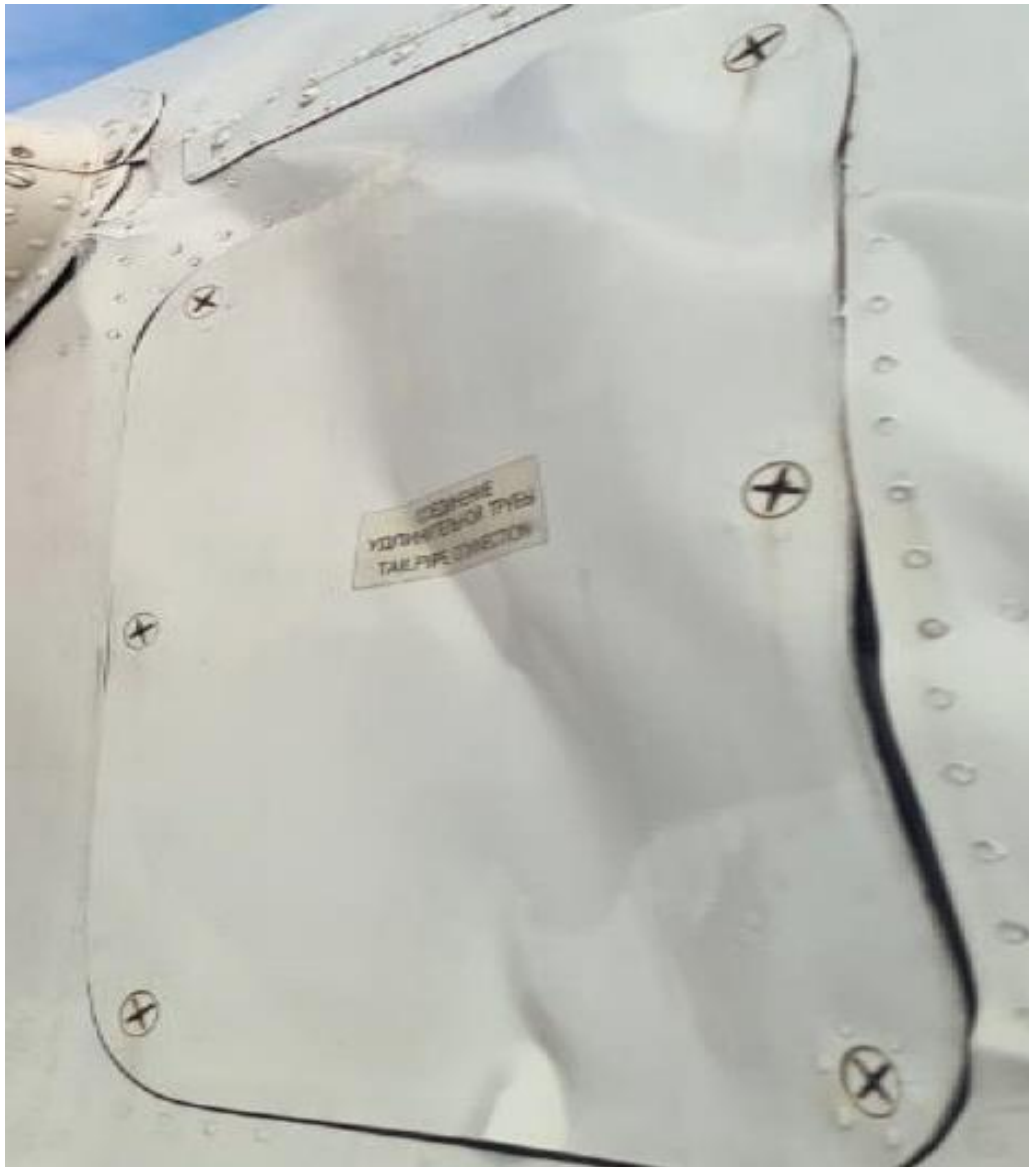
Figure 5 – External damages

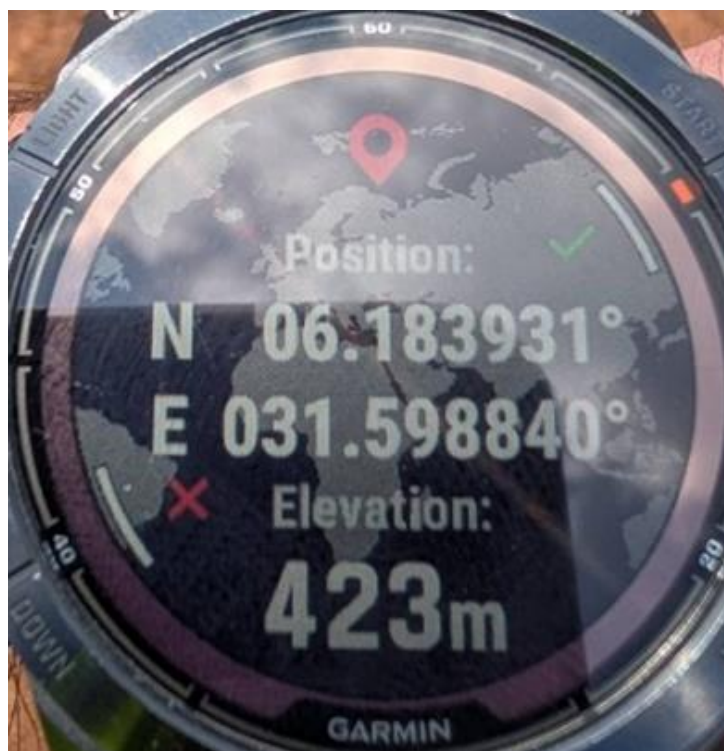
Based on measurements performed by the WFP Mission (Fig. 7) at the request of the NTIB, the coordinates of the RWY01 threshold are N06.183931 E031.598840, with a threshold elevation of 423 m. The runway surface consists of dry, compacted murram. No data on surface compaction or equivalent characteristics are available. UNHAS is not aware of any risk assessments conducted by Bor aerodrome services.

Figure 7 – Threshold coordinates RWY01

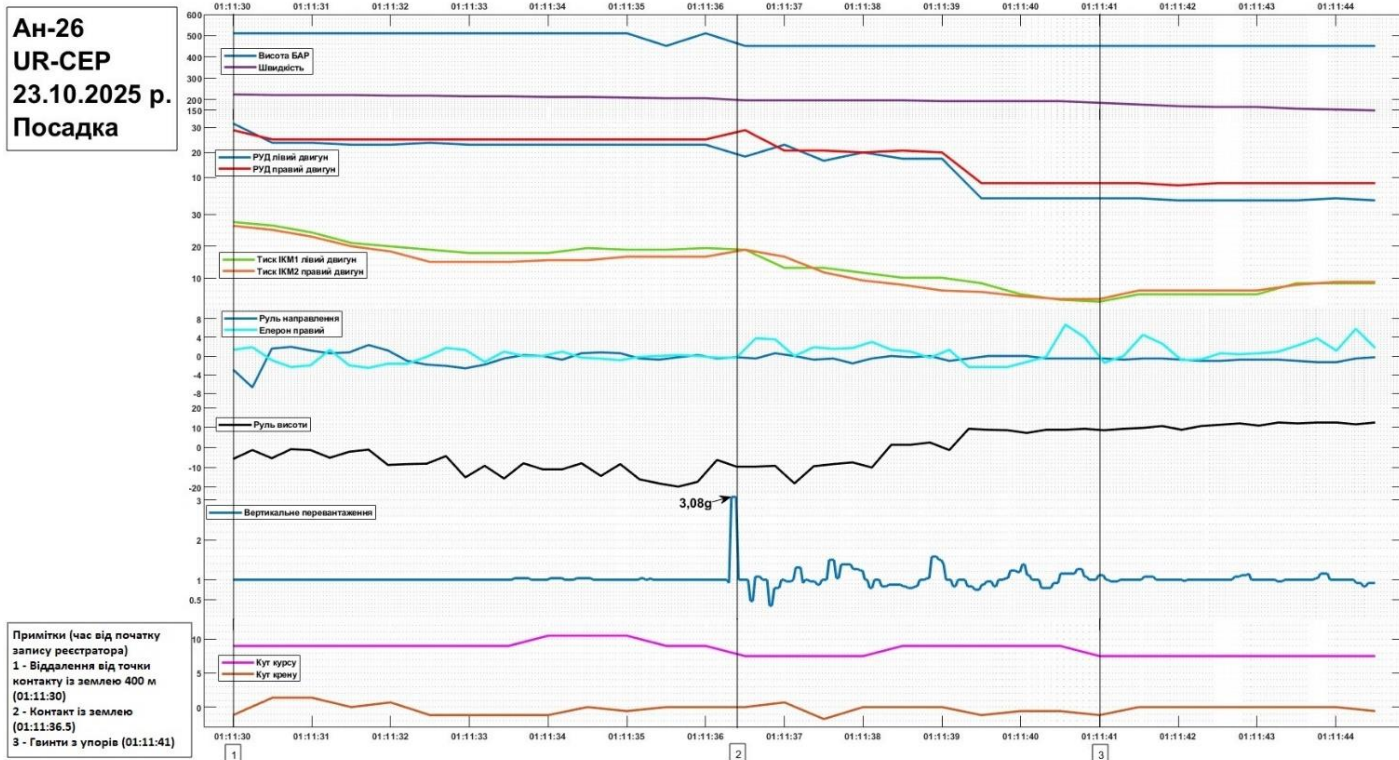
According to FDR data, at the moment of contact, the aircraft experienced a vertical load factor of 3.08G.

Figure 8 – Serious incident parameters line graph
