**FINAL REPORT**

**of Investigation into Serious Incident, Which Took Place With Piper PA30  
Twin Comanche, Reg. N918Y, Aircraft (Operator - INTERNATIONAL AIR  
SERVICES INC TRUSTEE 701 S CATRSON ST STE 200 Carson City NV  
89701 Corporation) on October 12, 2020, During Landing Roll at Lviv Airport.**

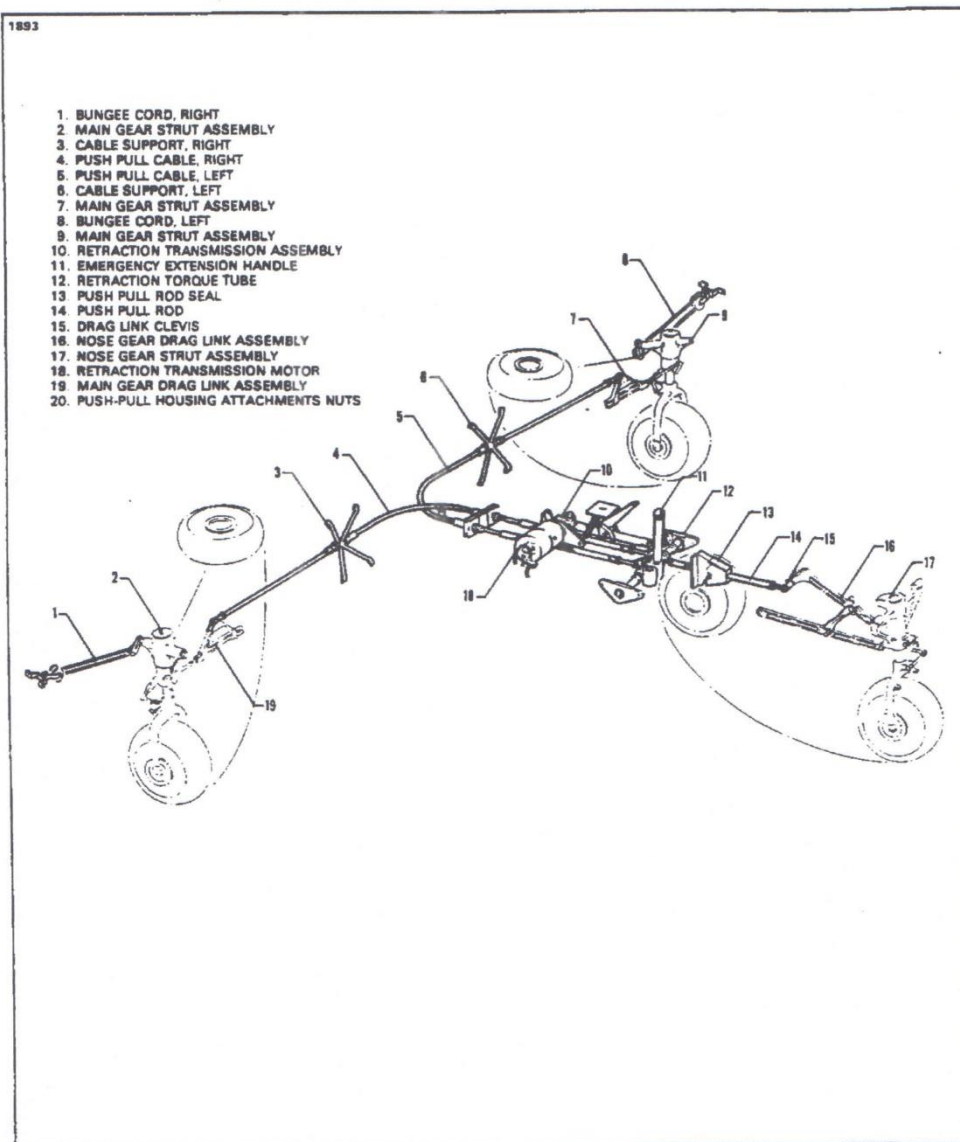
Figure 7-12. Landing Gear Retraction System

In the gear actuation system there was found a 8 mm backlash (travel) of the down lock of the right landing gear (Main Gear Side Brace Link Travel, Piper Twin Comanche Service Manual, par. 7-23a) and 2mm (travel) backlash of the down lock of the right landing gear (Main Gear Side Brace Link Travel, Piper Twin Comanche Service Manual, par. 7-23a).

Also there was found destruction of the frame, part No. 22631-02, with support, part No. 20954-00, and spar caps, part No. 20557-06, due to fatigue at the attachment point of the gear motor.
