**NATIONAL BUREAU  
OF AIR ACCIDENTS INVESTIGATION**

**FINAL REPORT**

**RUNWAY EXCURSION  
DURING LANDING AT “ODESA” AERODROME**

### **on Investigation into Accident (Runway Excursion) with Aircraft B-737-800, Registration No. TC-JGZ, Which Took Place on November 21, 2019, During Landing at "Odesa" Aerodrome**

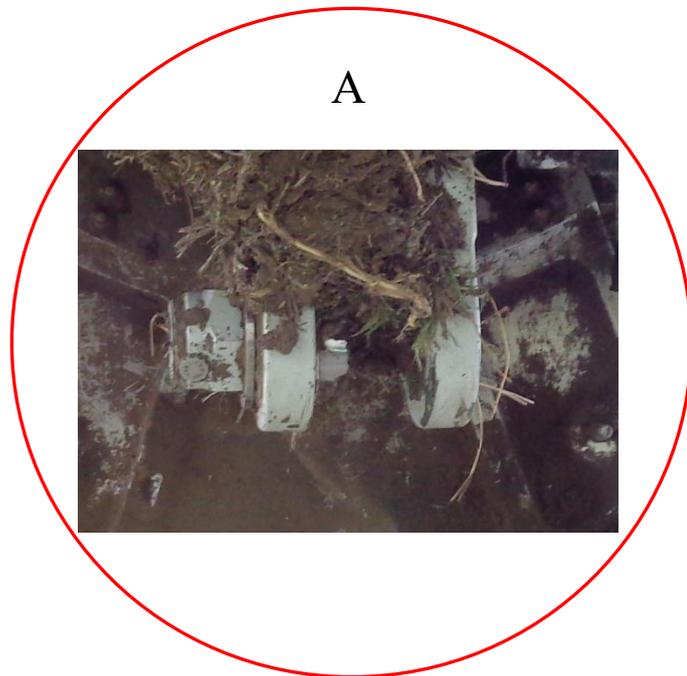
Photo 3. NLG retraction and extension link attachment assembly

- Destruction of the retraction and extension link attachment assembly of the nose landing gear (NLG), collapse of the NLG backward vs. the flight direction, with destruction of the fuselage skinning and electronic equipment access door (Photos 1, 2, 3);

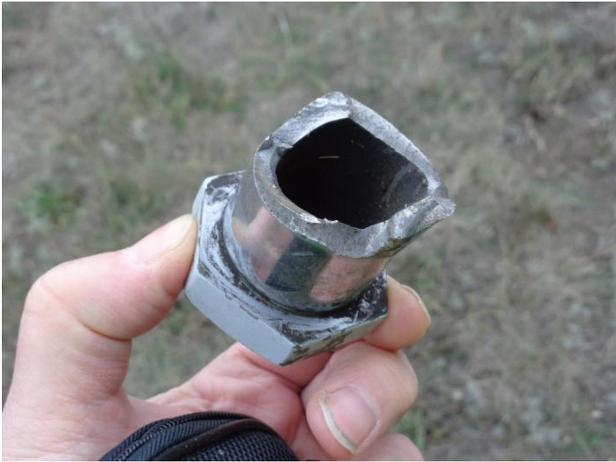
Fig.1

On the soil, at the distance of approximately 125-130 m from the NLG exit point of the left side boundary of the runway, the investigation team found the remains of a bolt (Photo 4, 5) of the NLG retraction and extension link attachment assembly (AMM 32-21-00 p.410 [18] PIN) (Fig.1).

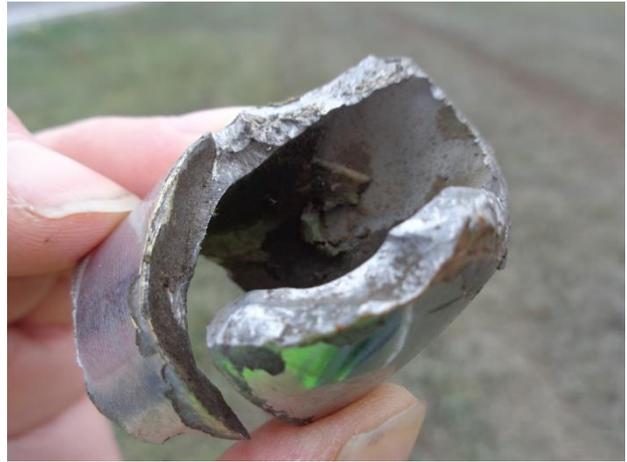
Photo 4

**Note:** Upon exit of the aircraft nose landing gear to the soil with the destroyed left wheel turned to the right, the NLG retraction and extension link attachment assembly suffered off-design loads due to deepening into the soil during 120-130 meter movement, which led to NLG collapse backward vs. the flight direction, and aircraft nose section sinking down onto the ground.

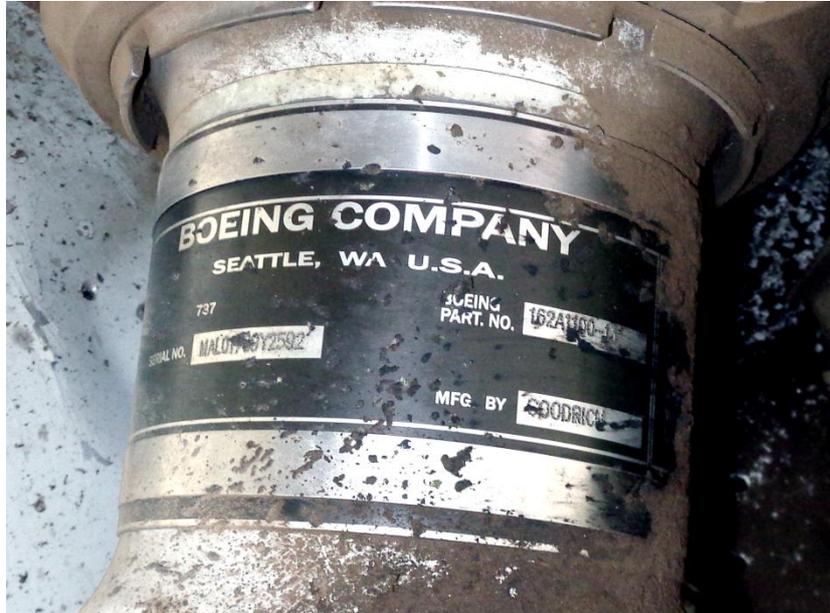
Photo 19

### **Nose Landing Gear (Photo 19):**

Manufacturer	GOODRICH
P/N	162A1100-13
S/N	MAL01789Y2592
Date of Shop Visit	23.06.2017 (TURKISH TECHNIC)
Date of Installation on	25.07.2017

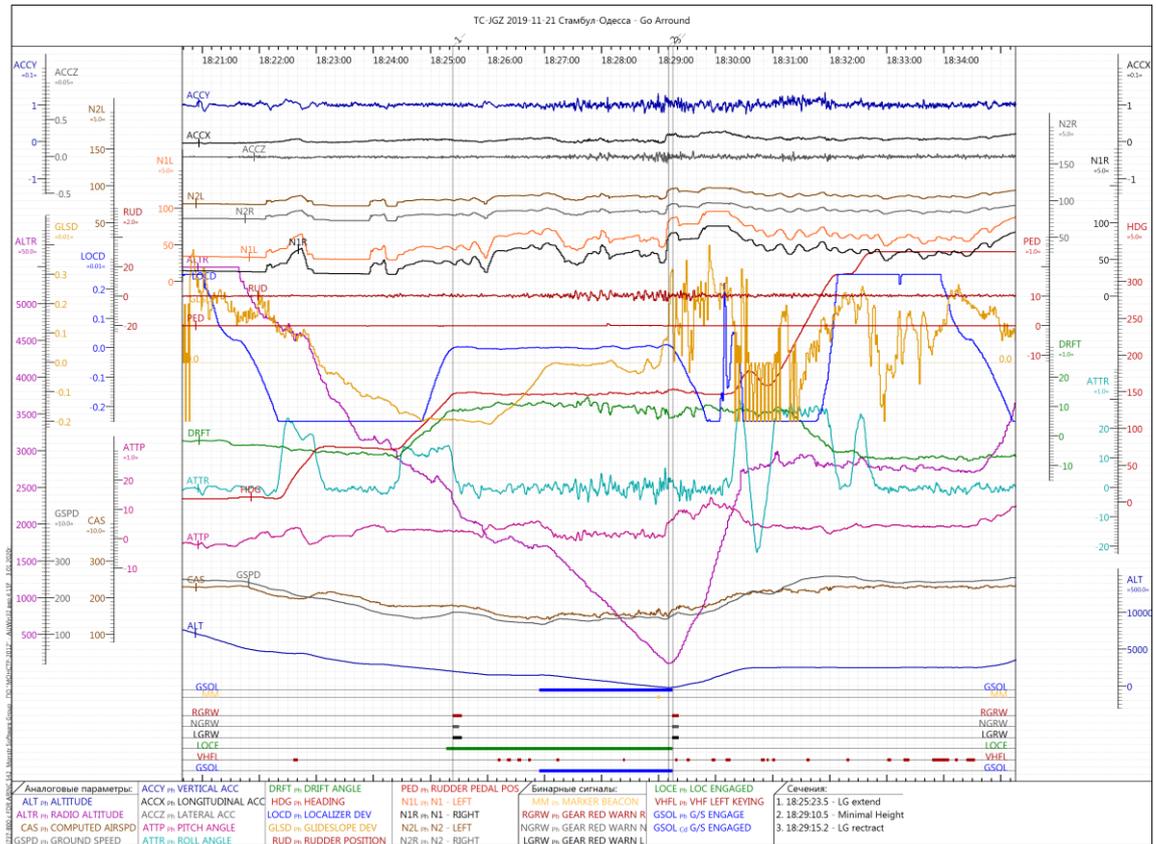
At 18:29:20, the crew reported the go-around, "Going around", and, at 18:31:31, indicated that the reason was a non-stabilized aircraft attitude.

**Note:** according to the FDR data, the aircraft attitude was non-stabilized by the instrument speed, which was 171 knots (exceeding the estimated one by 18 knots.)

Fig. 3. Graphs of flight parameters at the time of go-around

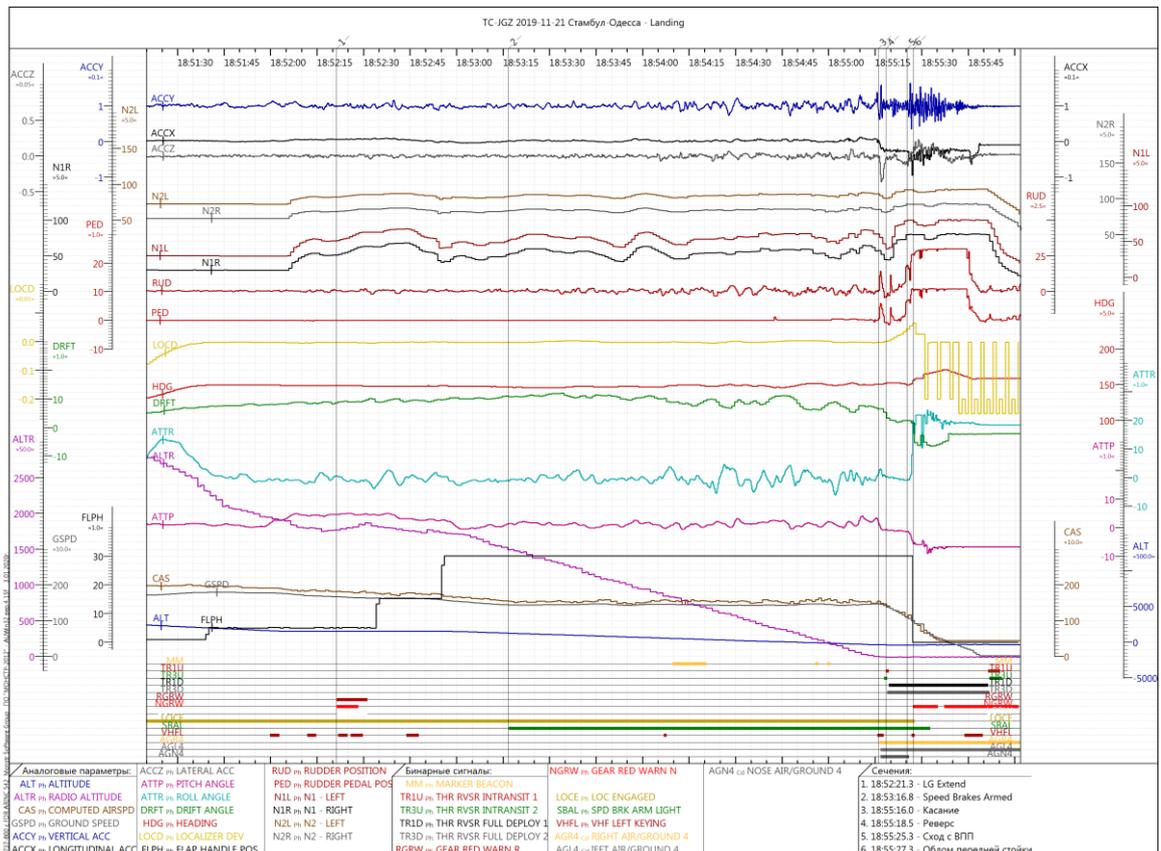
At 18:55:16, the touchdown took place first by the right landing gear at a distance of 444 m from the threshold of the Runway 16 and to the left of the centerline at the distance of 0.4 m with heading 151° and right roll of 3° (according to FDR data.) PIC deflects the right pedal to the angle of 5.6° (out of possible 12°.) The magnetic heading increased by 2° and reached 153°, the aircraft pitch decreased from + 2.6° to -0.7°, which caused the left landing gear touchdown at the distance of 454 m of the threshold and 6 m to the left of the centerline of the Runway 16, and nose landing gear touchdown at the distance of 552 m from the end and 1.5 m to the left of the centerline of the Runway 16.

Fig. 4. Charts of flight parameters during landing approach and landing

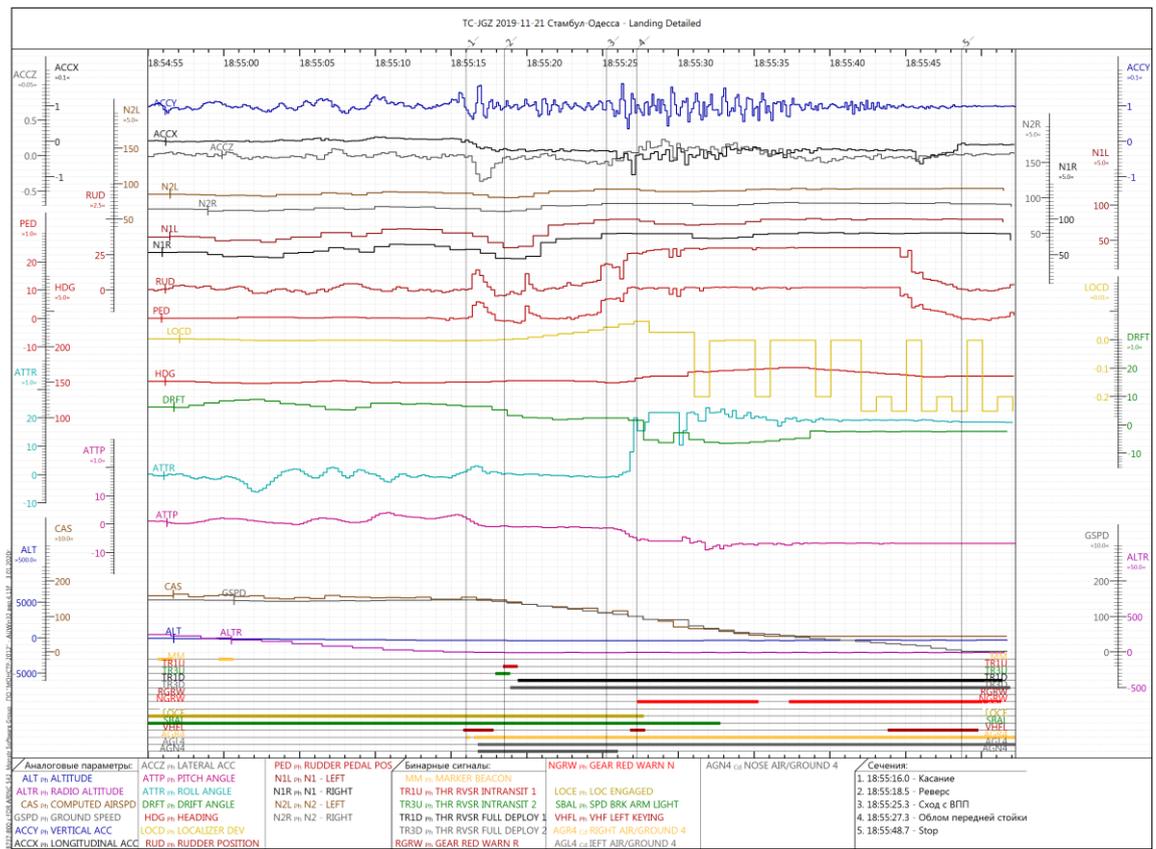
At 18:55:27, the pitch of the aircraft was -5.6°; right roll +20°, MH 152°, maximum pedal deviation to the right 11.2° (out of the maximum 12°), rudder 27° (out of the maximum 30°) and speed 101 knots, which evidenced NLG collapse in the direction opposite to the movement.

**Fig. 5. Graphs of flight parameters during aircraft landing and runway excursion**

At 18:55:28, the plane completely rolled out of the runway onto the soil and moved with MH 158°-159° for 3 seconds.
