**NATIONAL BUREAU
OF AIR ACCIDENTS INVESTIGATIONS**

**FINAL REPORT OF INVESTIGATION INTO SERIOUS INCIDENT –
DETACHMENT OF THE NOSE WHEEL AND COLLAPSE OF THE
FRONT LANDING GEAR, DURING TRAINING FLIGHT**

A/C OPERATOR:	Avia-Soyuz Airline LLC
A/C TYPE:	TECNAM P2002 JF
REGISTRATION NUMBER:	UR-ASC
OCCURRENCE SITE:	Mayske Airfield, Synelnykivskyi District, Dnipropetrovsk Region
COUNTRY:	UKRAINE
DATE:	November 1 st , 2021

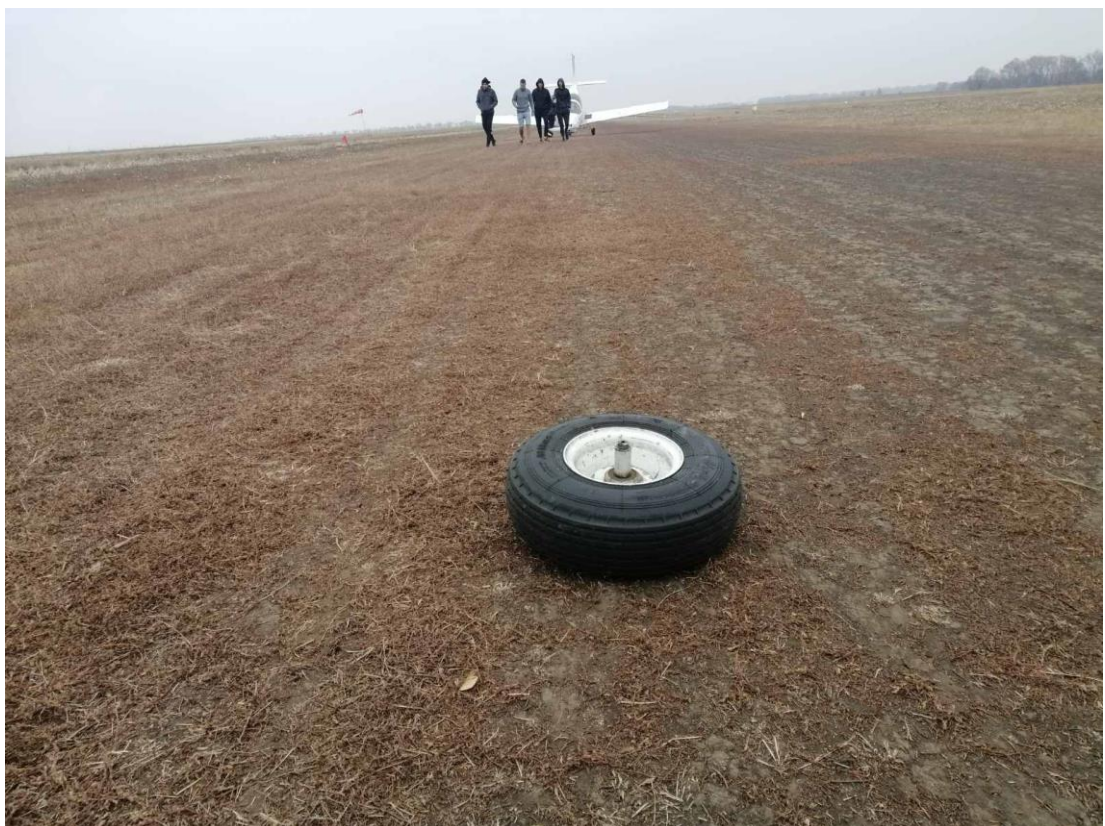
The nose landing gear wheel is at the distance of 40 meters from the aircraft in the direction of the aircraft movement.

The broken nose landing gear leg is near the aircraft.
