**NATIONAL BUREAU  
OF AIR ACCIDENTS INVESTIGATION OF UKRAINE**

**FINAL REPORT**

**RUNWAY EXCURSION AT LANDING  
AT KYIV (ZHULYANY) AERODROME**

<b>AIRCRAFT OPERATOR:</b>	Bravo Airways
<b>AIRCRAFT TYPE:</b>	DC-9-83 (MD-83)
<b>REGISTRATION NUMBER:</b>	UR-CPR
<b>PLACE OF OCCURRENCE:</b>	Kyiv (Zhulyany) Aerodrome
<b>STATE OF OCCURRENCE:</b>	UKRAINE
<b>DATE OF OCCURRENCE:</b>	June 14, 2018

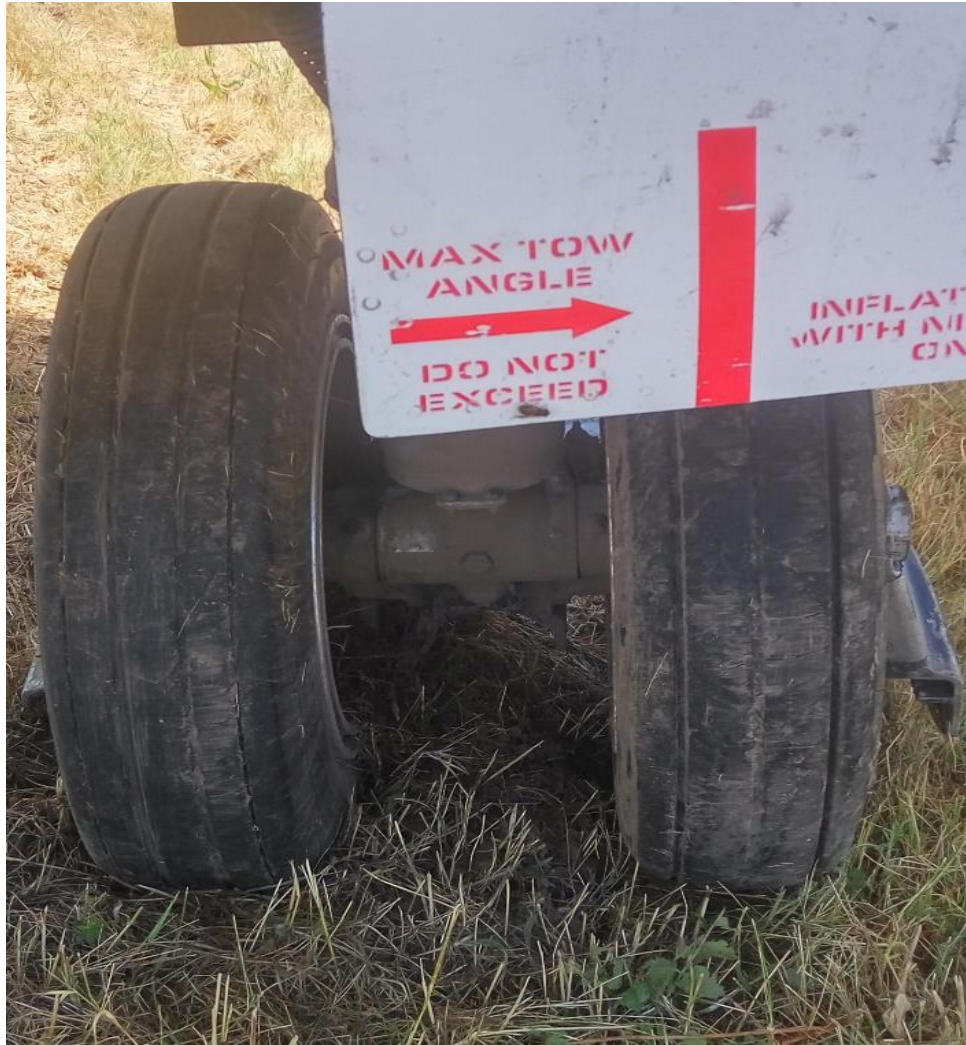
Photo 3

*Nose landing gear wheels*

In accordance with the terms of reference, the Investigation Team carried out the works to check the condition of the tires of the aircraft landing gear wheels. According to the inspection results, it is established that the wheel tires do not have characteristic damage, which would indicate to aquaplaning. Wheel tread depth is:

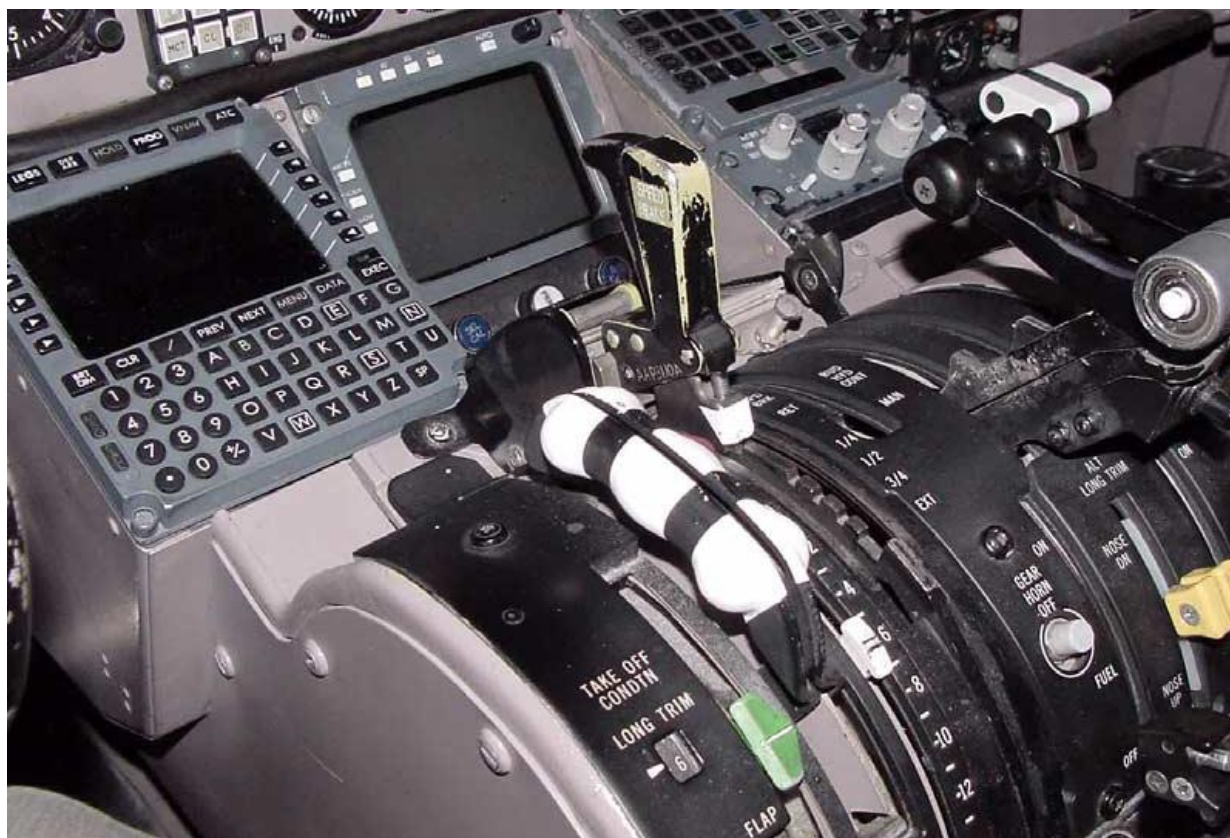
Photo 6

The ground (braking) spoilers are controlled by the SPEED BRAKE CONTROL HANDLE on the central panel of the cockpit (Photo 6). The ground spoilers system can operate in the automatic mode. The system consists of two control valves, spoiler control unit, four wheel speed sensors, and two switches on the front landing gear (Fig. 1.)

*Speed brake control handle*

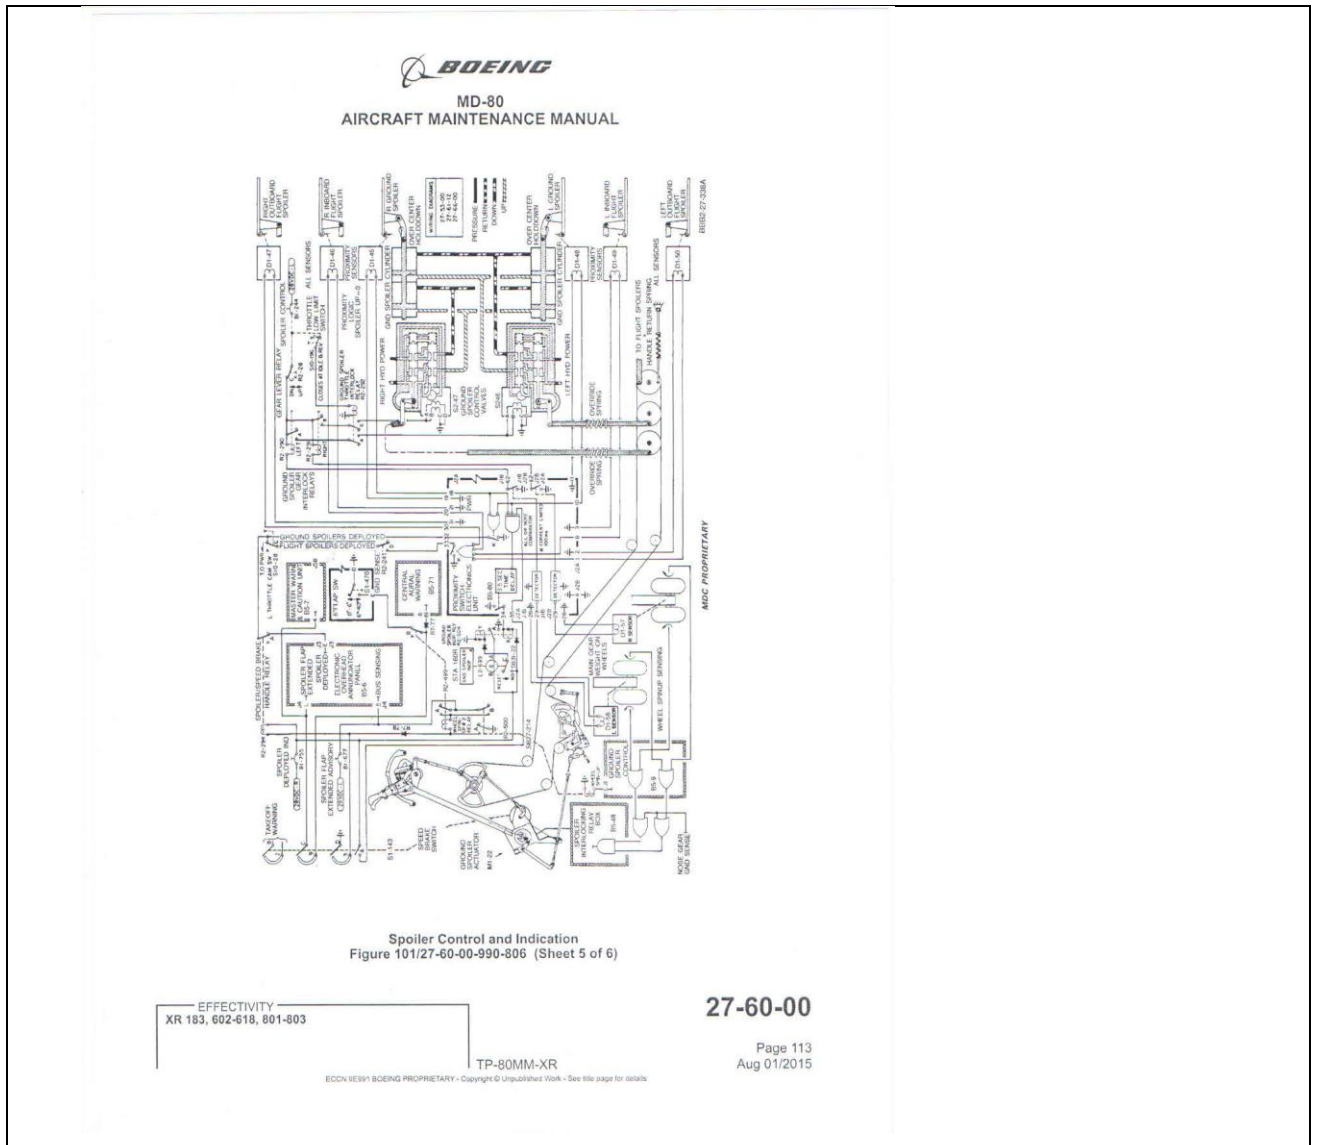
Figure 1

The automatic spoiler deployment system operates when at least two of the four wheel speed sensors rotate up to 700 rpm, and the spoiler control lever is in the ARM position. If the wheel rotation speed measurement system failed, the automatic spoiler deployment command is given by the switches on the front landing gear after its lowering and compression. In the event of failure of the automatic spoiler deployment system after aircraft landing, the spoilers shall be released by the spoiler control lever by the crew in the manual mode (AMM 27-60-00 page10.)

*Automatic spoiler control system diagram*

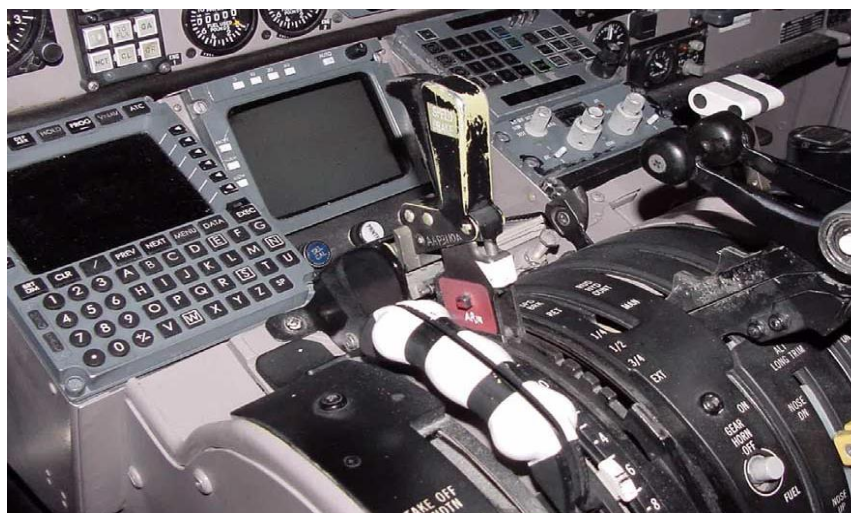
Photo 7

To use the spoiler deployment system automatically, the PIC must set the spoiler control lever to the ARM position, opening the red bar (Photo 7.) The red bar indicates to the crew that the spoiler automatic control system is ON. The automatic spoiler control system activates the spoiler control actuator at each landing, regardless of whether the lever is in the ARM position or not (AMM 27-60-00.)

*Speed brake control handle in ARM position*

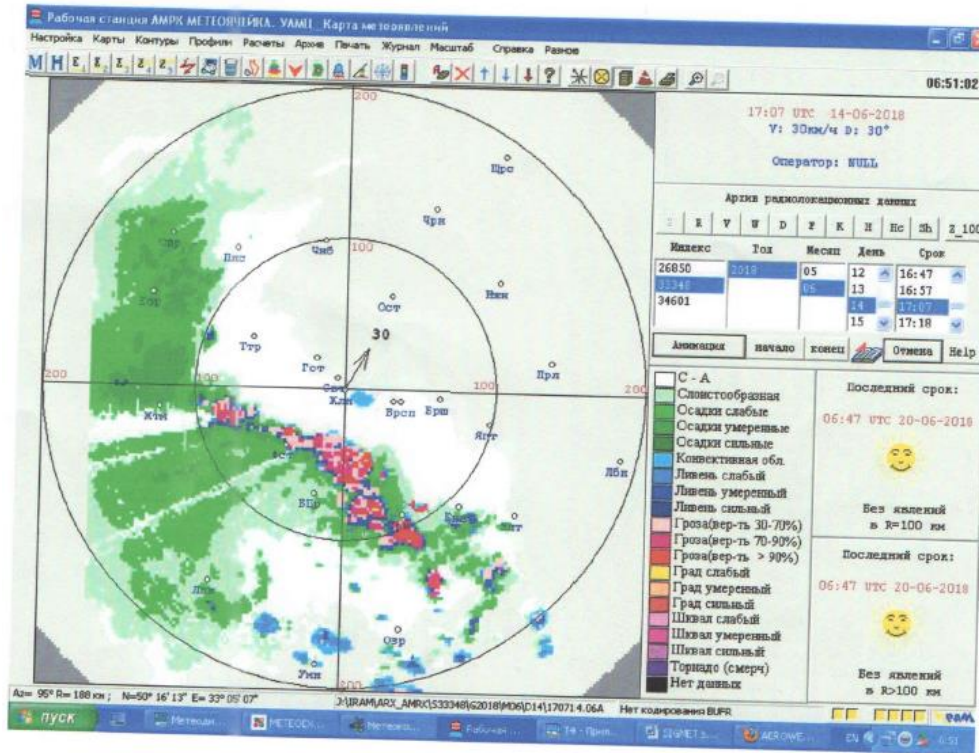
Photo 8  
Weather radar data for 17:07

Due to the thunderstorm activity in the Kyiv FIR, the aircraft performed maneuvers to bypass hunderstorm areas during the descent. Below are 4 photos of meteorological phenomena cards, which show the weather radar data for the Kyiv (Zhulyany) Aerodrome.

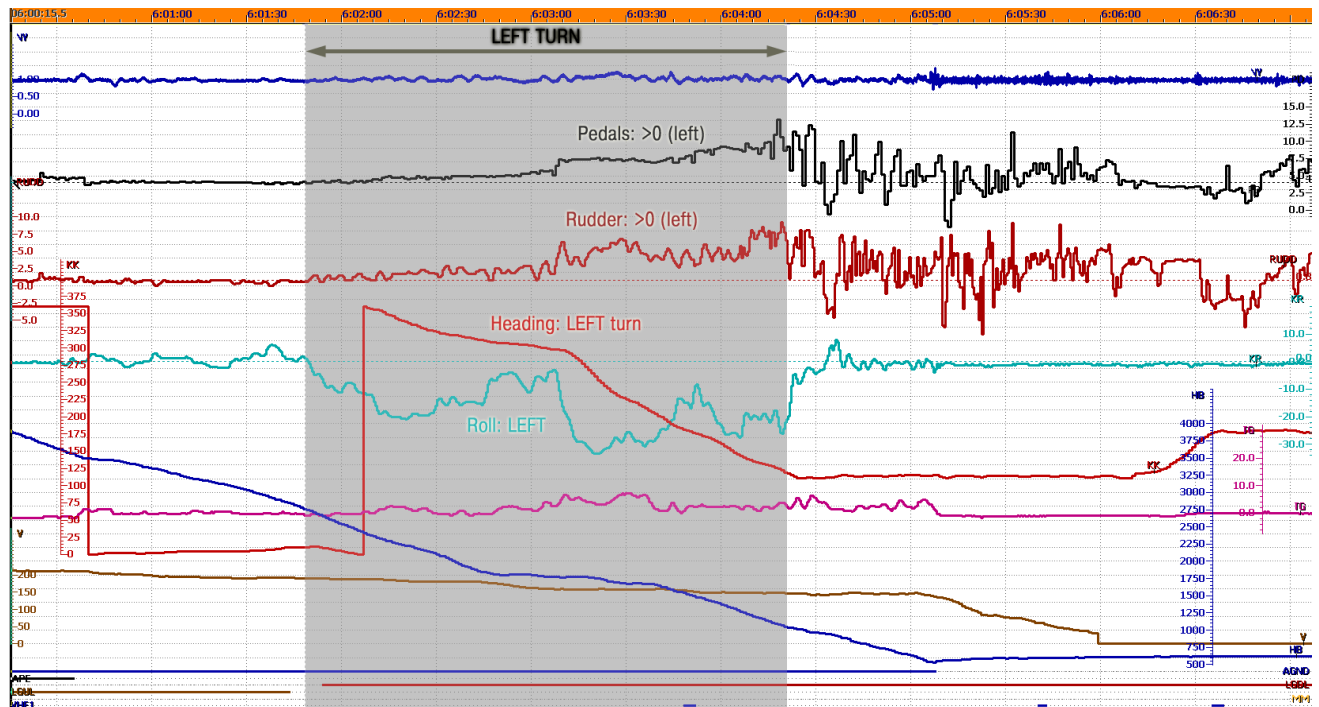
Figure 3.

Figure 3 shows the decoded fragment of one of the previous flights at performance of the left aircraft turn. The Heading (red line) decreases – the turn to the left, at that, the values of the Roll are negative, and the rudder position values (Rudder) are positive.

*Left turn in flight*

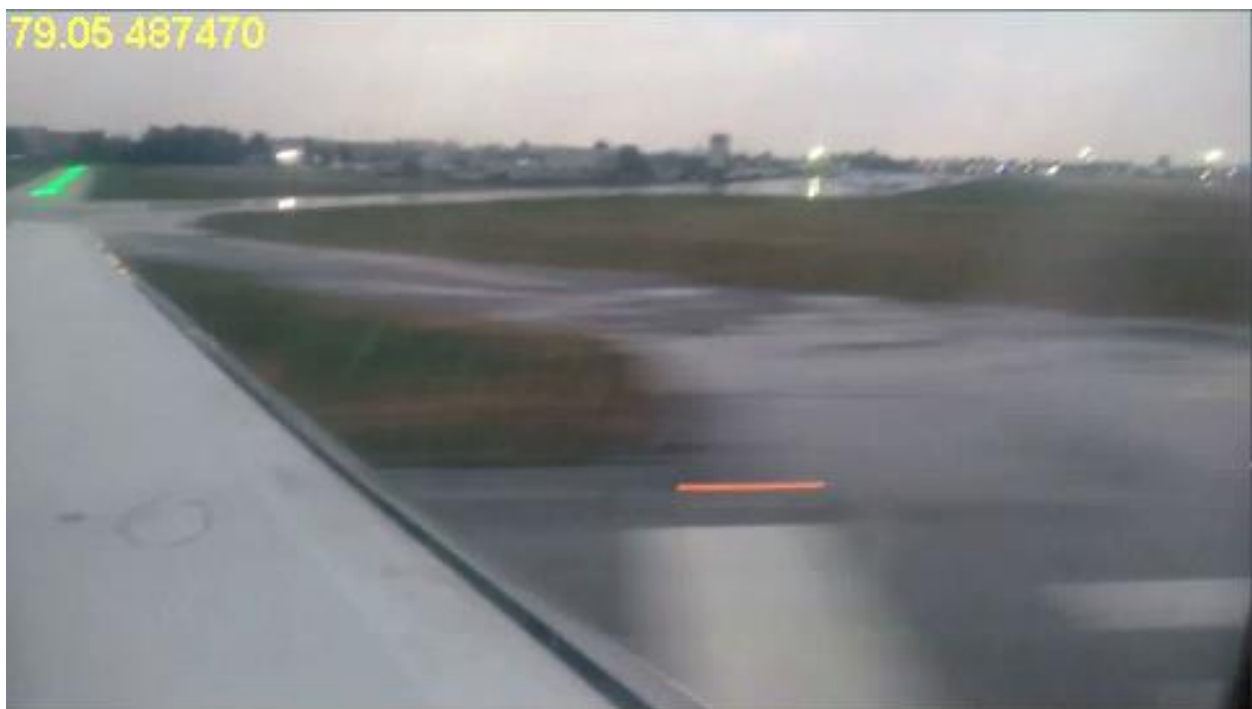
Photo 12.

The video clearly shows and defines the time of the runway threshold fly-over (Photo 12).

*Runway threshold fly-over on video*

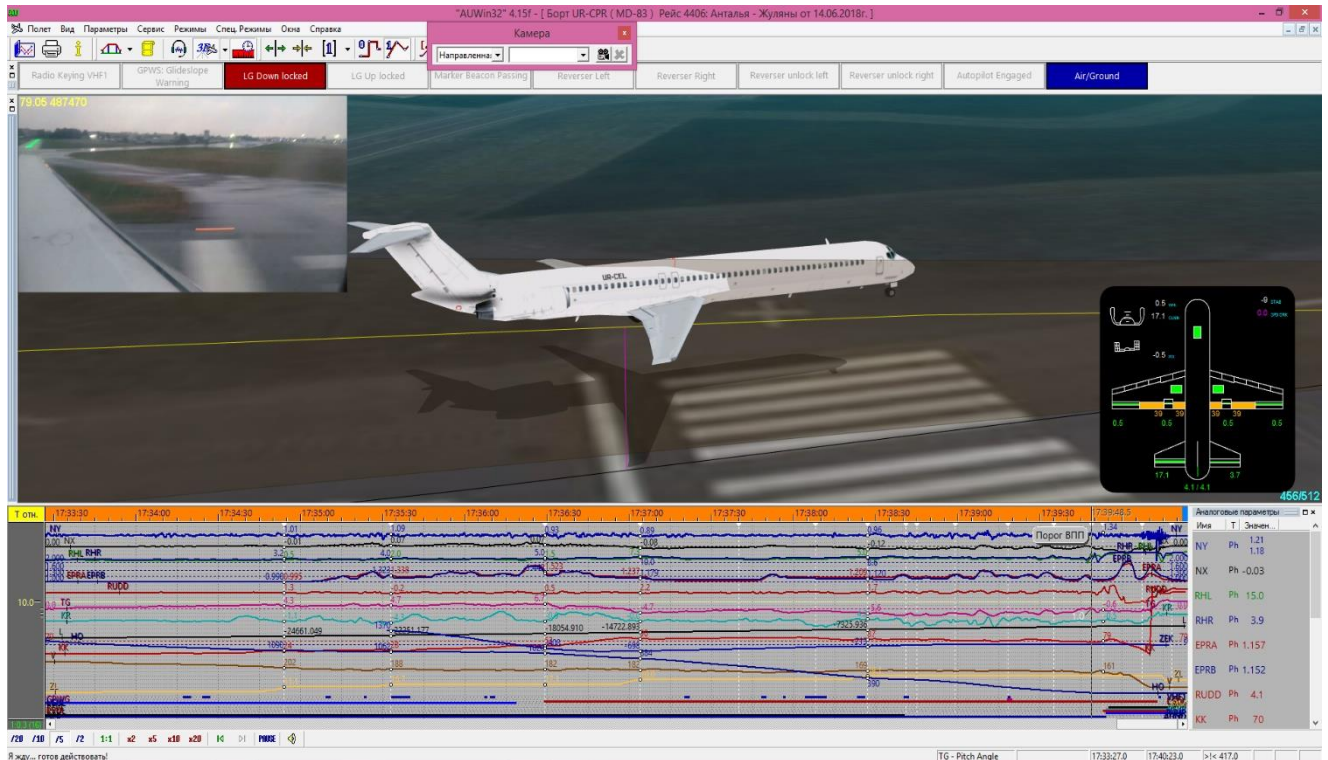
Figure 4.

According to the flight synchronized with video, the runway threshold fly-over time point was determined by the FDR data (Figure 4.)

*Runway threshold fly-over according to FDR data*

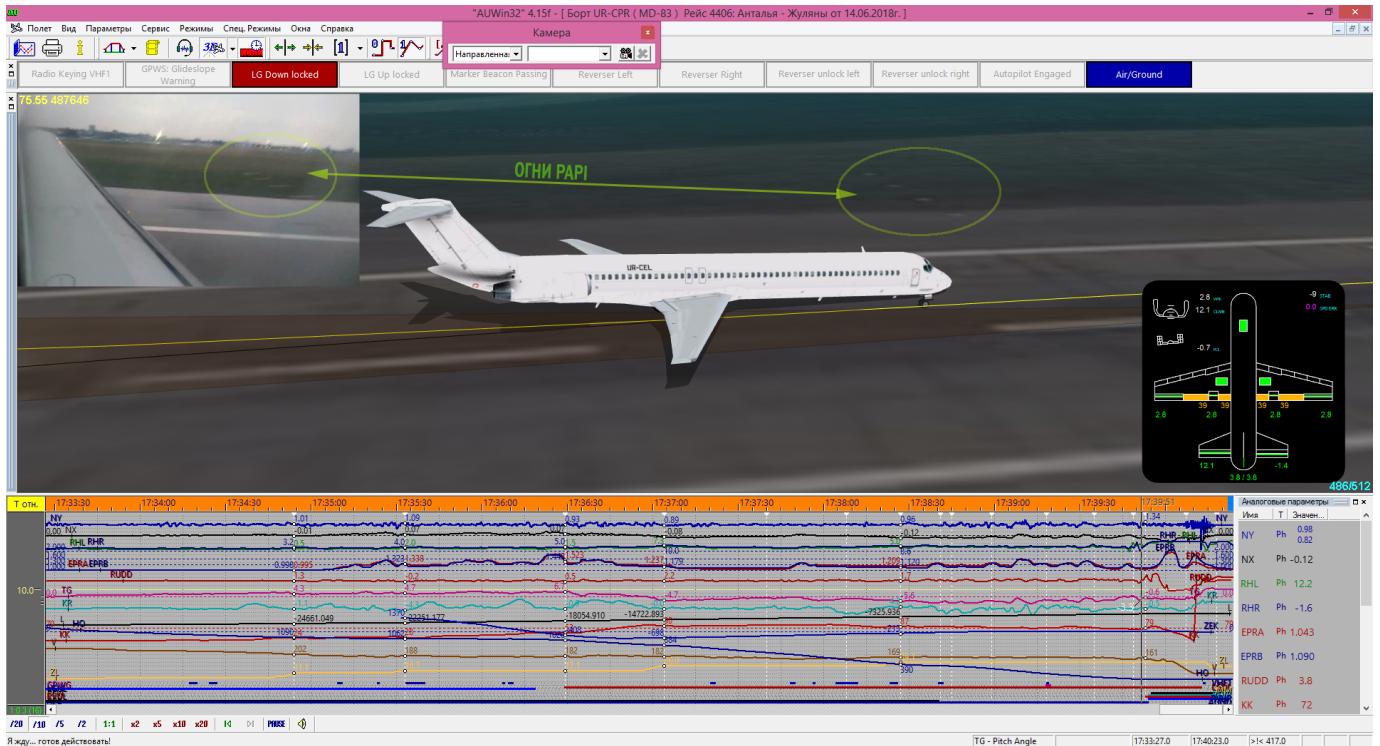
After calculating the path and drawing it on a map of the earth's surface, the conformity of the calculation results with the video was verified (Figures 5, 6, 7.)

Figure 5. PAPI lights

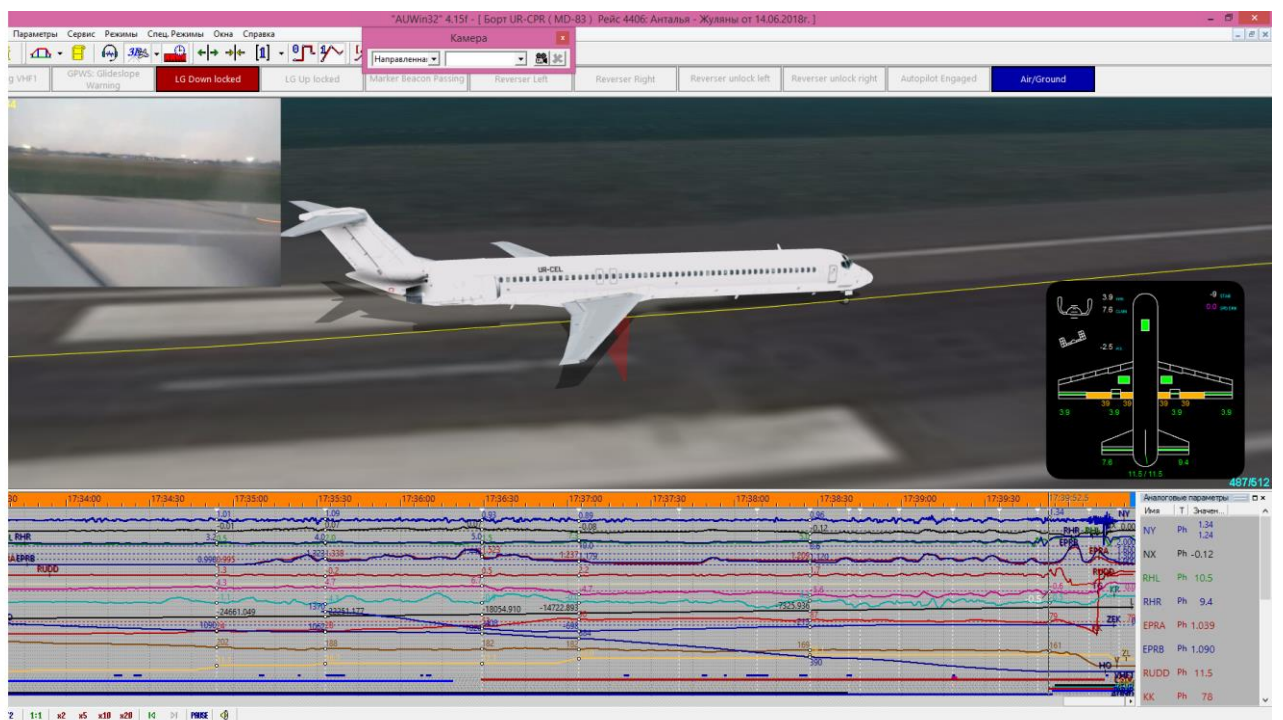
Figure 6. 1/24 sec (from video) till touchdown

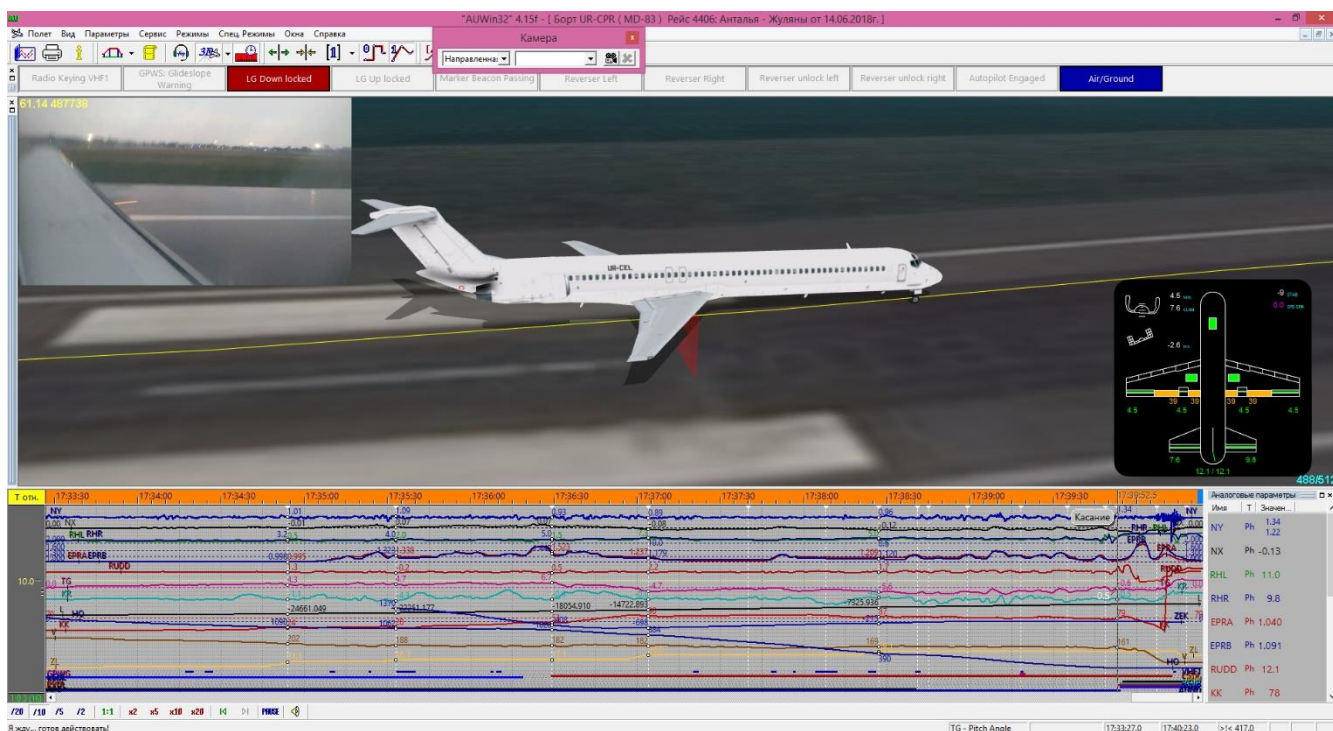
The touchdown time point was determined by the maximum value of  $n_y$  - "Vertical Overload" (normal acceleration.) At that, the calculated distance from the runway threshold was 350 m.

Figure 6.  
*Touchdown point*

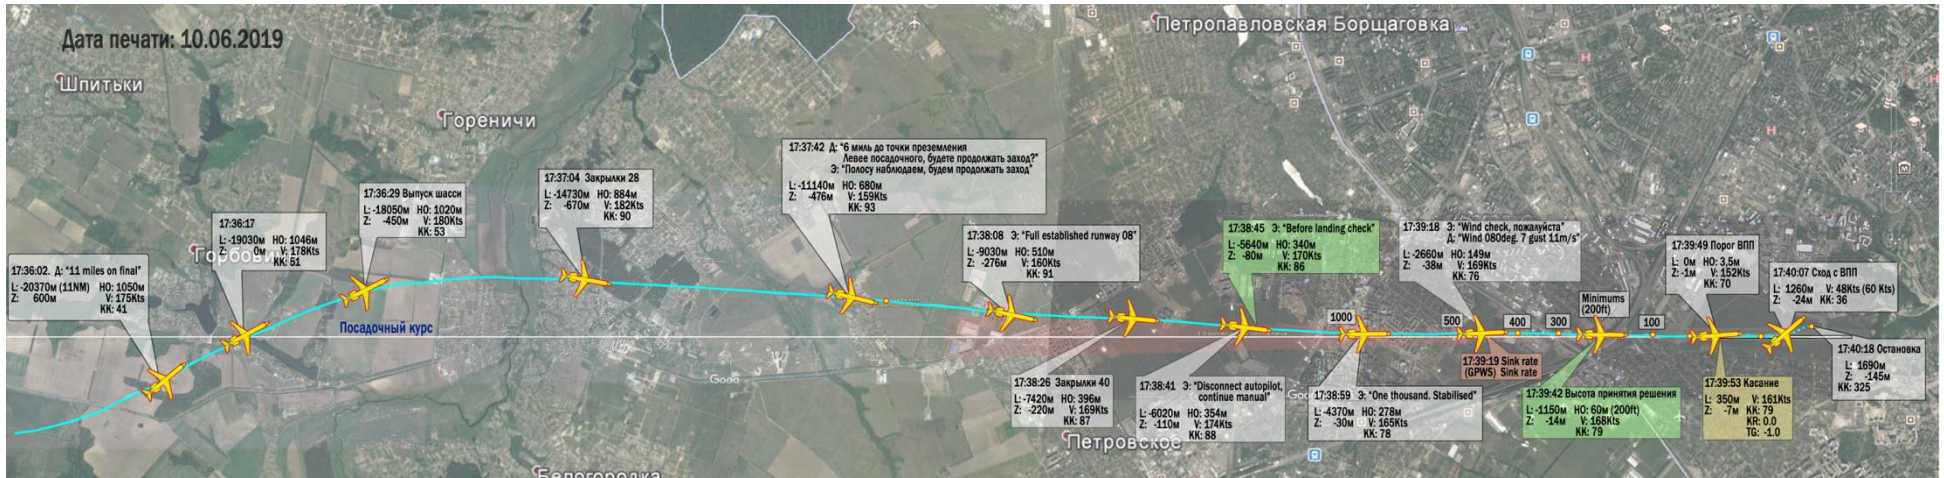
Till the turn on final, the aircraft approached deviated to the right from the runway centerline. In the process of turning to final, the aircraft crossed the landing heading and deviated to the left. The maximum deviation was 730-740 m at the distance of 16 km from the runway threshold. Further, as it approached to the

runway threshold, the aircraft was approaching the landing heading, all the while remaining to the left of the runway center line. At the time of the runway threshold fly-over, the lateral deviation was 1 m to the left of the runway center line.

Fig. 8. Aircraft approach path mapped on earth's surface

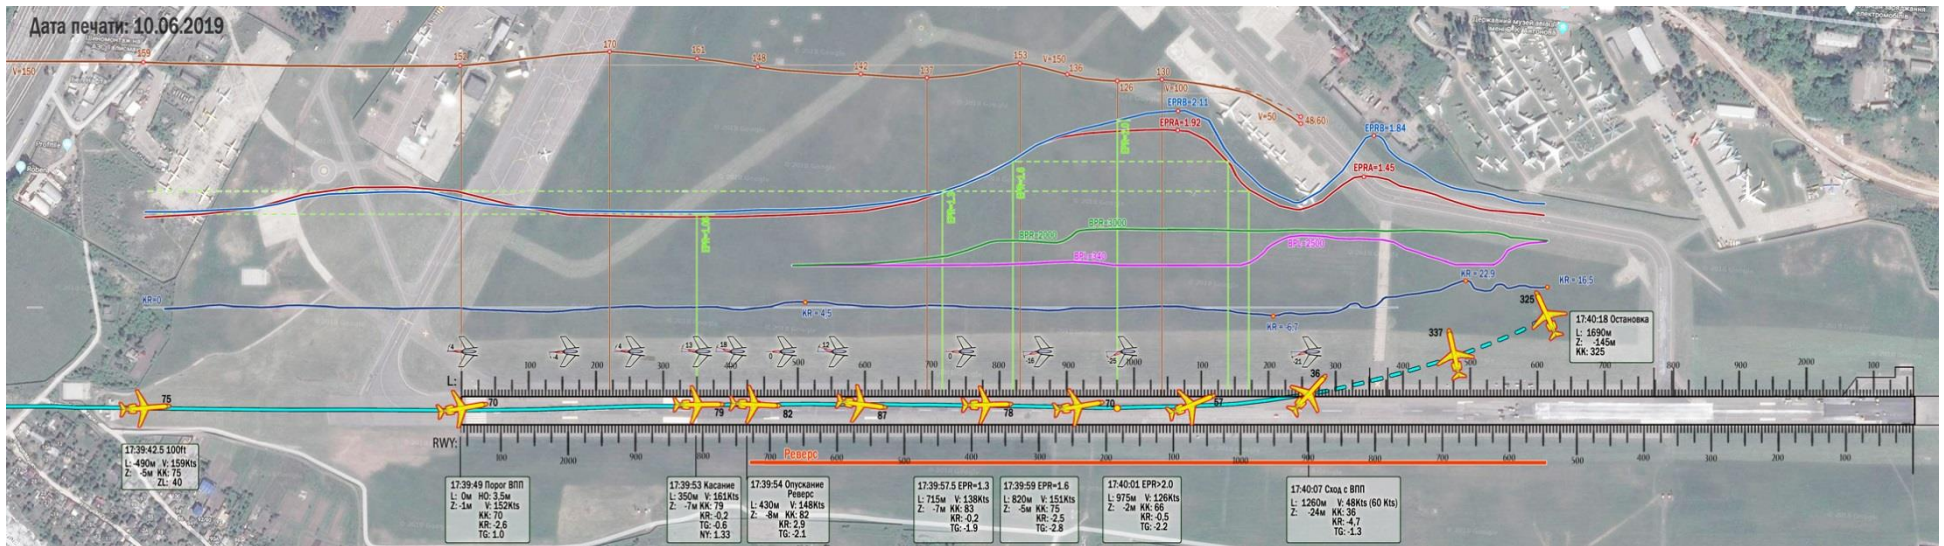
Fig.9. Aircraft path on runway with indicated values of flight parameters, distances from runway threshold and rudder position

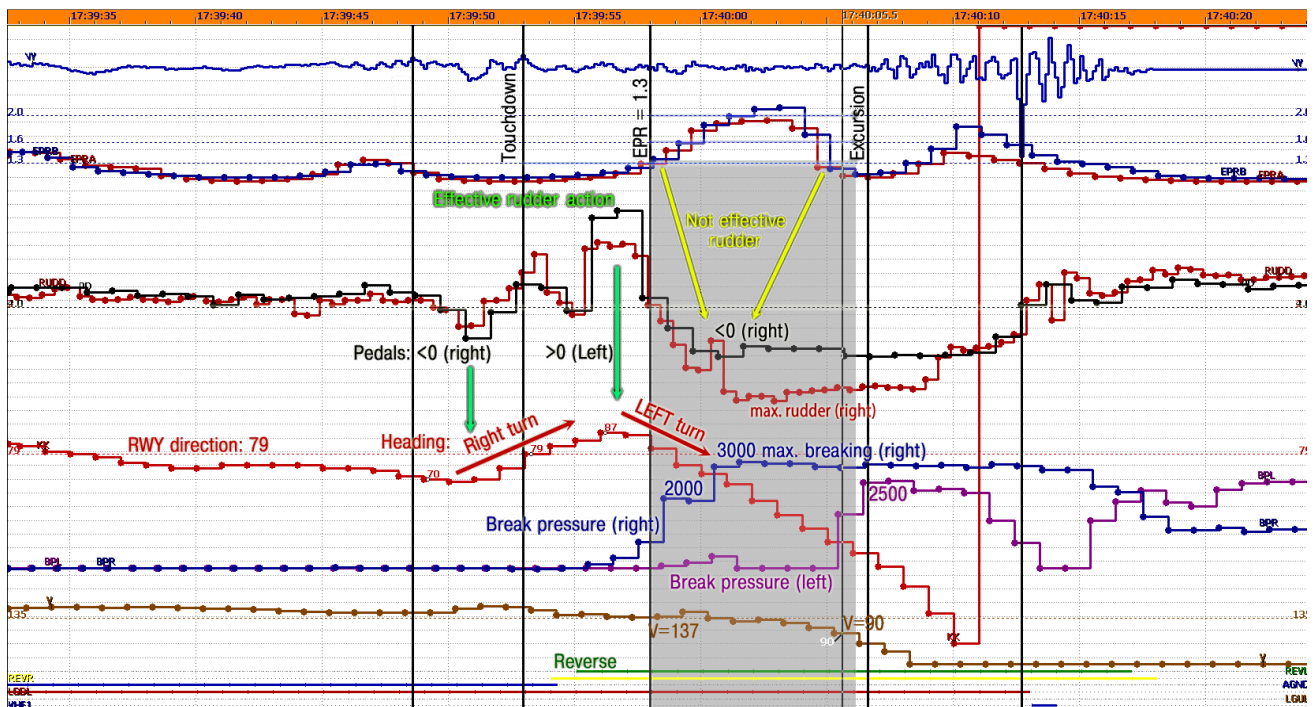
Figure 10.

Figure 10 shows the basic parameters of the position of the aircraft, controls and engine operation modes from the final till the runway excursion and stop outside the runway.

*Movement parameters at touchdown*

**05:39:53 pm: Touchdown.** After the runway threshold fly-over, the rudder deviation to the right (minus), the aircraft starts turning to the right by heading in order to turn to the landing heading (shown in Figure 10 by the first green arrow between the "Threshold" and "Touchdown" markers.) The main landing gear touchdown took place at **05:39:53.5 pm** at the distance of 350 m from the displaced runway threshold, 7 m to

For compensation of the created right-of-heading turning moment for the purpose of landing in the runway heading, **the rudder was twice deviated to the left by 17-21 degrees (80-90% of the rudder movement)** – shown in Figure 10 by the second green arrow between the "Touchdown" and "EPR = 1.3" markers.) The rotation to the right stops (the maximum fixed course was 87 degrees.) As a result of these actions, in 3-3.5 seconds after touchdown, **the aircraft left-of-heading turn begins**.

**05:39:57.5 pm: EPR = 1.3** In 4 seconds after the runway touchdown by the main landing gear, at 715 m from the runway threshold (365 m from the touchdown point), the engine reverse thrust reaches 1.3 EPR and continues to increase. Simultaneously with achievement of EPR = 1.3 in the reverse thrust mode, the aircraft had a tendency to turn by heading and deviate to the left due to the previous deviation of the rudder to the left (Figure 10.) Differential braking of the right landing gear wheels up to the pressure of 2000 psi and then – to the maximum pressure of 3000 psi was applied to compensate the turning moment to the left and maintain the aircraft heading along the
