**NATIONAL BUREAU
OF AIR ACCIDENTS INVESTIGATION OF UKRAINE**

FINAL REPORT

**GROUND IMPACT
OF
SCHROEDER FIRE BALLOONS GmbH G42/24
HOT AIR BALLOON**

REGISTRATION NUMBER: D-OWUE

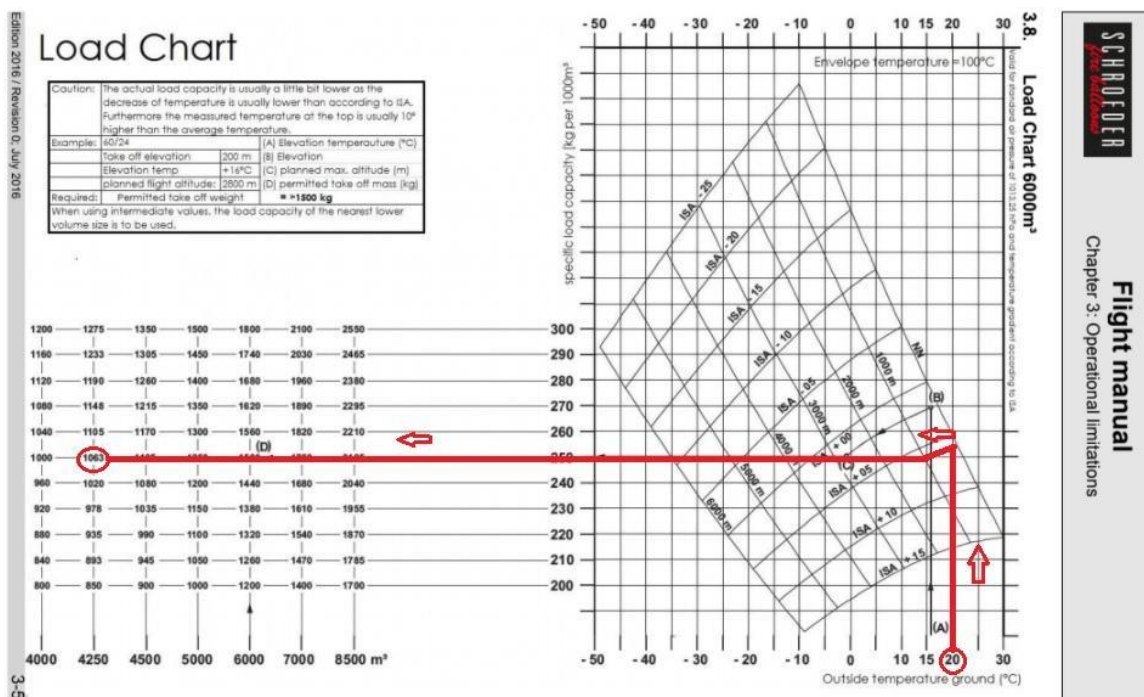
Actual takeoff weight was:

Empty HAB weight	310 kg.
Crew weight (1 crew)	90 kg.
Passenger weight (5 pax)	450 kg.
Fuel weight	63 kg.
Total aircraft takeoff weight	913 kg.

According to the Flight Operation Manual, the maximum take-off weight under these conditions shall be 1063 kg.
