National Bureau of Air Accidents Investigation

INTERIM REPORT ON INVESTIGATION INTO (FATAL) ACCIDENT

Accident site:	Sheparivtsi village, Kolomyia district, Ivano-Frankivsk region.	Number of the case/investigation:	48/2021
Date and time:	28.07.2021 10:35 UTC	AC registration number:	UR-PAMA
AC Type:	WT-10 ADVANTIC	Injuries:	4 persons killed
Type of Flight:	Sightseeing

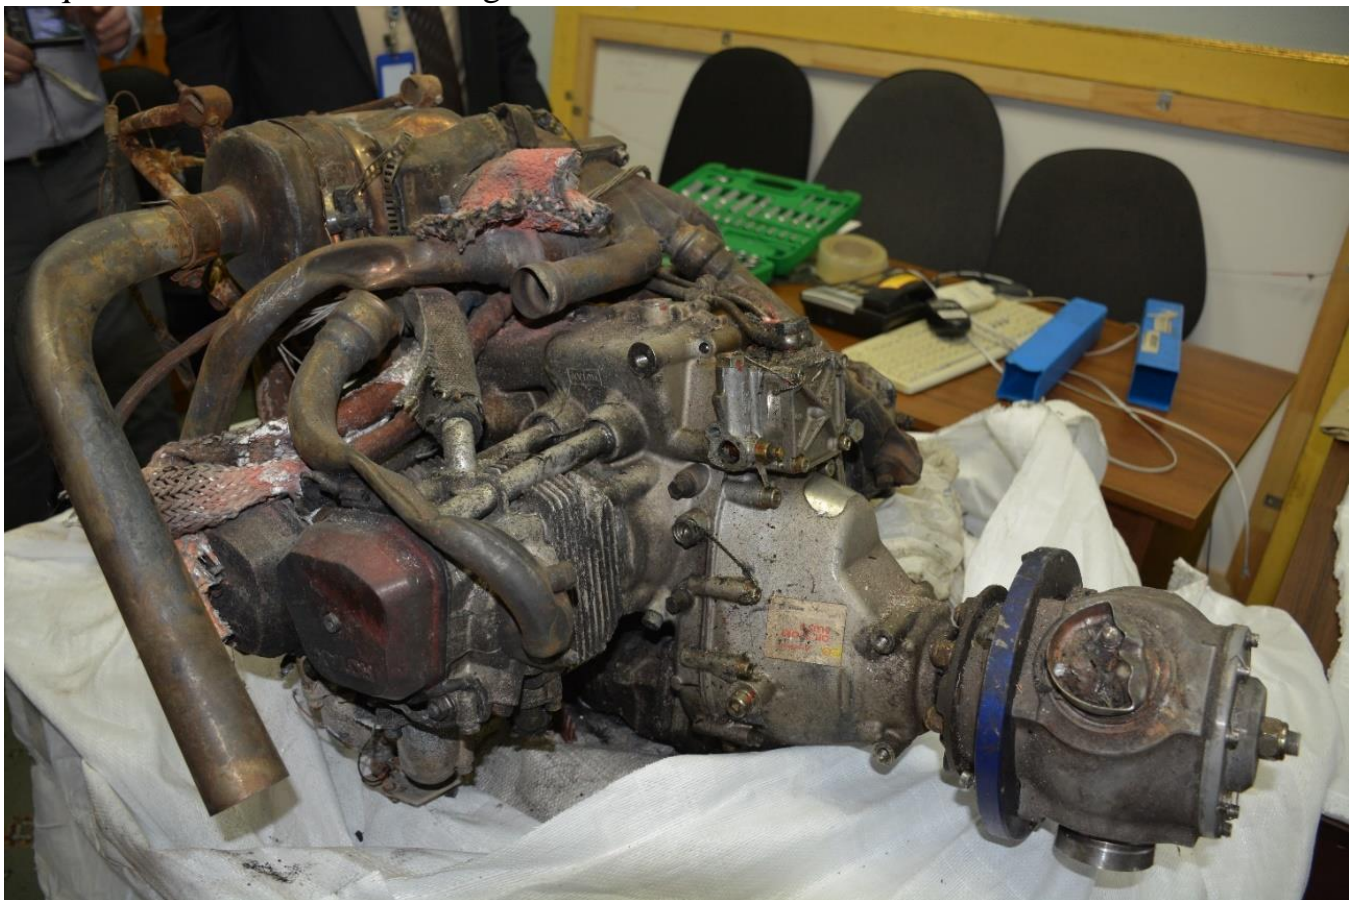
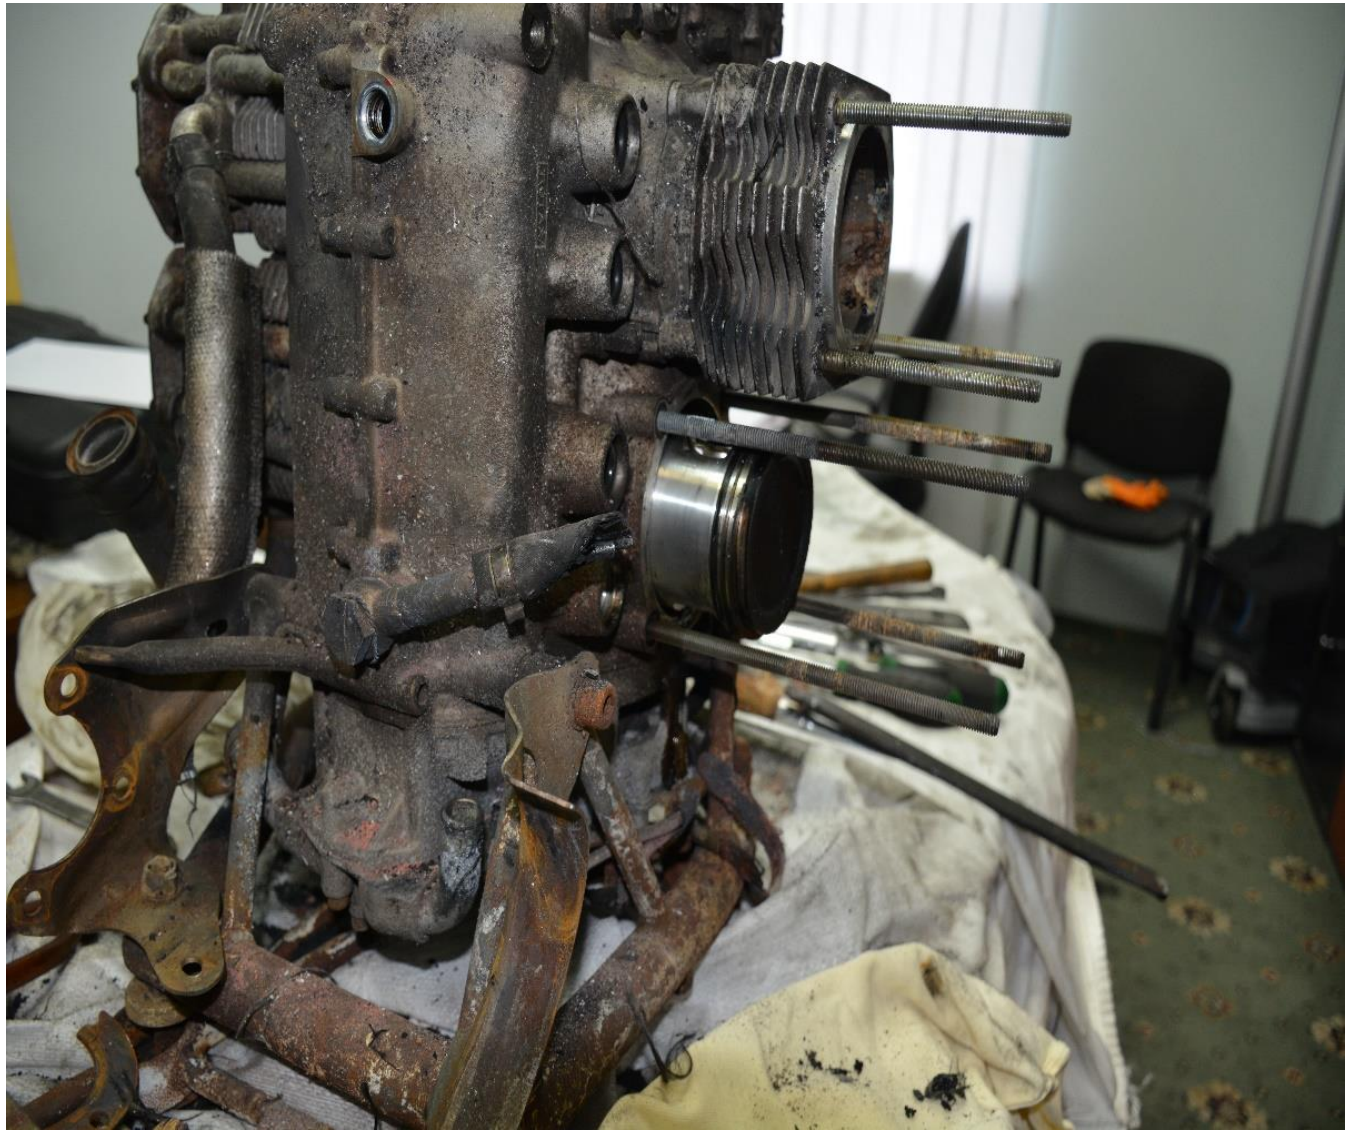
The plane impacted the ground on a private yard under the wall of a two-story stone house on the Prut River side. As a result of the crash, the wires of the power line were broken, the power supply to the surrounding houses was cut off, fruit trees were broken and damaged, the roofs and walls of two outbuildings, the wall of the house and the metal fence of the private territory were damaged. The aircraft wreckage is scattered on the ground on the territory of about 600 m². During the ground impact, a fire broke out, as a result of which the plane completely burned down. Only the engine and some metal parts of the aircraft remained.

The fire broke out after the aircraft impacted the ground. The fire engulfed the aircraft and spread to the building. All four people on board the aircraft received fatal injuries. The people in the house escaped on their own. The private house partially burned down.
