**NATIONAL BUREAU OF AIR ACCIDENTS INVESTIGATION
OF UKRAINE
(NBAAI)**

FINAL REPORT

**OF INVESTIGATION INTO SERIOUS INCIDENT, WHICH TOOK PLACE
WITH CESSNA C510 AIRCRAFT, NATIONALITY AND REGISTRATION
MARK YR-CMO, ON MARCH 03, 2021, DURING PERFORMANCE OF
FLIGHT EN-ROUTE KYIV (ZHULYANY) – ODESA**

**of Investigation into Serious Incident (Take-Off from Left Shoulder of RW-26),
Which Took Place with Cessna C510 Aircraft, Nationality and Registration
Mark YR-CMO, Operator – CONARG MOTION S.R.L., on March 03, 2021,
During Performance of Flight En-Route Kyiv (Zhulyany) – Odesa**

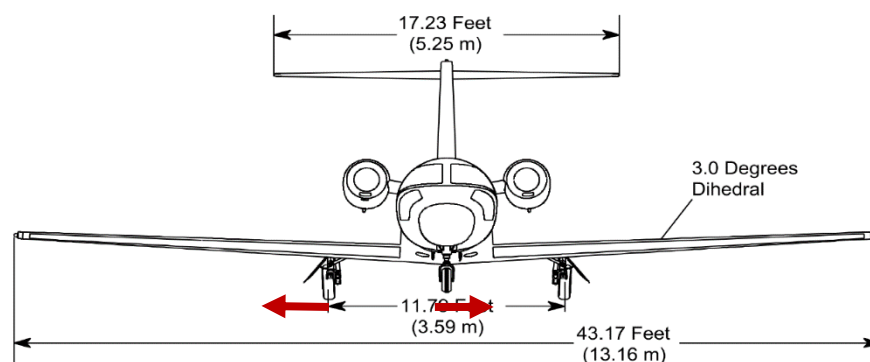
Fig. 10. Dimensions of the Cessna C510-type aircraft

The NTSB was requested for the data regarding the dimensions of the Cessna C510-type aircraft – in order to confirm the assumption about the type of the aircraft that left tire tracks while performing take-off from the RW-26 shoulder. According to the information provided by the aircraft manufacturer, the track width of the Cessna C510 aircraft is 11.79 feet (3 m 59 cm), which corresponds to the track width left on the left shoulder of RW-26.
