**NATIONAL BUREAU
OF AIR ACCIDENTS INVESTIGATION**

OCCURRENCE CLASS:	FATAL ACCIDENT
AIRCRAFT OPERATOR:	Private Person
AIRCRAFT TYPE:	WT10 Advantic
REGISTRATION:	UR-PAMA
OCCURRENCE LOCATION:	Outskirts of Sheparivtsi Village, Kolomyia District, Ivano-Frankivsk Region
STATE OF OCCURRENCE:	UKRAINE
DATE OF OCCURRENCE:	July 28, 2021.

Final Report

**on Investigation into Fatal Accident with WT10 Advantic UR-PAMA Aircraft
Manufactured by AEROSPOOL Ltd (Slovakia), Operated by Private Person,
Which Took Place on July 28, 2021, at Outskirts of Sheparivtsi Village,
Kolomyia District, Ivano-Frankivsk Region, During Recreational Flight.**

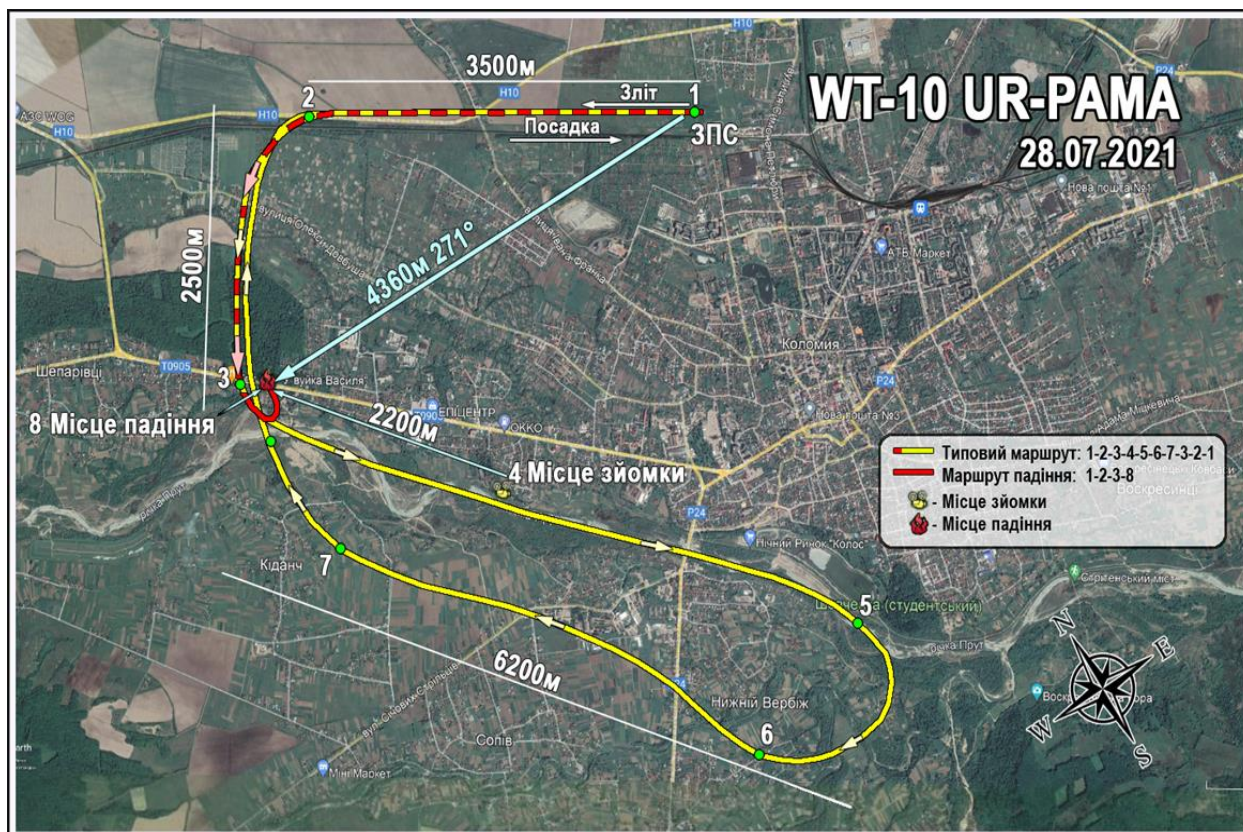
Calculation of Aircraft Flight Trajectory and Route Layout.

Місце падіння = Ground Impact Location; Місце зйомки = Filming Location.
